Single Event Effects and Their Mitigation for the Collider Detector at Fermilab

Richard J. Tesarek, Saverio D'Auria, Peter Dong, Andy Hocker, Kostas Kordas, Susan McGimpsey, Ludovic Nicolas, Rainer Wallny, Wayne Schmitt, and Steven Worm
(CDF radiation monitoring group)

Abstract— We present an overview of radiation induced failures and operational experiences from the Collider Detector at Fermilab (CDF). In our summary, we examine single event effects (SEE) in electronics located in and around the detector. We present results of experiments to identify the sources and composition of the radiation and steps to reduce the rate of SEEs in our electronics. Our studies have led to a better, more complete understanding of the radiation environment in a modern hadron collider experiment.

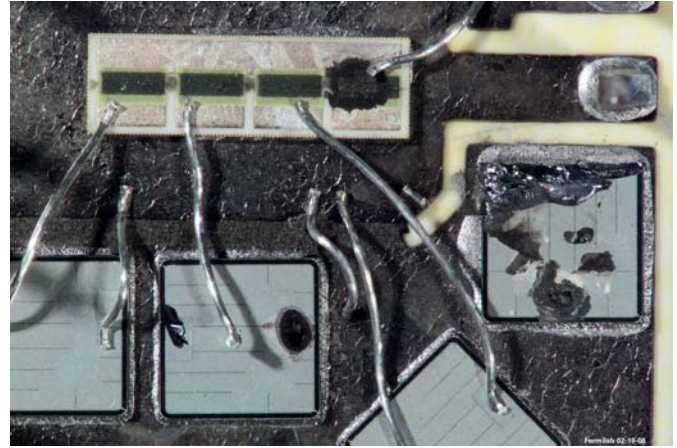
Fig. 2. Photograph of the power MOSFETs in the switching supply power factor corrector circuit after undergoing a single event burn-out. Note the fractured silicon and the burn marks near the wire bonds.

The failures were tracked down to a power MOSFET in a power factor corrector circuit in the supply which underwent a single event burn-out (SEB) [5]. Figure 2 shows a photograph of a failed power MOSFET in the circuit. From the photograph, one can see that the failure was quite spectacular as the silicon of the failed MOSFET has sublimated. In many of the failures, the epoxy covering of the power factor corrector circuit had cracked or chipped above the failed MOSFET.

The sensitivity of the offending power MOSFET to radiation was evaluated using 200 MeV protons at the Indiana University Cyclotron Facility. The SEB cross was measured as a function of the source-drain voltage difference (V_{sd}) for the failing component and several candidate replacements. The results of these cross section measurements are shown in Figure 3. Working with the power supply engineers at ASTEC [4], we learned that the lead time for a re-designed supply was over a year. However, the power supply could be run with a $V_{sd} = 350$ V, 50 V lower than originally designed without compromising the performance of the supply. The change was implemented in the spring of 2002. No failures of these supplies

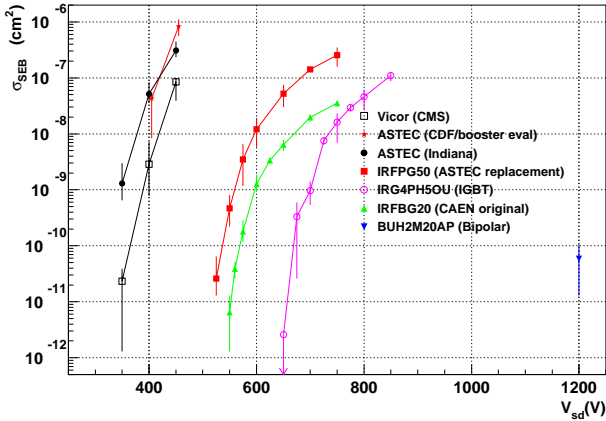
Fig. 3. Single event burn-out (SEB) cross sections for 200 MeV protons as a function of the source-drain voltage (V_{sd}) for the failed MOSFET (denoted ASTEC) and several candidate replacement components. Note the suppressed zero for the horizontal axis. The original operating voltage was 400 V and was reduced to 350 V.

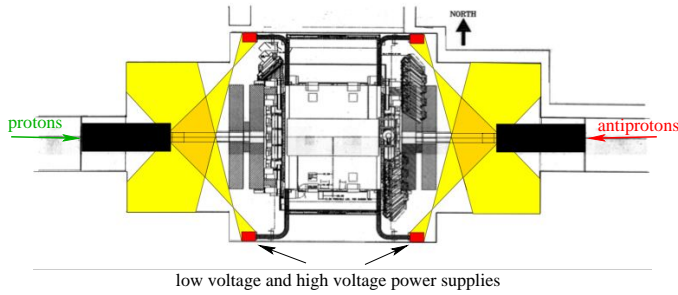
Fig. 5. Plan view of the CDF collision hall. The black regions represent new shielding around the final focus quadrupoles. The shaded regions represent the electronics view of the beam-line. The shielding reduces the solid angle subtended by the beam-line at the electronics by approximately 25%.

In order to reduce the charged particle radiation at the detector electronics, a 45 cm thick iron shield was added surrounding the quadrupole magnets over the region of the magnets which could be shielded. A schematic of the shielding in the collision hall is shown in Figure 5. The shielding reduces the solid angle of the beam-line observed by the electronics by approximately 25%.

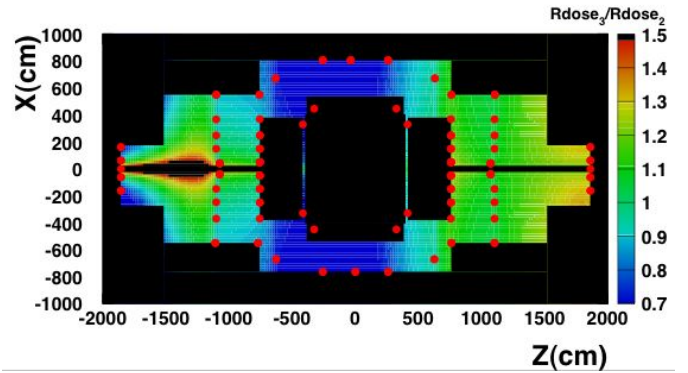
The effectiveness of a shield installed on the incoming proton ($-z$) side of the detector was evaluated using TLD measurements. Figure 6 shows the ratio of measurements taken after the above shield was installed, R_3 , to the same measurements taken before a shield is installed, R_2 . The new shielding reduced the radiation in the regions where SEE were observed in the high voltage and low voltage power supplies by 25%. The increase in the radiation on the incoming antiproton ($+z$) side of the collision hall is due to the removal of a restricting aperture which was acting as a shield upstream of the detector.

Fig. 6. Ratio of ionizing radiation measured after a shield was installed (R_3) relative to no shield (R_2). The evaluation was performed for a shield installed on the incoming proton ($-z$) side of the detector only. The red dots indicate positions of TLD chips used for these measurements. A 25% reduction in the ionizing radiation is observed at the locations of radiation sensitive electronics.

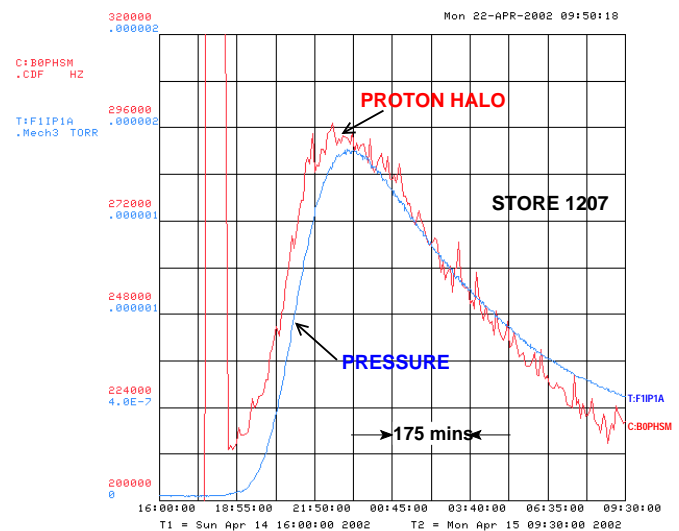
In addition to shielding, one may reduce the radiation in the CDF collision hall by reducing the amount of beam lost. A system of scintillation counters is installed to measure and monitor the amount of beam lost near CDF. Details of the counter systems are given in reference [11]. Figure 7 shows the rate in one of the counter systems and the Tevatron vacuum in a short warm section of the Tevatron as a function of time. This figure lead to a program to improve the vacuum throughout the

Fig. 7. Rates in scintillation counters surrounding the beam (proton halo) and vacuum in a warm section of the Tevatron (pressure) as a function of time during a proton- antiproton store. Improvements in the Tevatron vacuum have lead to a reduction in beam losses (as measured above) of over 40%.

Tevatron and reduced the lost beam by over 40%. Since the improvements in the beam quality are incremental, improvements in the reliability are difficult to quantify.
