Magnet Reliability in the Fermilab Main Injector and Implications for the ILC

M. A. Tartaglia, J. Blowers, D. Capista, D. J. Harding, O. Kiemschies, S. Rahimzadeh-Kalaleh, J. C. Tompkins

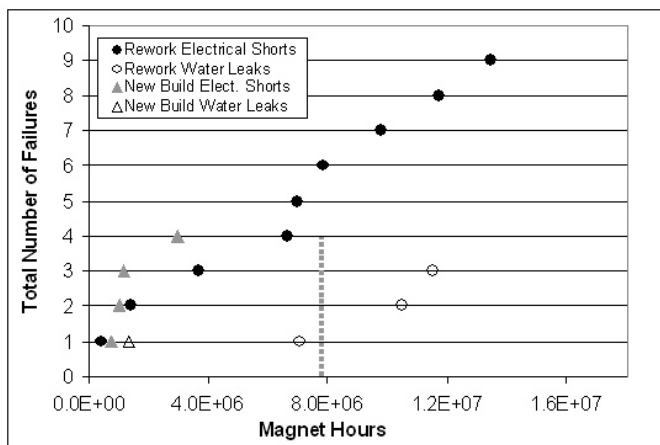
Fig. 1. History of quadrupole magnet failures in the Fermilab Main Injector. Dashed line shows newly built FMI quadrupole service time, and full scale shows the total number of magnet hours for rebuilt Main Ring quadrupoles.

The actual history of failures in these categories, from start of operations to present, is plotted in Fig. 1 separately for all newly constructed FMI quadrupoles and refurbished Main Ring quadrupoles. In this figure, the full time scale represents the total service history for the reworked Main Ring quadrupoles, while the newly designed and built FMI quadrupoles have experienced about half that, as shown by the

vertical dashed line. Not shown in Fig. 1 is the single Main Ring dipole electrical failure, which occurred after $7.12E+06$ integrated magnet hours of reworked dipole operation in the FMI.
