CM2, SECOND 1.3 GHZ CRYOMODULE FABRICATION AT FERMILAB*

Abstract

CM2 is the second 1.3GHz Cryomodule assembled at the Cryomodule Assembly Facility (CAF) in Fermi National Accelerator Laboratory. The string has a corrector coil magnet, a beam position monitor and eight cavities. All cavities are qualified at ≥ 33 MV/m gradient at the Horizontal Test Facility (HTS) before assembly. The dressed cavities were outfitted with magnetic shielding, blade tuner. The cold mass was assembled based on the Tesla TTF Type III+ cryomodule design. CM2 is currently being installed into the test stand in NML where it will be cooled down and high power tested. CM2 will also be the first cryomodule to be tested with an electron beam at the NML facility. This paper describes the assembly steps, the quality assurance methods and the challenges experienced during assembly and qualification at CAF.

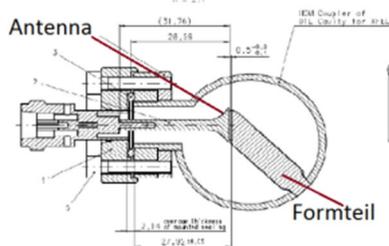
Figure 9: HOM Antenna assembly to the HOM Coupler

During the electrical quality assurance checks of CM2 cryomodule, electrical shorts were found in three cavities at the high order mode (HOM) feedthrough connectors. An investigation of component dimensional tolerance stack up was undertaken to determine the cause. As it can be seen from Figure 9, the design distance between the antenna tip and the formteil is 0.5 mm. Taking into account that the antenna is assembled on the connector with a press-fit method in the cleanroom prior to the assembly of the feedthrough flange to the cavity, a tolerance stack up due to out of spec dimensions of individual components might cause an electrical short when the tip of the antenna touches the formteil.

It was deemed that this problem will not be a critical issue for CM2 operations. However, all components in inventory were measured and the antenna tips were trimmed appropriately. It was also decided to conduct capacitance measurements on feedthrough flanges after these are assembled on the cavity in the cleanroom to ensure that there are no shorts.
