BROOKHAVEN NATIONAL LABORATORY

SSC Technical Note No. 71

Analysis of Commercial Cabling  
at  
New England Electric Wire Corporation  
Under Contract to  
Oxford Superconducting Technology

March 16, 1988

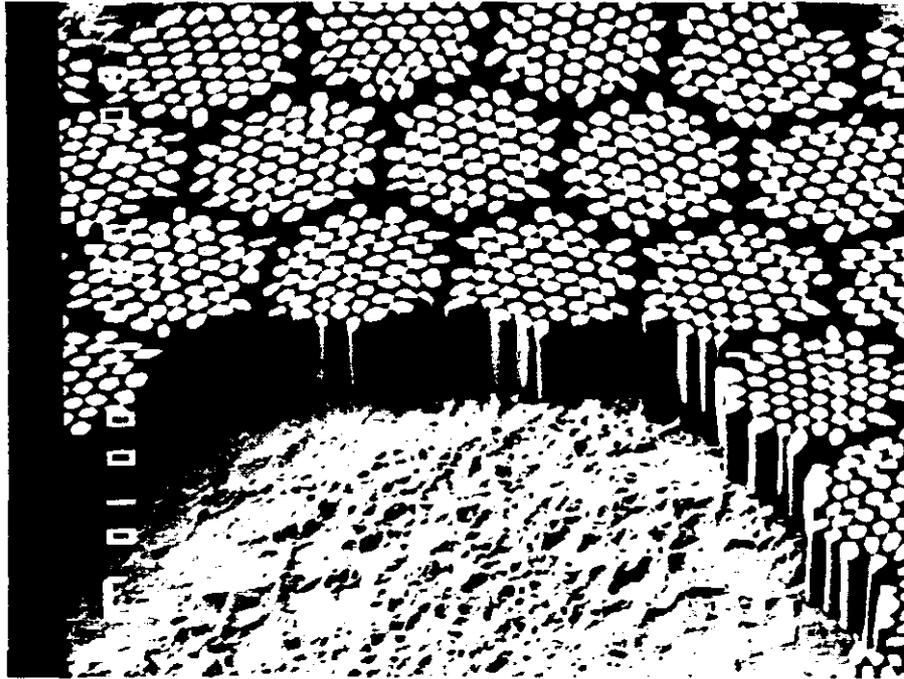
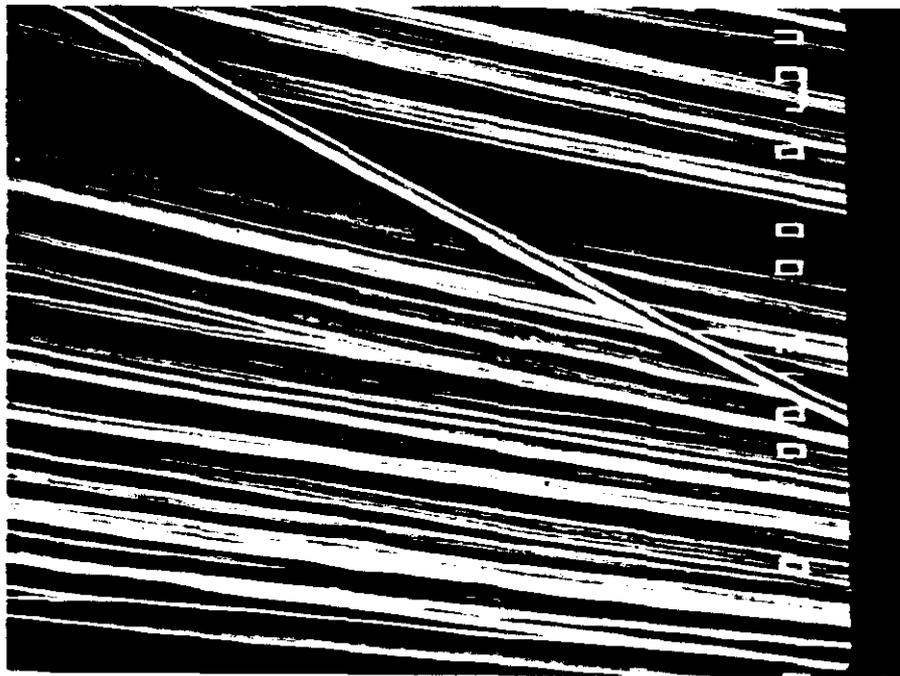
Figure 6.

Even though Fig. 6 shows that the OST wire used in this cabling run exhibited distortion of some filaments and slight sausageing, the wire appears to be typical for NbTi conductor.

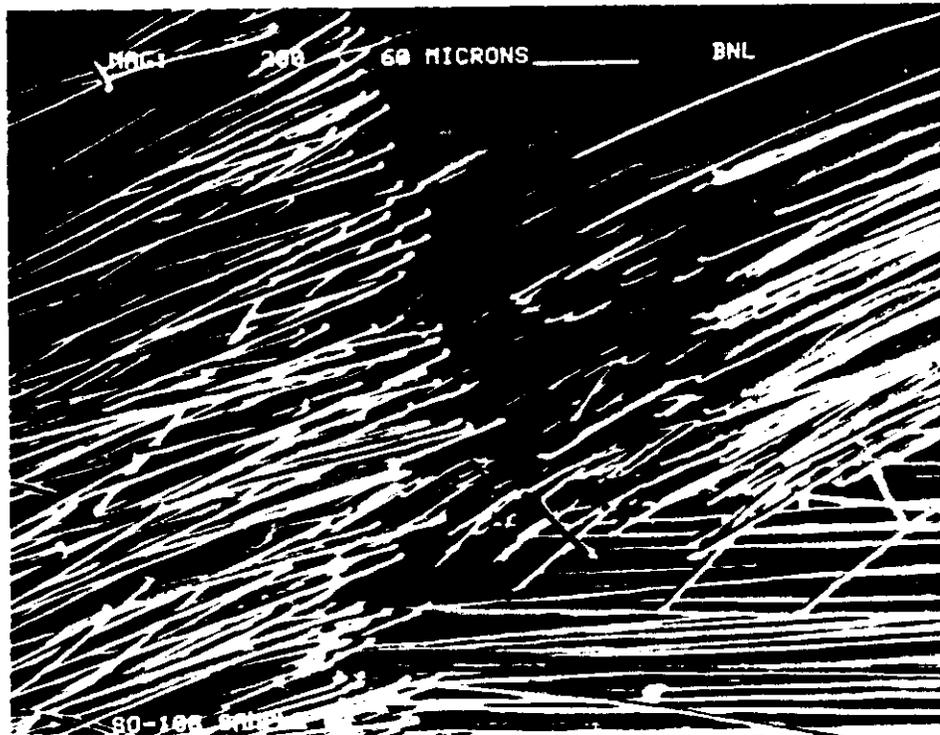
Figure 10.  
A Typical Broken Strand.

In addition to mean thickness measurements, these samples (each 10" - 12" long) were acid etched and examined under a microscope. Extensive filament damage was observed (see Fig. 10). The broken strands were noted and recorded (see Worksheets 1 thru 6). As one can see, there is no pattern to the breaks and the same strand, in most cases, did not break in every "pitch length" section of the cable. However, the breaks in each strand did appear along the same corner of the thin edge. One sample of cable was removed from the spool and its orientation noted and traced back to the turkshead roller (Fig. 11). This sample shows that the strand is breaking as it comes out of the thin edge and lays on the long flat side.

From this analysis one may conclude that the broken strands were not caused by over compressing of the cable as  $T_m$  was well within the cable specifications. The breaks are random and form no pattern with regard to which strands break. Furthermore, all breaks are consistent in their location within the cable.

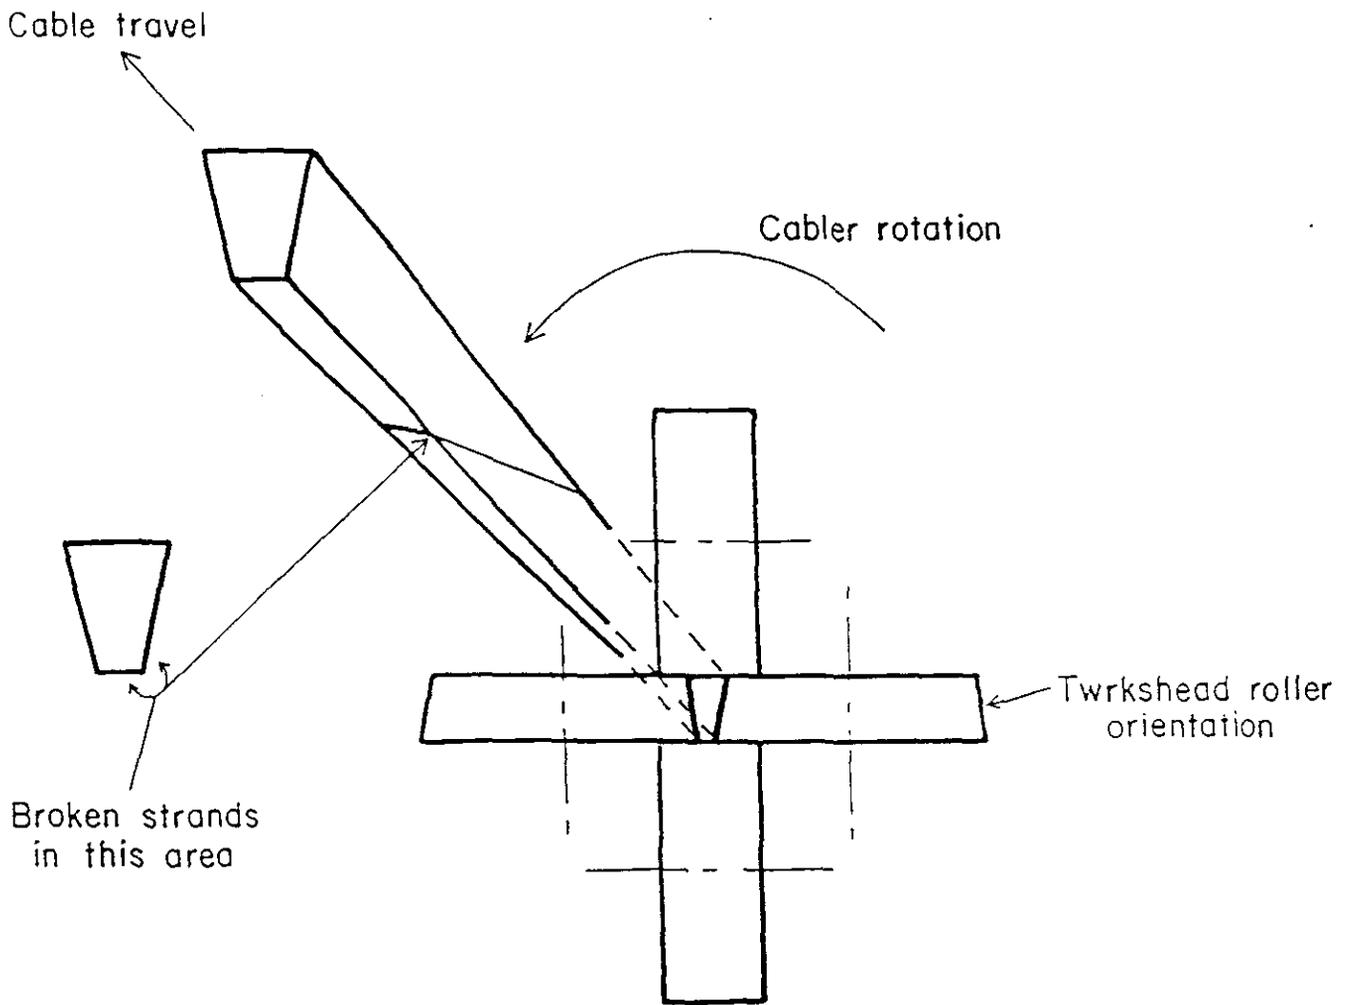
Figure 11.

Broken Strand Orientation
