Wayne Koska
1-21-91

Failure of DC0303 During Impulse Test

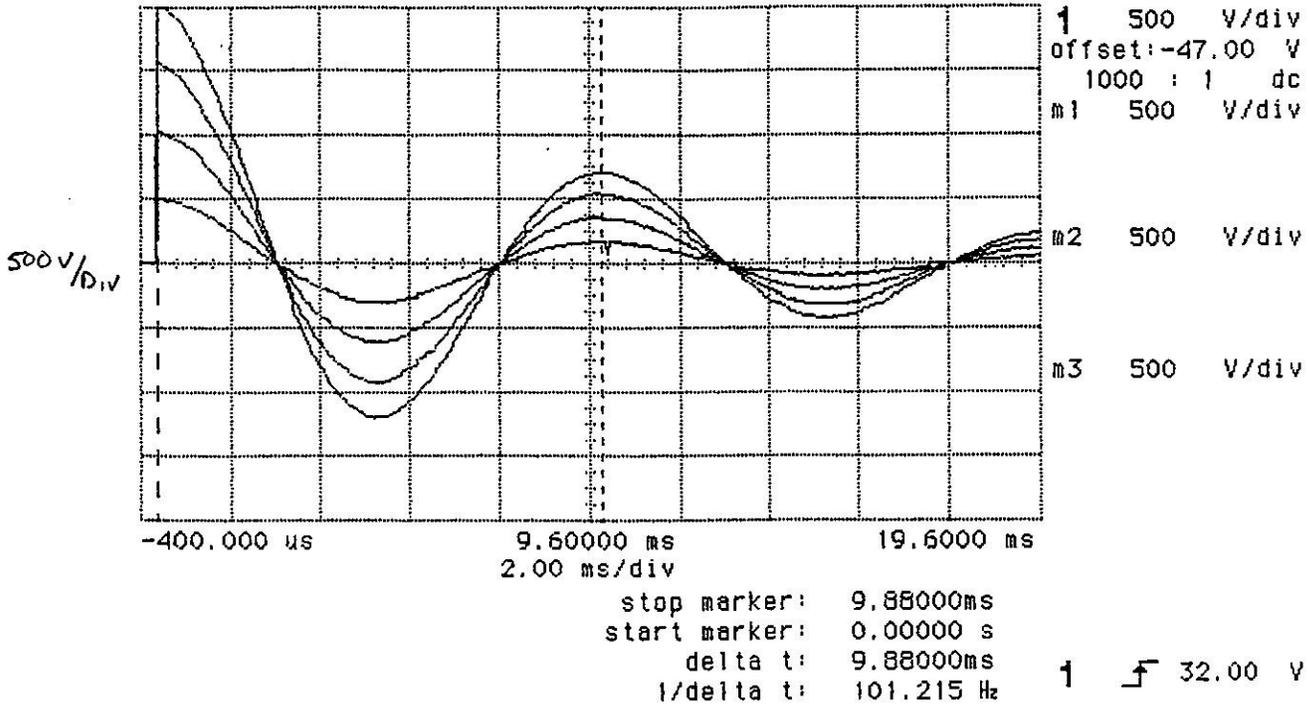
Figure 1

303 WHOLE MAGNET

Whole Magnet
DC ϕ 3 ϕ 3

Collared Coil Assembly

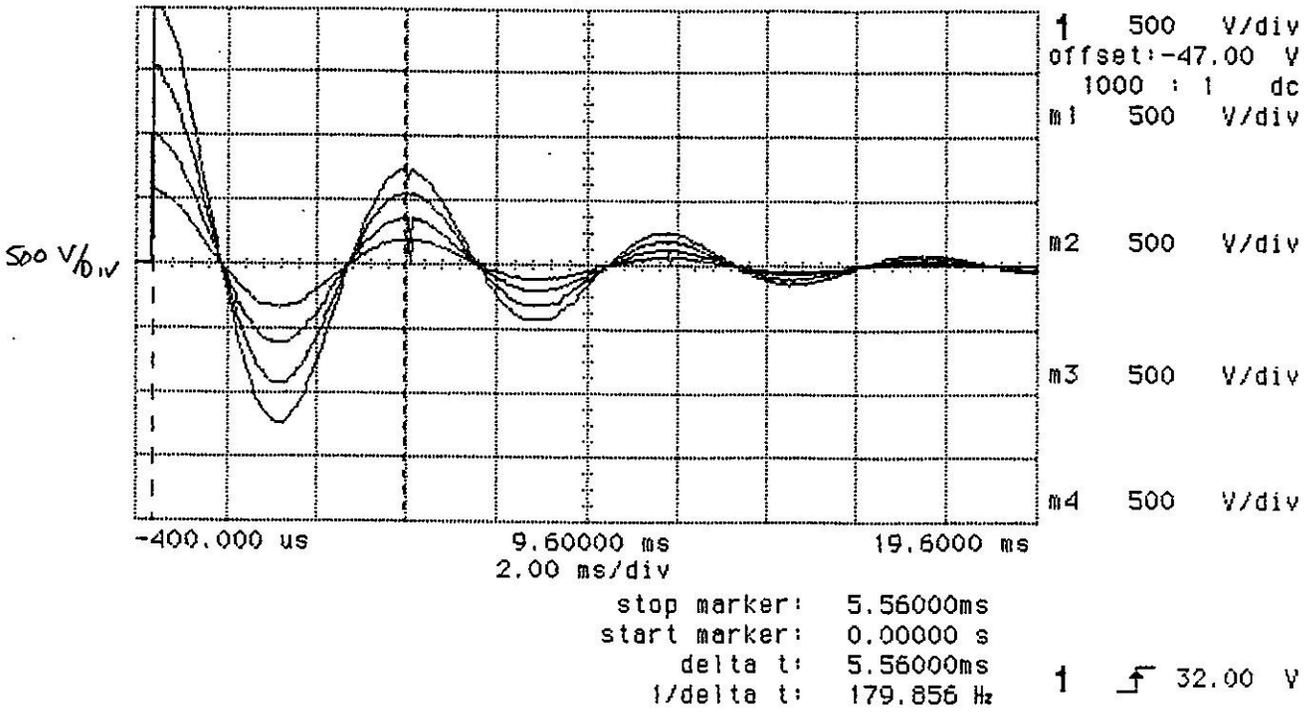
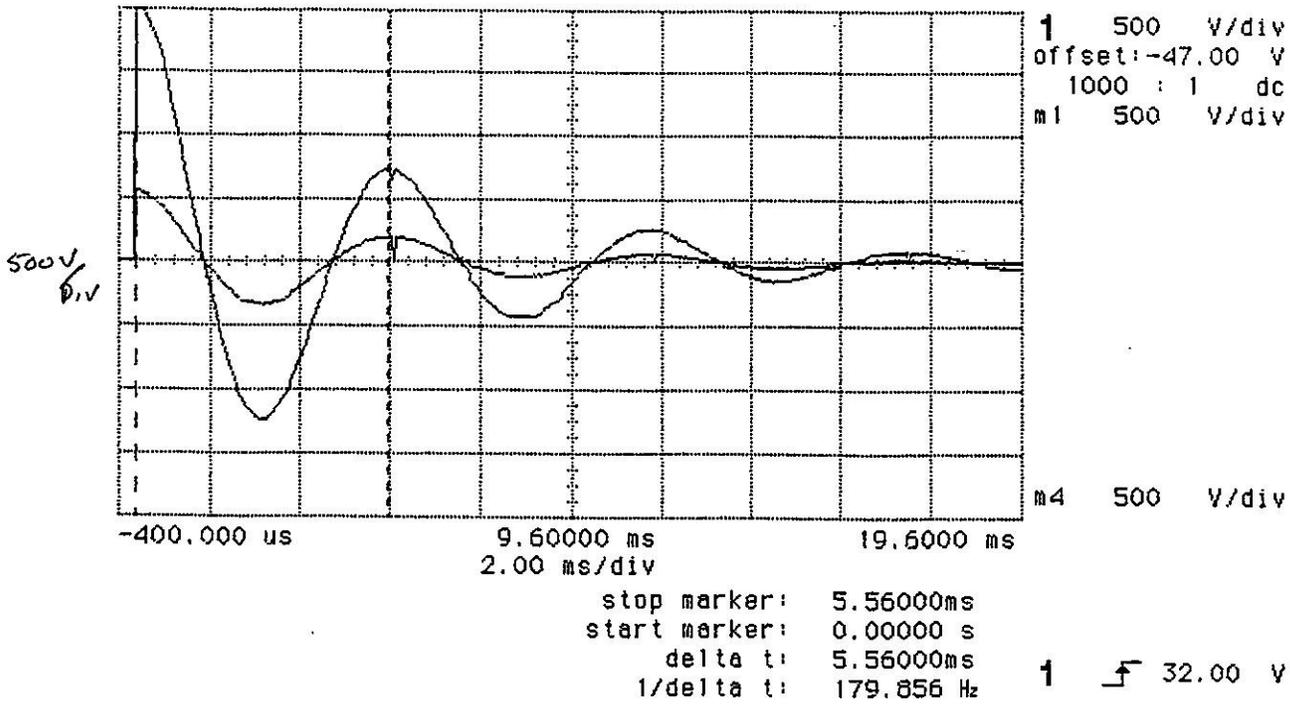
Figure 2

Upper Coils

Collared Coil Assembly

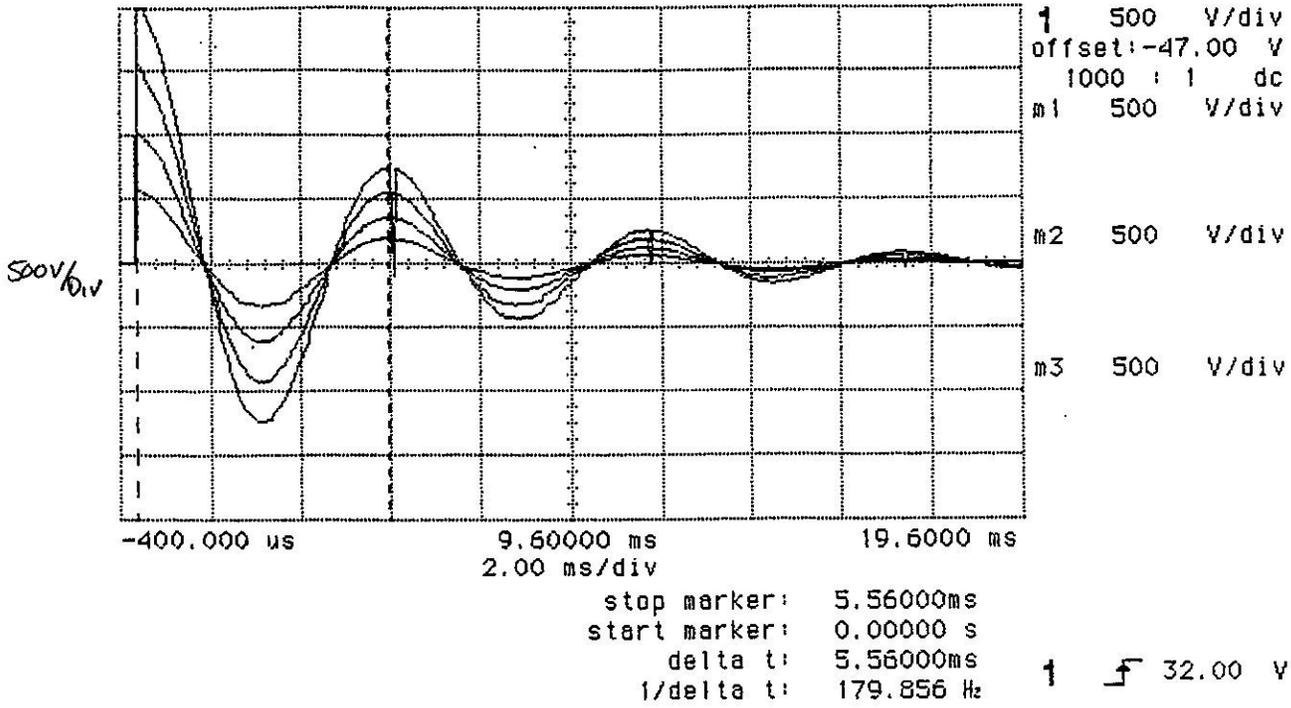
Figure 3

LOWER Σ
Lower coils
DC ϕ 3 ϕ 3

Collared Coil Assembly

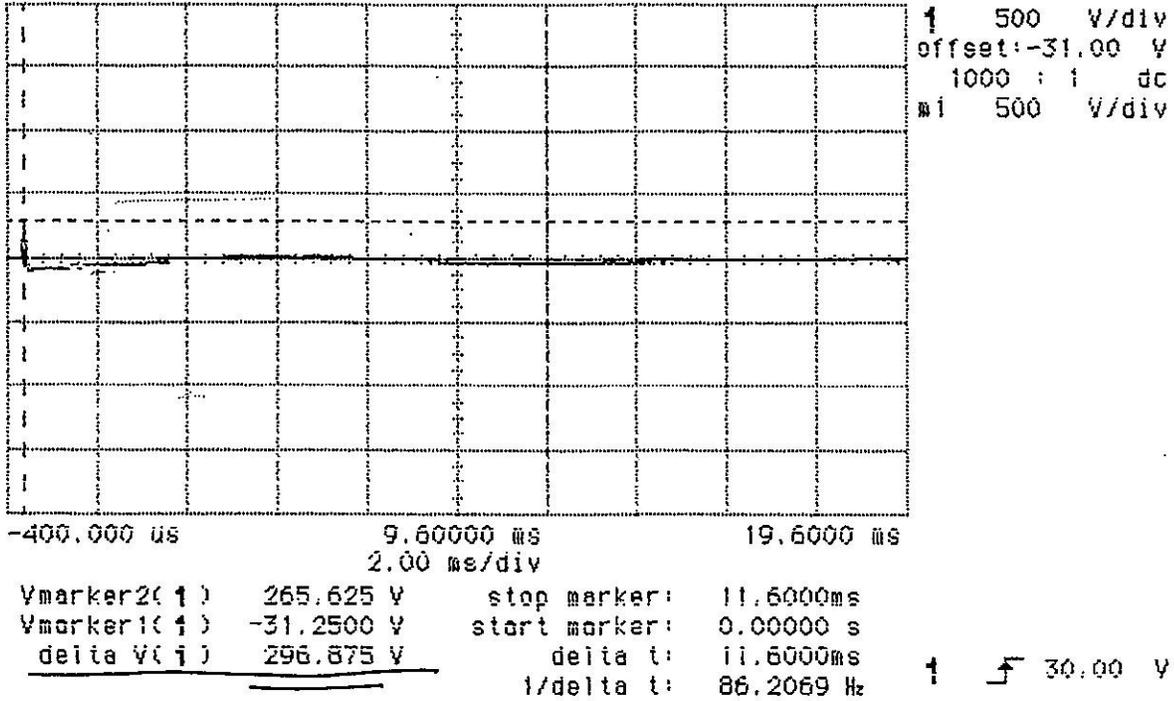
Figure 4

To summarize, an electrical breakdown occurred in DC0303 between the upper and lower inner coils across the mid-plane during impulse testing at 500 V. The magnet had successfully withstood D.C. hipotting across the mid-plane to 3000 V before the upper to lower splice had been made, and impulse testing, to a maximum of 2000 V, of the collared coil assembly.

Whole Magnet

Yoked Coil Assembly

Capacitor Voltage = 500 V
