TS-SSC 91-058
March 29, 1991
Masayoshi Wake

DS0314 Inspection Memo

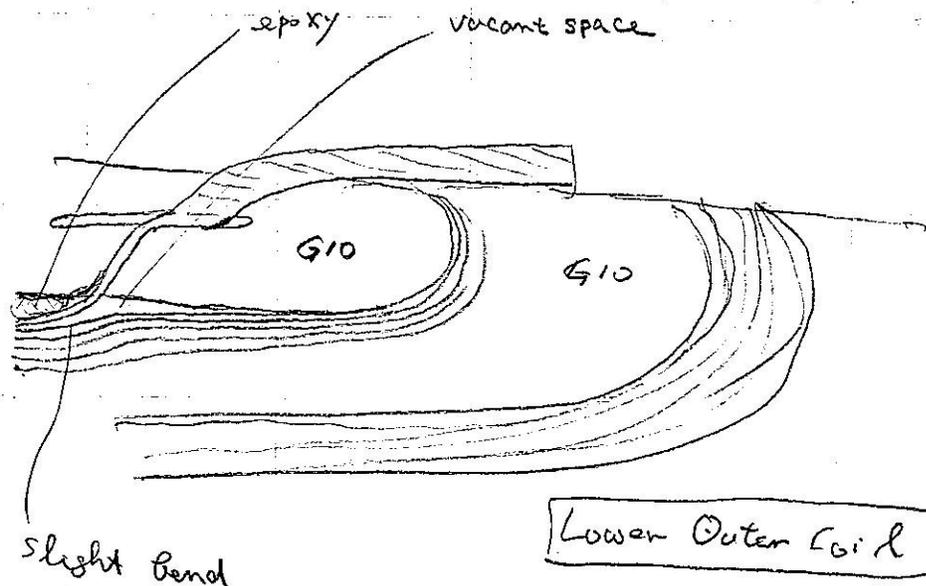
The end part of DS0314 was taken apart to find the cause of unexpected quenches in the lower outer coil near the land splice. A peculiar thing in this coil was a large gap between the coil and the G10 key. The gap was about 2 mm in the lead side while others had less than 1 mm gap. Actually, the G10 key was not pushed in to the proper position and had a tilt to the coil.

Since the next turn had a slight bend toward the midplane at this position, this may be caused by the too much epoxy to protect the voltage tap. A clod of epoxy at the voltage tap prevented the G10 key from properly pressing the pole turn and the land splice.

Since they have to use epoxy before the clamping, this could happen in any magnet. These epoxy should be used minimum amount and has to be dried with proper clamping not to create an obstacle for the closing of gaps. Use of some tempolary end clamp might be necessary.
