TS-SSC 91-245
12/30/91
G. Tassotto

LOCATION OF UPPER INNER LEAD TO GROUND SHORT IN MAGNET DCA315

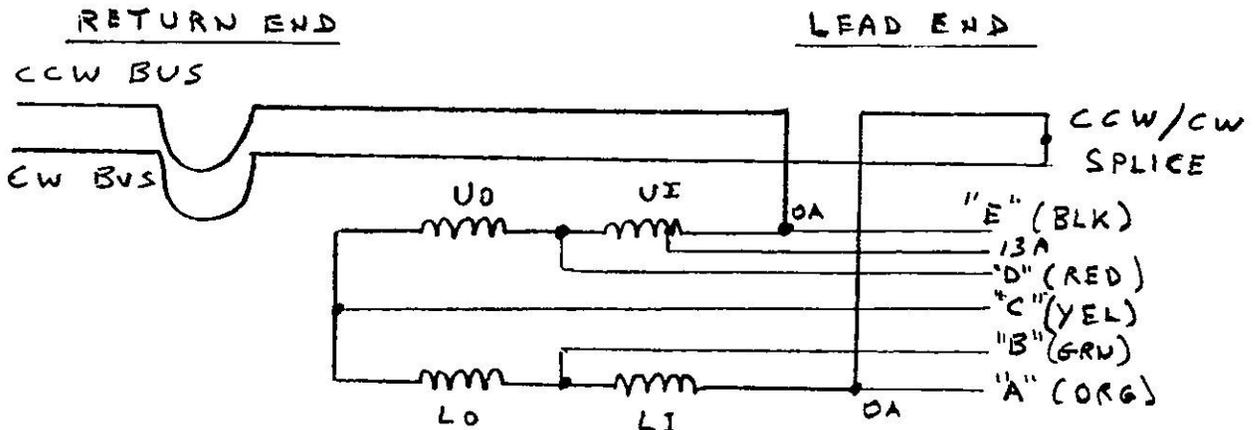
On Wednesday 11/27/91 technicians found what looked like a bus to ground short during an electrical checkout prior to end-dome assembly installation. FNAL magnet DCA315 is electrically connected in a CCW configuration. This means that, for the single magnet test, the magnet leads are connected to the bus as shown below. See also FNAL DRW# ME-167548 and # MB-292688 Rev. A.

After troubleshooting we determined that the short was localized between the lead end plate and the end cap.
