DCA316 Production Report

DCA316 is the sixth complete 50 mm SSC dipole magnet built at Fermilab and the fourth that was assembled by General Dynamics personal. It is built according to the specifications in "50 mm Collider Dipole Magnet Requirements and Specifications", Baseline Issue, August 16, 1991 ("The Yellow Book"). It contains no intentional deviations from the baseline design.

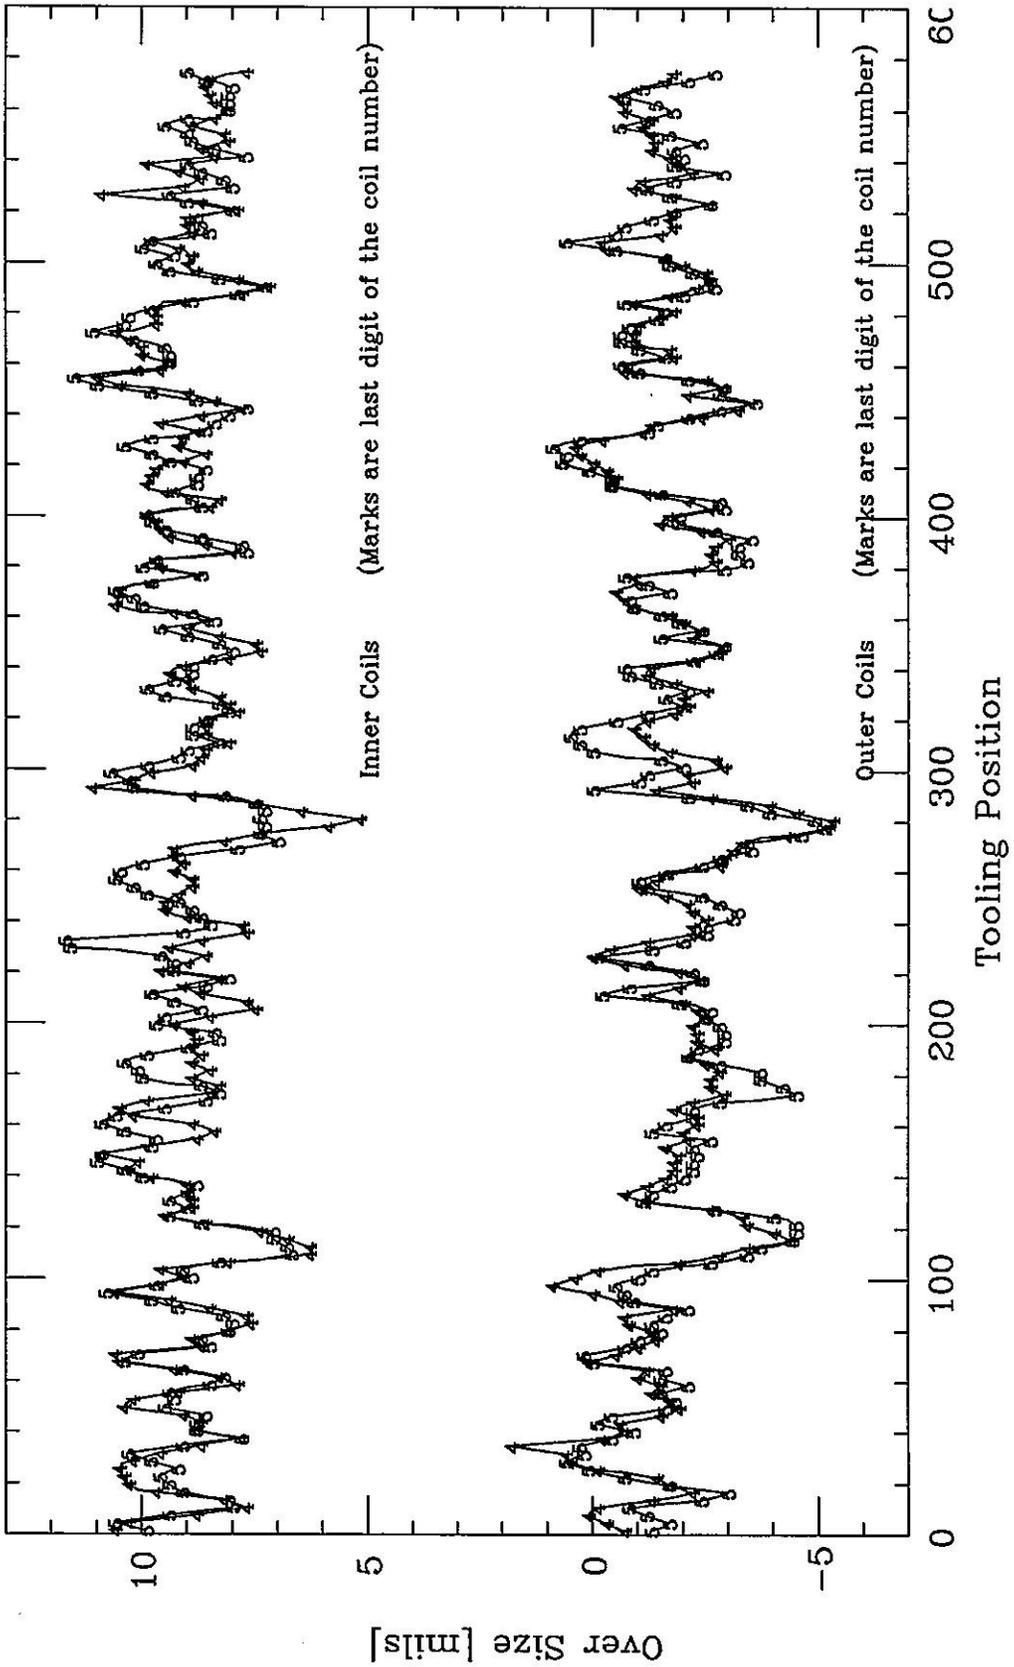
Fig 1-B

The averaged coil sizes were very well controlled at this stage of production. However, the coil size distribution had large variation as shown in Fig.1. This has been an unsolved problem in this series of production coils. The gage pack position was assigned to the minimum and maximum size of inner coils *i.e.* 57" and 9" toward the lead end from the center of the magnet (TS-SSC-92-020).

DCA316 Coils (II/IV side)

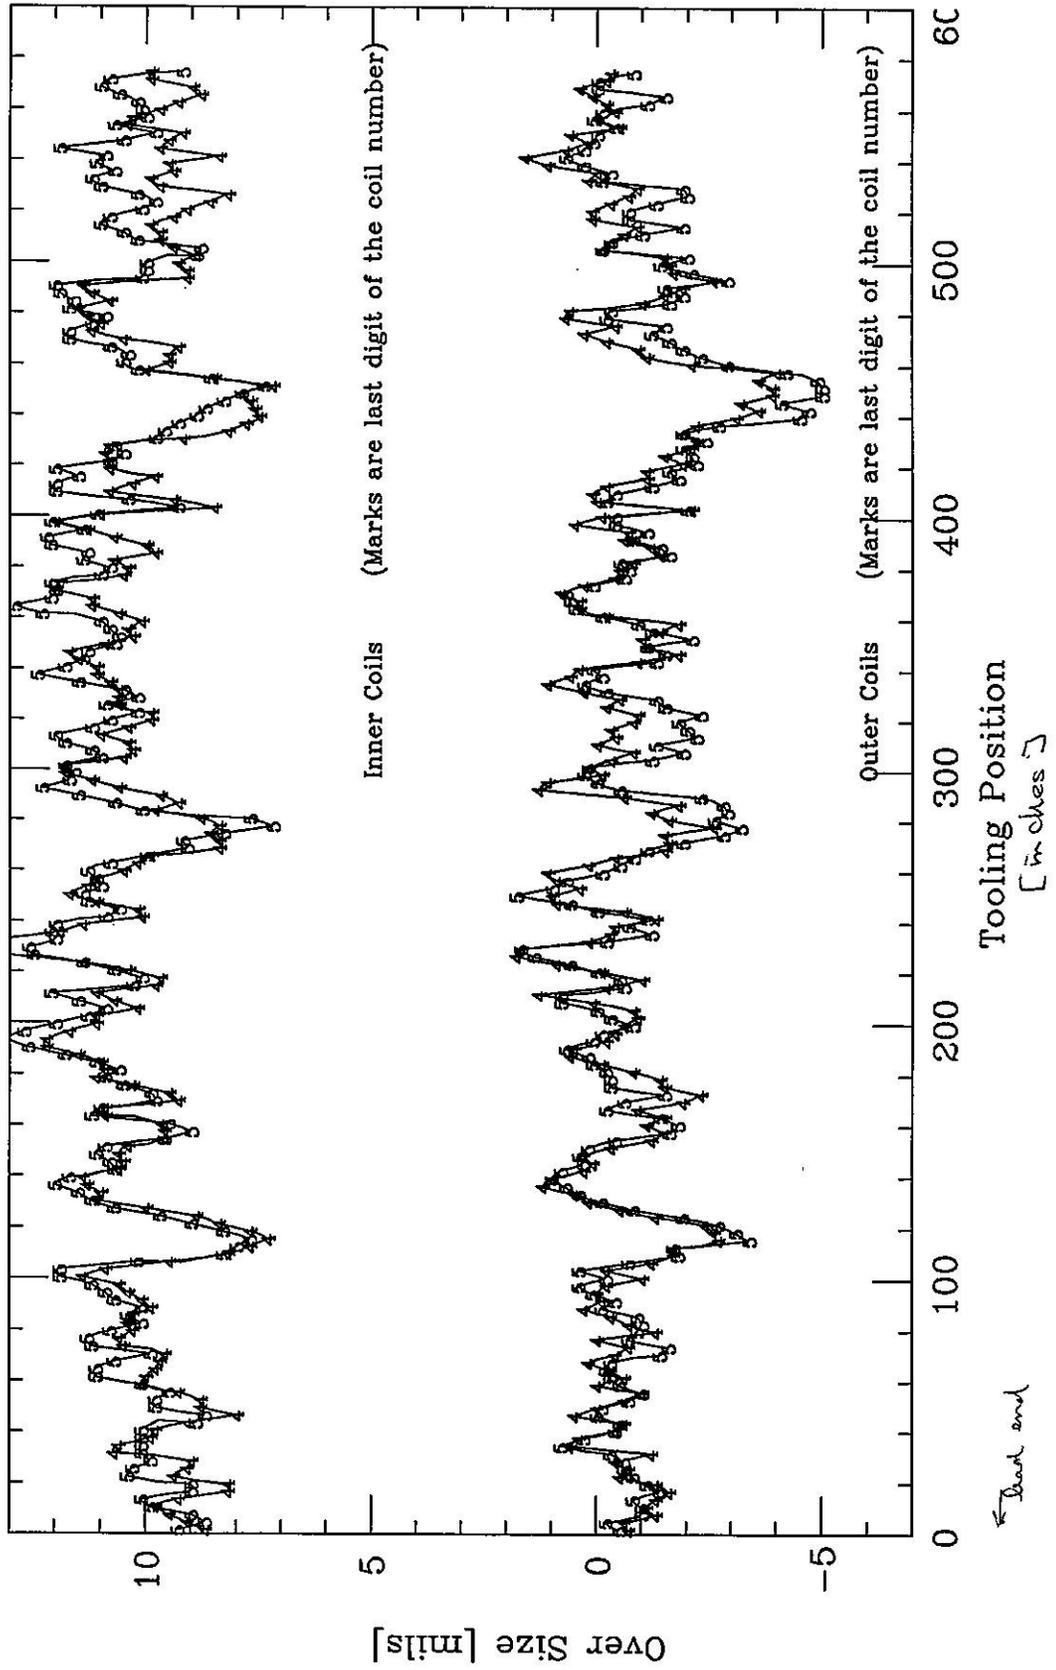
Fig 2

DCA316 Coils (I/III side)
