Disassembly of DSA323 Collared Coil

TS-SSC 91-045
S. Delchamps
March 11, 1991

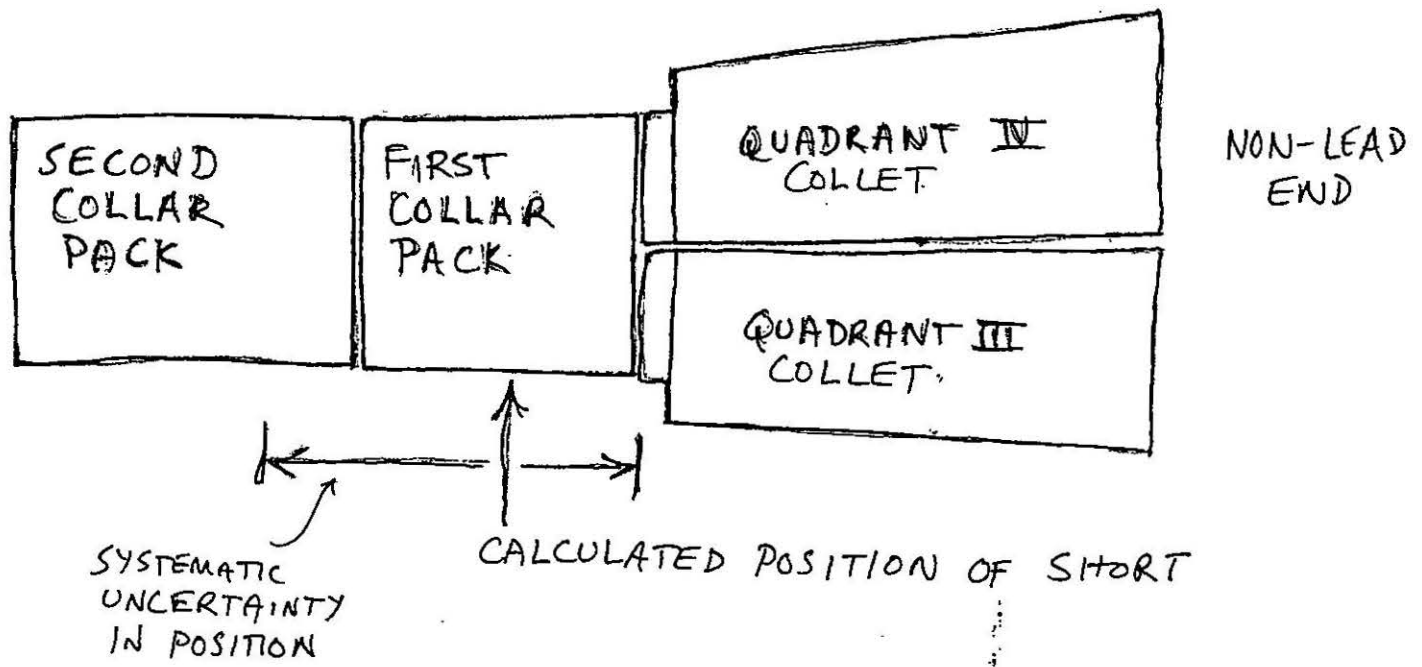
FIGURE 1

Measurements done with the collared coil assembly out of the yoking-skinning press [1] showed that the short (resistance ~ 25 k Ω) was between the coil and the collar packs (or collaring shoes), *not* the coil and either of the end clamps. (No coil to collar short had ever occurred previously in the Fermilab series of SSC model and 17 m dipole magnets.) It was determined that the short was in the second turn from the pole in the lower outer coil, within the first or second non-lead end collar pack in quadrant III. (See Figure 1.)

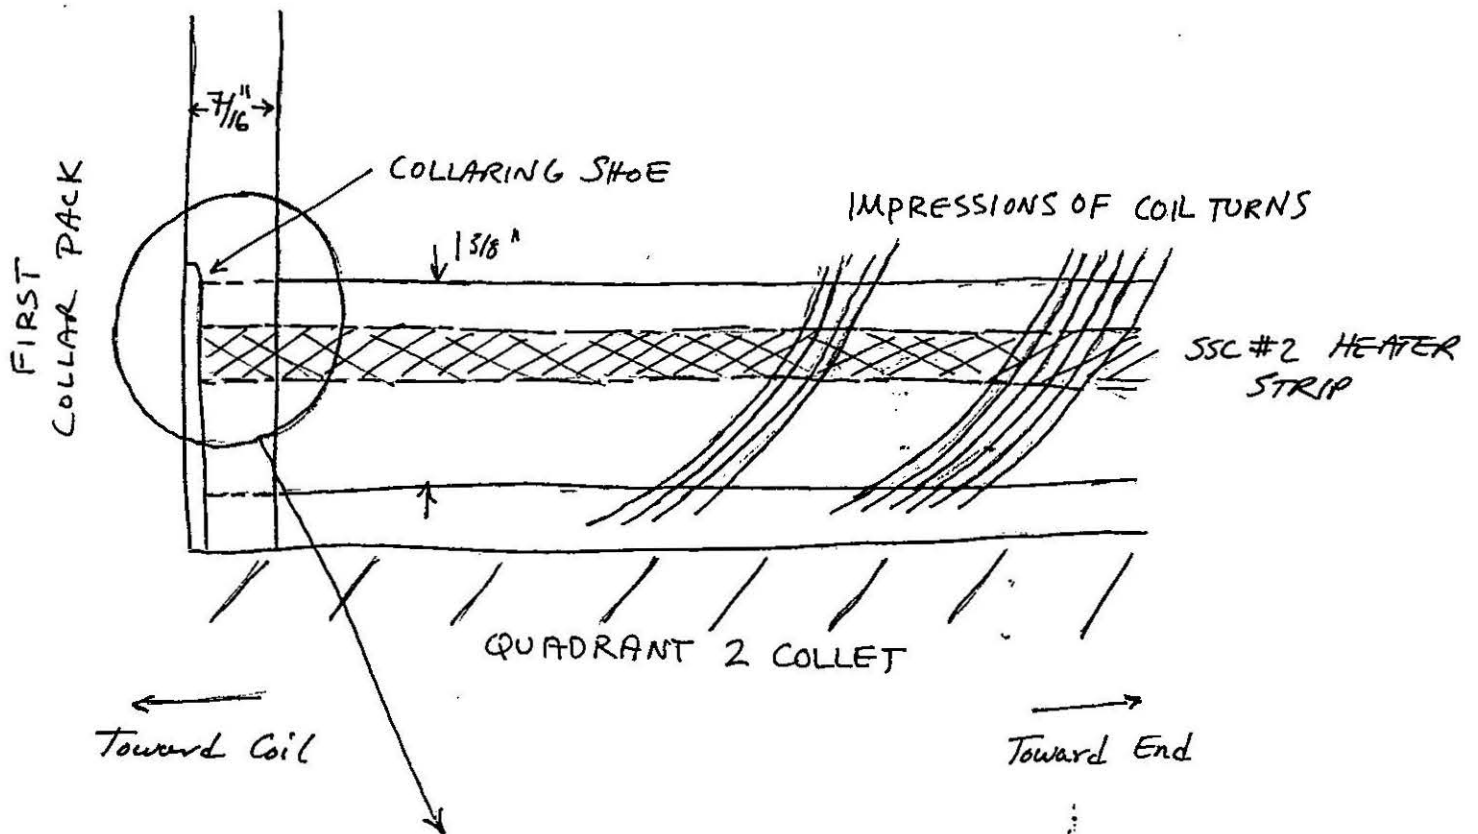
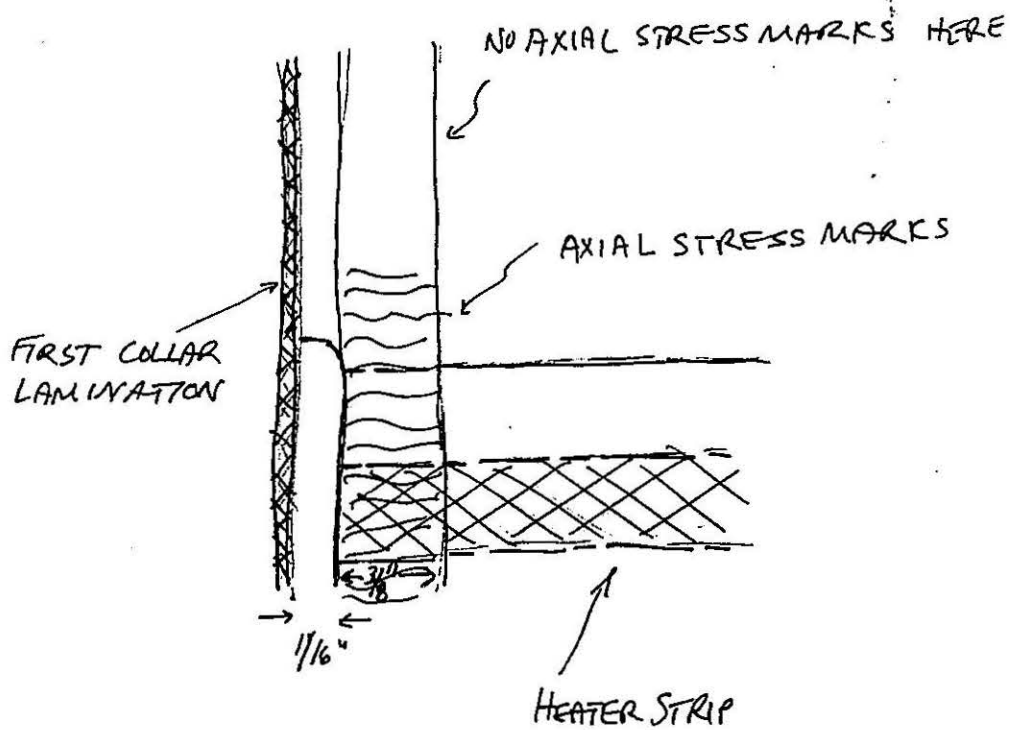
FIGURE 2

The non-lead end quadrant III collet insulator was removed, and a visual inspection of the region near the calculated short location was made. (See Figure 2.) We suspected that the problem might be caused by the corner of the brass collaring shoe, which projects about 1/16" beyond the end of the collars. However, there was no obvious damage to the kapton insulator near the corner of the collaring shoe.

Clear impressions of the coils were visible in the outer kapton insulator layers. Axial stress marks in the kapton near the collaring shoe indicated high stress near the end of the collar packs.

Sections of the brass collaring shoe and kapton insulating layers closest to the return end of the coil were cut off to allow closer examination. A small burr could be felt on the corner of the collaring shoe nearest the calculated position of the short. Some creasing of the kapton insulator layers near this burr could be seen. However, there were no obvious holes, cracks, or black marks.

Discussion: No obvious cause of the short was discovered, and no effects of arcing such as black deposits on the kapton insulating layers were seen. However, the burr on the collaring shoe is highly suspect, partly because of its close proximity to the calculated location of the short.

Disposition: Since no clear cause of the short was determined by these investigations, it was decided to take a conservative approach; DSA323 will be rebuilt from its component coils, with all new insulation and collaring shoes.

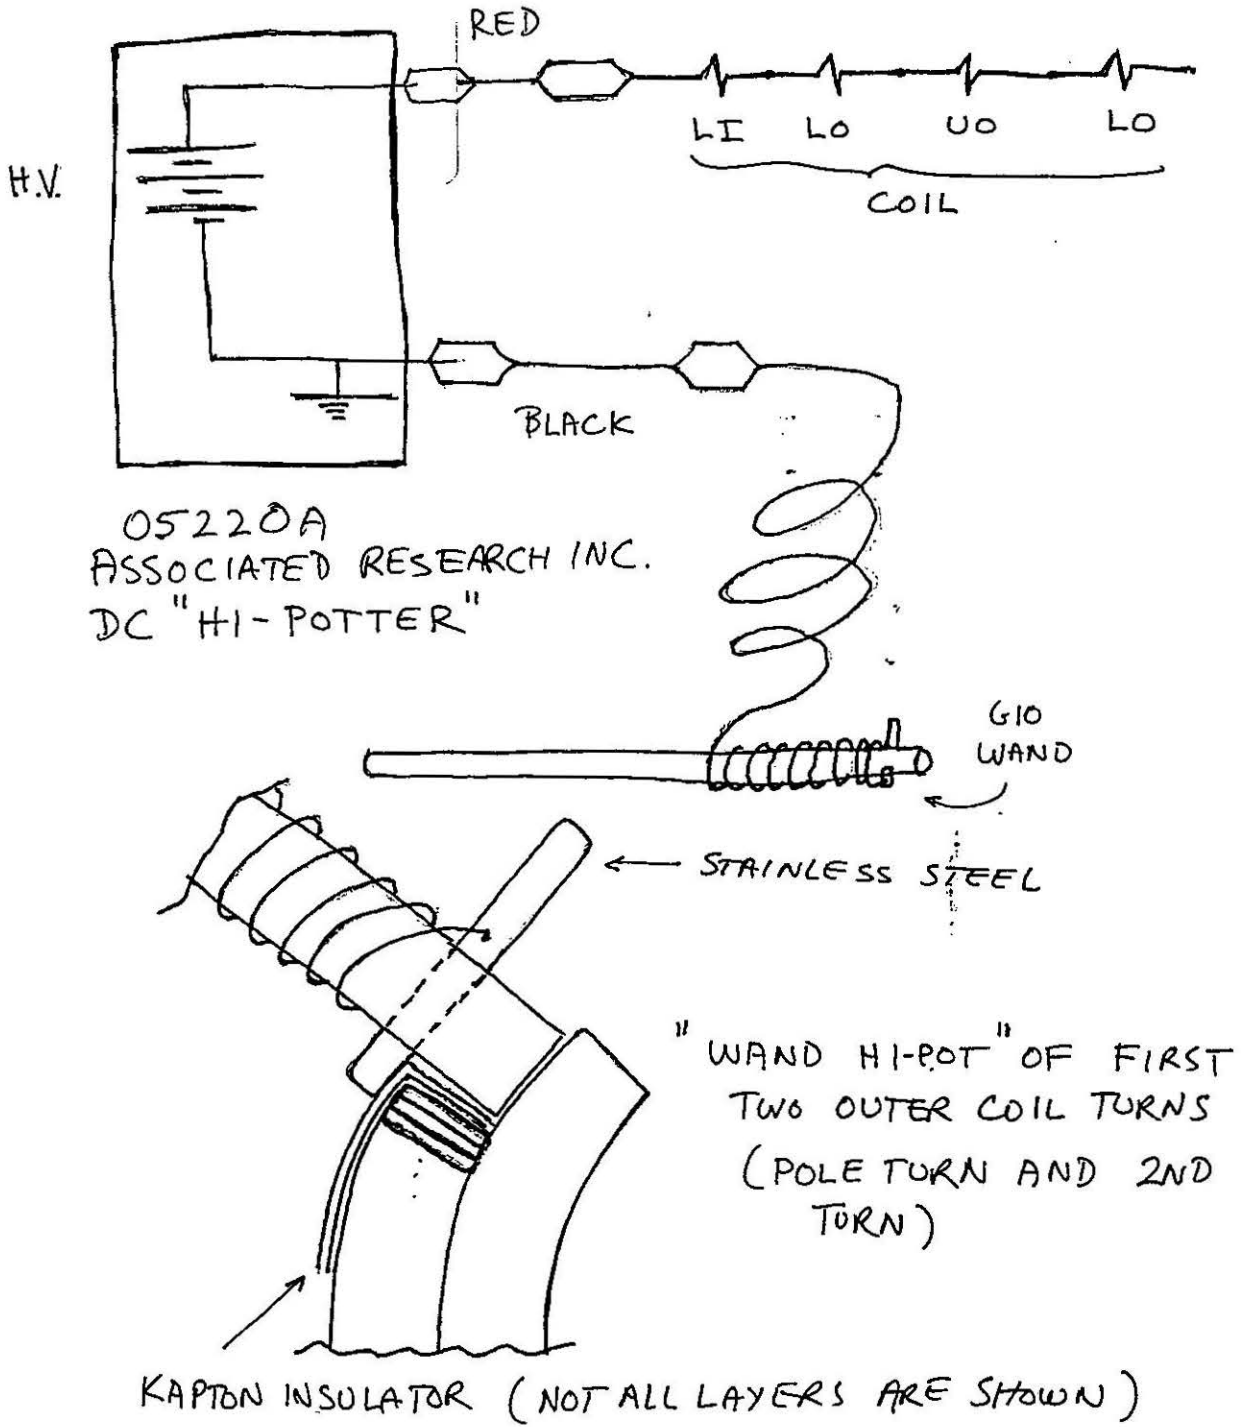
FIGURE 3

2. A wand hi-pot is done in the following manner. The high voltage lead of the hi-pot supply is connected to one of the coil leads. The low voltage lead is connected to a metal rod ~ 1" long and ~ 1/4" in diameter, which is attached to a G10 "wand." The rod may then be dragged up and down the surface to be hi-potted. (See Figure 3.) This technique has proved useful for finding areas in kapton insulator susceptible to breakdown.
