DCA317 Coil 1007 Turn-to-Turn Short II

TS-SSC 91-233
December 3, 1991
S. Delchamps

This and TS-SSC 91-207 both deal with the turn-to-turn short in coil 15M-50-1007, the upper inner coil of magnet DCA317, which occurred during the first installation of the DCA317 lead end clamp. The original discrepancy report is DR-267 attached to this report as Appendix 1.

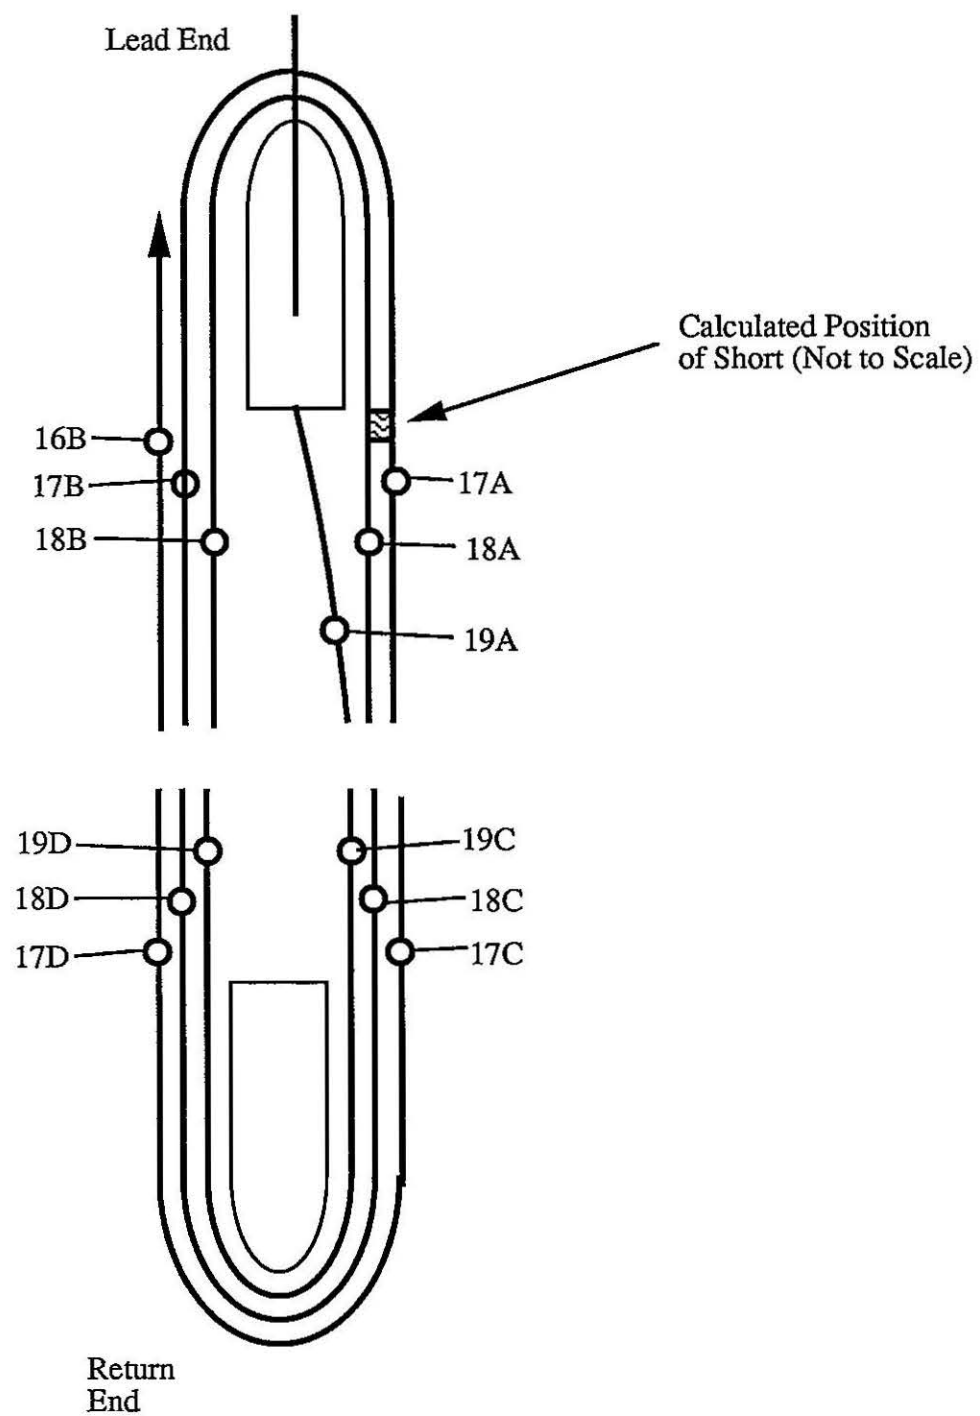
FIGURE 1

1. Initial Report (TS-SSC 91-207): TS-SSC 91-207 documented the voltage tap data taken at the time the turn-to-turn short occurred. A calculation of the location of the turn-to-turn short based on those data was given. The calculated short location was at the lead end, just inside the end clamp, between the segments 18B-18A and 17B-17A. The calculated position of the short was about 8 inches from tap 18 B in the direction of 18 A. (See Figure 1.)

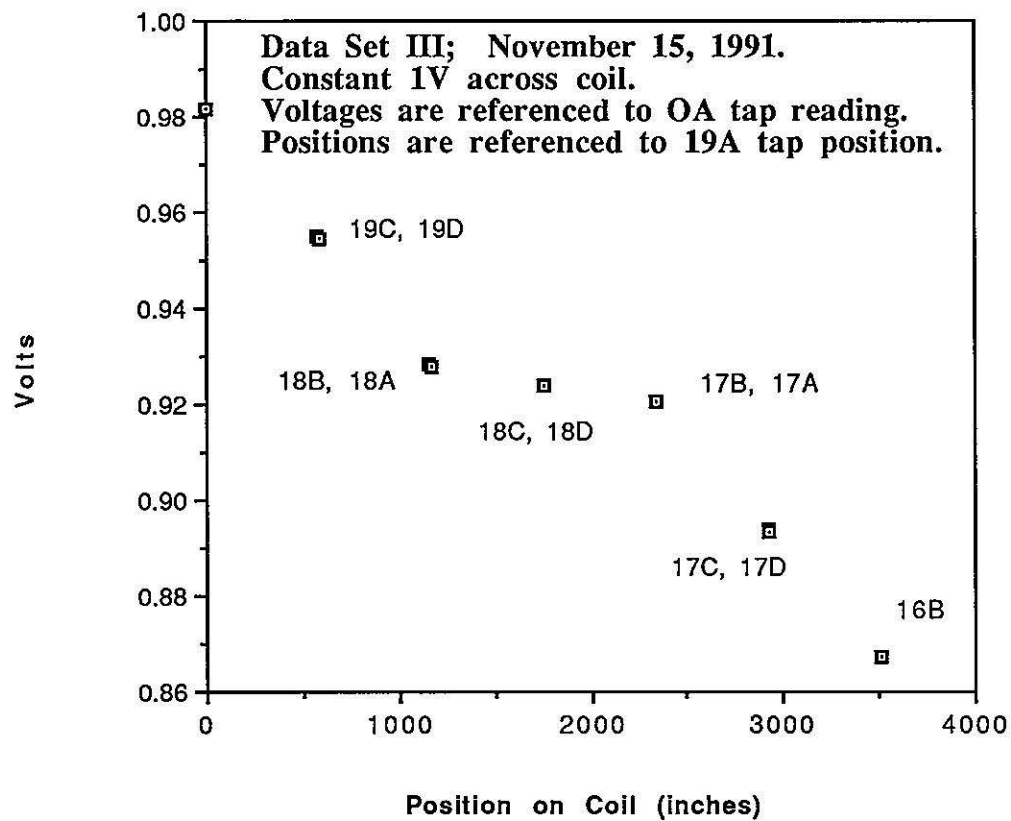
FIGURE 3

5. Graphical Determination of Short Location: During the final inspection and repair, accurate measurements of a subset of the voltage tap positions along the coil were made. These measurements are tabulated in the first column of Table 1. Figure 3 shows a plot of the Data Set III voltage tap readings versus position coordinate along the coil relative to tap 19A. The voltage taps are labeled on the drawing. The C and D taps and A and B taps for each turn lie within about 10 inches of each other and so are difficult to distinguish on the graph.

The full current flows in the segment 19A-19C-19D-18B. The change in slope near tap 18B indicates that less than the full current is flowing through segment 18A-18C-18D-17B. (Close examination of the Table 1 data make it clear that the short occurs *after* tap 18B and *before* tap 18A.) The slope becomes normal again after tap 17B, indicating that the current flowing in the segment 17B-17C-17D-16B is the full current.

Linear fits to the data in these three segments were made for Data Sets I, II, and III. The intersections of the "left-center" and "right-center" pairs of lines give two coordinates along the cable where the turn-to-turn short occurs. (Of course, these two coordinates really correspond to the same position in space, where the short is located.) Table 3 gives the positions for Data Sets I, II, and III, as well as the average over the three sets of data. The final row in Table 3 shows the calculated distance of the short in inches from taps 17A and 18A. The difference between these two distances is 1.4 inches, and the actual distance between 17A and 18A on the coil is about 1 inch.
