TS-SSC 92-048 4/6/92 J. Strait

Location of First Quench in DCA317

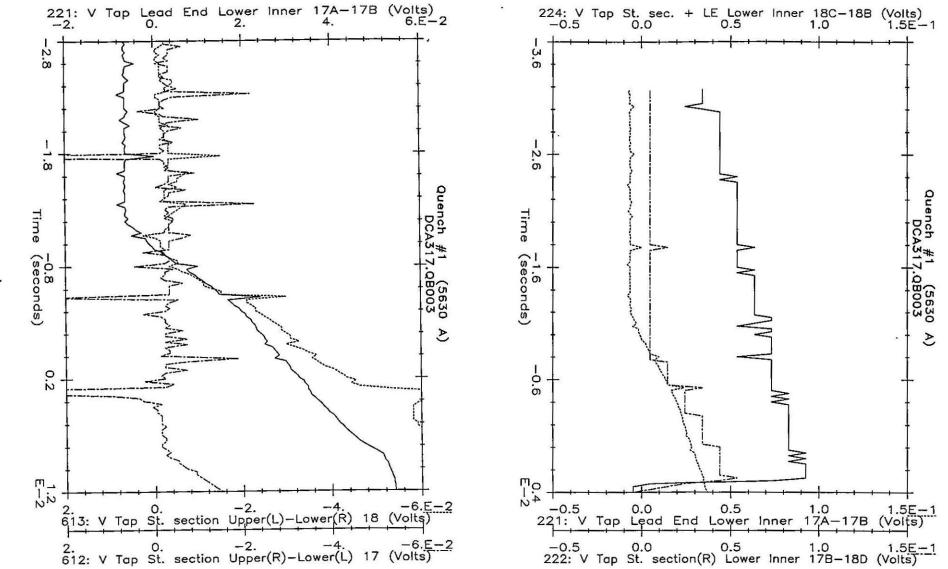
The first quench in DCA317 is very similar to the first quenches [1] of DCA313 and DCA314, both in current (5630 A) and location. As in those magnets the quench originates in the pole turn at the lead end on the side opposite the splice. Because of the low current and consequent slow quench propagation, the quench begins before the earliest voltage data recorded. Therefore the precise quench location must be determined from the point where the quench appears in the next turn. Figure 1 shows the voltage traces for the relevant cable segments. The segment in which the quench began, 18C-18B (tap 18A is broken), shows a non-zero and rising voltage when data collection begins. The quench first appears in the 2nd turn from the pole in the lead end segment, 17A-17B, and then propagates into the straight section 17B-18D 3.5+-0.5 msec later. The quench velocity is gotten from the known length [2] of the lead end segment and the sum of the quench propagation times to the two ends, assuming a constant velocity. An uncertainty of +-20% is arbitrarily assigned to this estimate. The deduced quench velocity is 10.4+-2.1 mm/msec. This locates the quench origin in the pole turn 36+-9 mm from the position of tap 17B towards the lead end, or 11+-14 mm from the collar - end clamp boundary. The error on the last quantity has been increase by 5 mm to account for mechanical tolerances and no error has been assigned for the use of the adjacent turn for quench location.

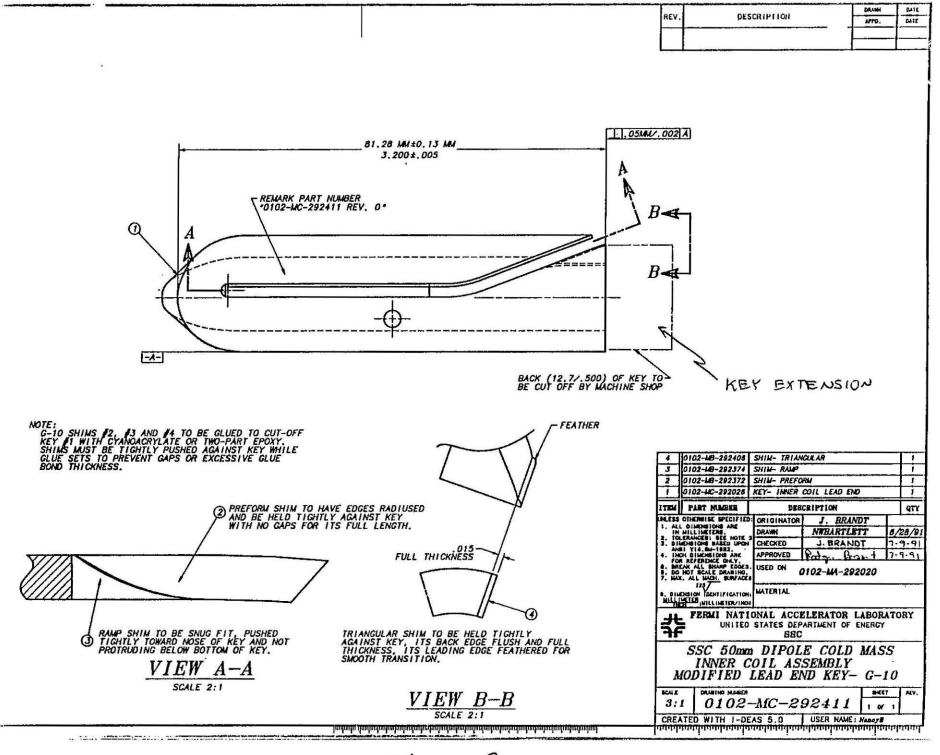
Figure 2

Three of 8 magnets tested so far have had one initial low current training quench in this location. A candidate cause of the problem may be mis-seating of the key extension. The last nominally 12.7 mm of the key is recessed to allow for the extension of the ground insulation into the end clamp region, and this piece of the key is made as a separate piece. This is done at both ends of the inner and outer coils. After all four coils have been assembled but before the collar packs are installed, key extensions of the proper length are inserted to bring the distance from the end of saddle to the end of the key plus extension to the correct value and to match all 4 coils. The key extensions are cemented to the appropriate key with just enough cement to hold them during assembly. The intent is that the glue joint will break if necessary during end clamp assembly and the key extension will seat itself to its natural and correct position. Perhaps these low current quenches indicate that the lead end inner key extensions sometimes remain slightly out of place until the first high current excitation. It may be that the presence of the splice lead at the lead end makes the key extension more likely to be mis-placed there than at the return end. The fact that the outer coil key extension is larger, is more accessible, and is supported by the inner coil may make it more likely to be properly seated during assembly.
