CCI Report No. 390-106

10,000 Liter LHe Dewar Repair Magnet Test Facility

Prepared Under Fermilab Subcontract No. 94199
By Cryogenic Consultants, Inc.
Allentown, Pa.

February 14, 1979

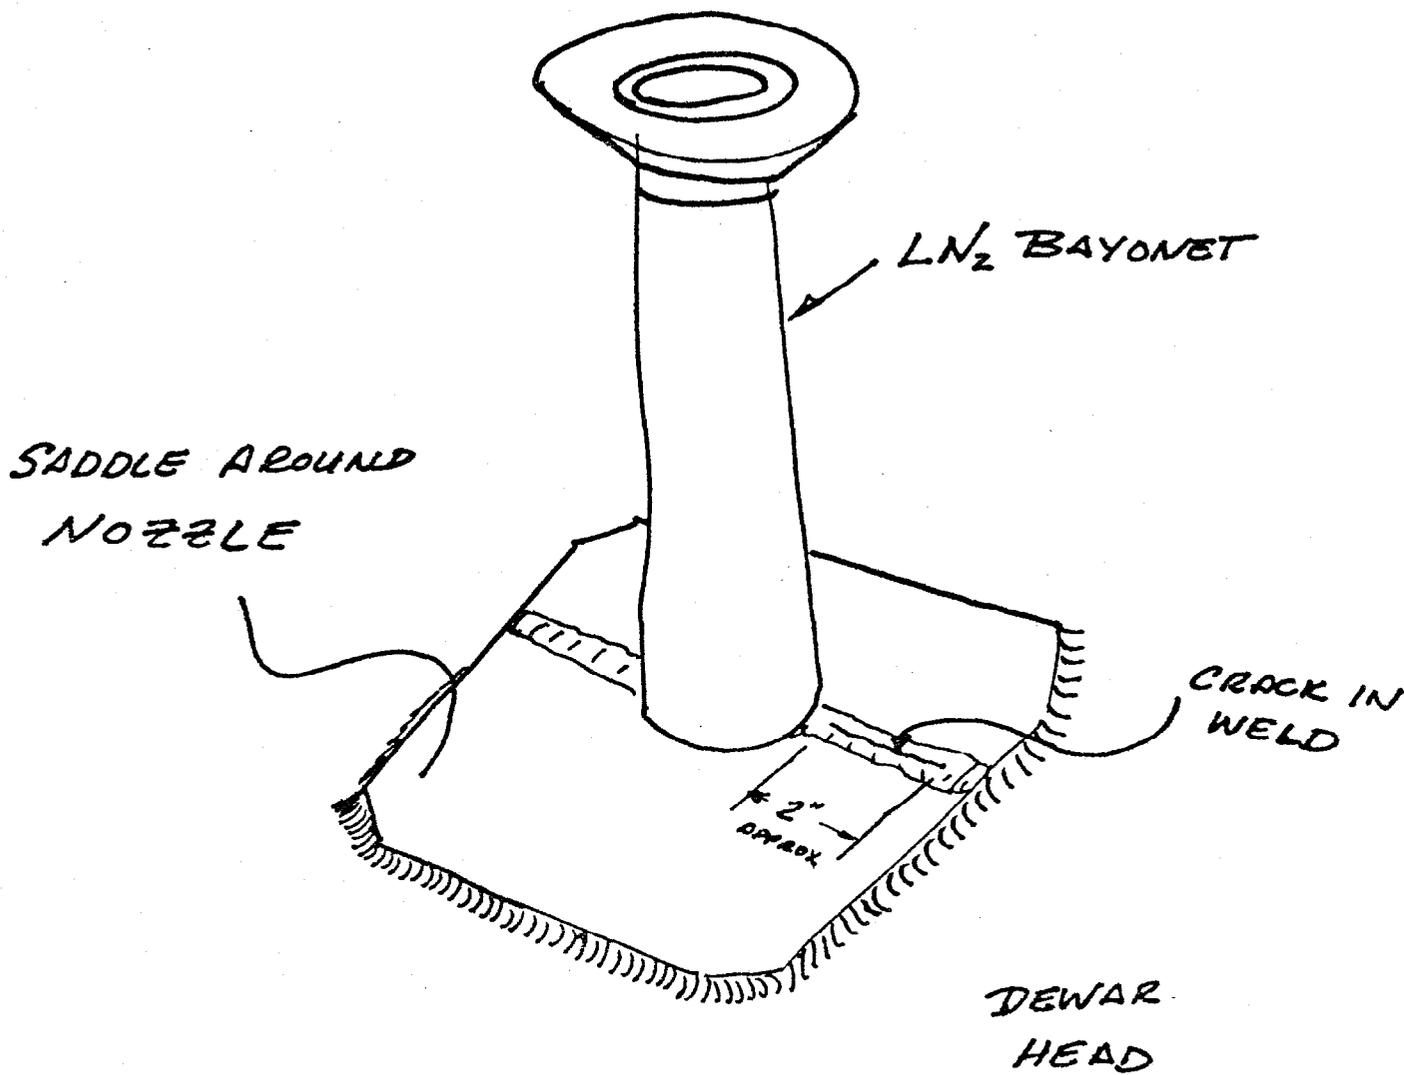
FIG 1

A LN₂ line feeding the shield of the LHe vessel suffered a broken seal and allowed liquid to drip onto the carbon steel vessel. Enough liquid spilled to crack a weld at the root of the bayonet thermal break. The dewar insulating vacuum was subsequently lost after a period of time. We estimate that 70 or so pounds of water were drawn into the vessel along with the cryopumped air.

The first step in the repair of the vessel was to isolate this leak. By pressurization of the shield and annular space with nitrogen gas to approximately 7 psi, the leak was found with soap bubble solution. The leak was a crack in a weld as shown in Figure 1. The crack was \approx 2 in. in length and easily detected. Next the surrounding area of about 1 ft² was stripped of paint and retested to make certain no other cracks existed or were masked. The area of the crack and \approx 1 in. to each side of the cracked weld was ground away prior to re-welding. The weld was repaired with care being taken to weld well into either side of the crack to insure that no pinholes or micro cracks went unrepaired.

The tank was repressurized and retested. No detectable leak was evident. At this point, "rain gutters" were added to the thermal break of both the LN₂ inlet and outlet lines to channel cold fluids off and away from the carbon steel shield in the future. To reestablish vacuum in the vessel, all cryopumped water had to be removed. Early evacuation stages showed clear indications of the presence of water. Repeated evacuation and backfilling of the annulus with dry nitrogen gas over a period of four days, along with heating of the inner vessel to approximately 170°F, dried the annulus completely. The hot gas also served to reactivate the getter located on the inner vessel.
