**Fermi National Accelerator Laboratory**

TM-1439

**Operational Experience with  
Superconducting Synchrotron Magnets\***

March 1987

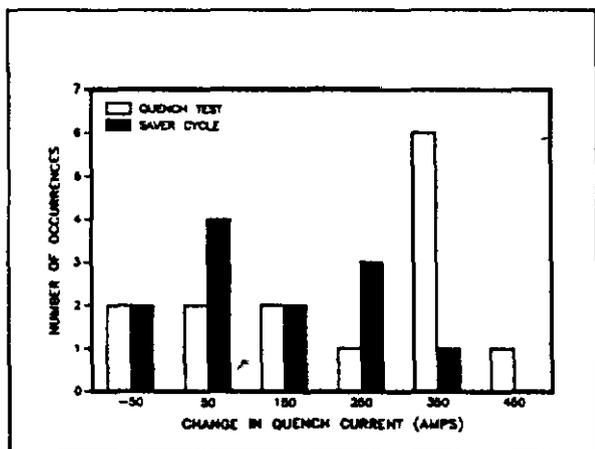
ramped at a given rate of rise until it quenches. In the "Saver Cycle" test, the magnet is ramped up and down, beginning with peak currents well below where it should quench; the peak energy is increased gradually until the magnet finally quenches. Figure 1 shows the results of the remeasurements on those dipoles which were recently removed from the Tevatron. Not shown in Figure 1 is one dipole which had decreased in quench current for the Saver Cycle test by more than 800 amps. (900 GeV corresponds to an excitation current of 3996 amps.) There has been an apparent increase in the quench currents on the average. This may be due to lower temperatures on the test stand for the more recent measurements. Another possibility is a marginal splice during the earlier measurements. Questions have also been raised about the accuracy of the current measurements during the Quench Test. With the one exception, there is no evidence for degradation due to ramping, quenching or repeated thermal cycling. The harmonic content was also remeasured, with good reproducibility except for the quadrupole component, which is strongly affected by the manner in which the large negative sextupole in the ends of the dipole is taken into account. There was a small change in the sextupole, which would arise from changes in the conductor placement. The angle of the dipole field changed by less than 0.5 mrad.

FIGURE 1  
Change in Quench Current for Magnets Retested after Removal from Tevatron

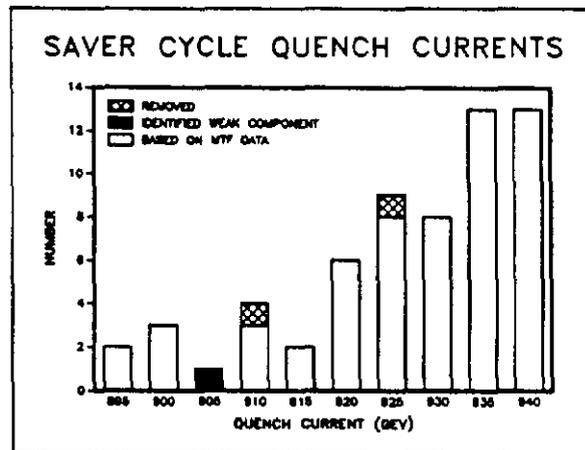
Figure 2 shows the Saver Cycle quench currents for the 48 weakest magnets in the ring, based on the original MTF data, prior to the recent removal of the two magnets. Their positions have been indicated, along with the component which has been identified as being the weakest one remaining. There are clearly a few components in the Tevatron which exceed their MTF

measurements. Equally clear is that the spectrum is rising; many components would have to be replaced to gain another 25 GeV.

FIGURE 2  
Quench Currents of the Weakest Magnets in the Tevatron
