TM-1439

**Operational Experience with
Superconducting Synchrotron Magnets***

P.S. Martin

March 1987

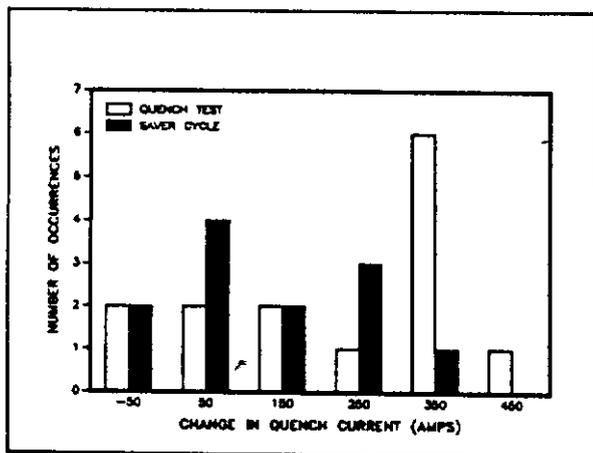
ramped at a given rate of rise until it quenches. In the "Saver Cycle" test, the magnet is ramped up and down, beginning with peak currents well below where it should quench; the peak energy is increased gradually until the magnet finally quenches. Figure 1 shows the results of the remeasurements on those dipoles which were recently removed from the Tevatron. Not shown in Figure 1 is one dipole which had decreased in quench current for the Saver Cycle test by more than 800 amps. (900 GeV corresponds to an excitation current of 3996 amps.) There has been an apparent increase in the quench currents on the average. This may be due to lower temperatures on the test stand for the more recent measurements. Another possibility is a marginal splice during the earlier measurements. Questions have also been raised about the accuracy of the current measurements during the Quench Test. With the one exception, there is no evidence for degradation due to ramping, quenching or repeated thermal cycling. The harmonic content was also remeasured, with good reproducibility except for the quadrupole component, which is strongly affected by the manner in which the large negative sextupole in the ends of the dipole is taken into account. There was a small change in the sextupole, which would arise from changes in the conductor placement. The angle of the dipole field changed by less than 0.5 mrad.

FIGURE 1
Change in Quench Current for Magnets Retested after Removal from Tevatron

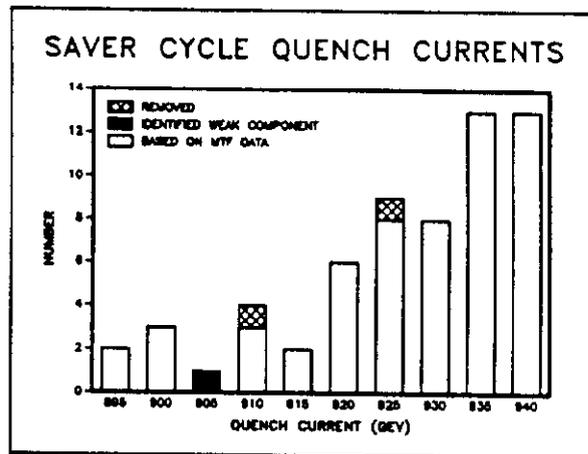
Figure 2 shows the Saver Cycle quench currents for the 48 weakest magnets in the ring, based on the original MTF data, prior to the recent removal of the two magnets. Their positions have been indicated, along with the component which has been identified as being the weakest one remaining. There are clearly a few components in the Tevatron which exceed their MTF

measurements. Equally clear is that the spectrum is rising; many components would have to be replaced to gain another 25 GeV.

FIGURE 2
Quench Currents of the Weakest Magnets in the Tevatron
