**FERMILAB-TM-1795**

# **Reasons for the Removal of Tevatron Dipoles From the Tunnel: A Summary**

Norman M. Gelfand

August 1992

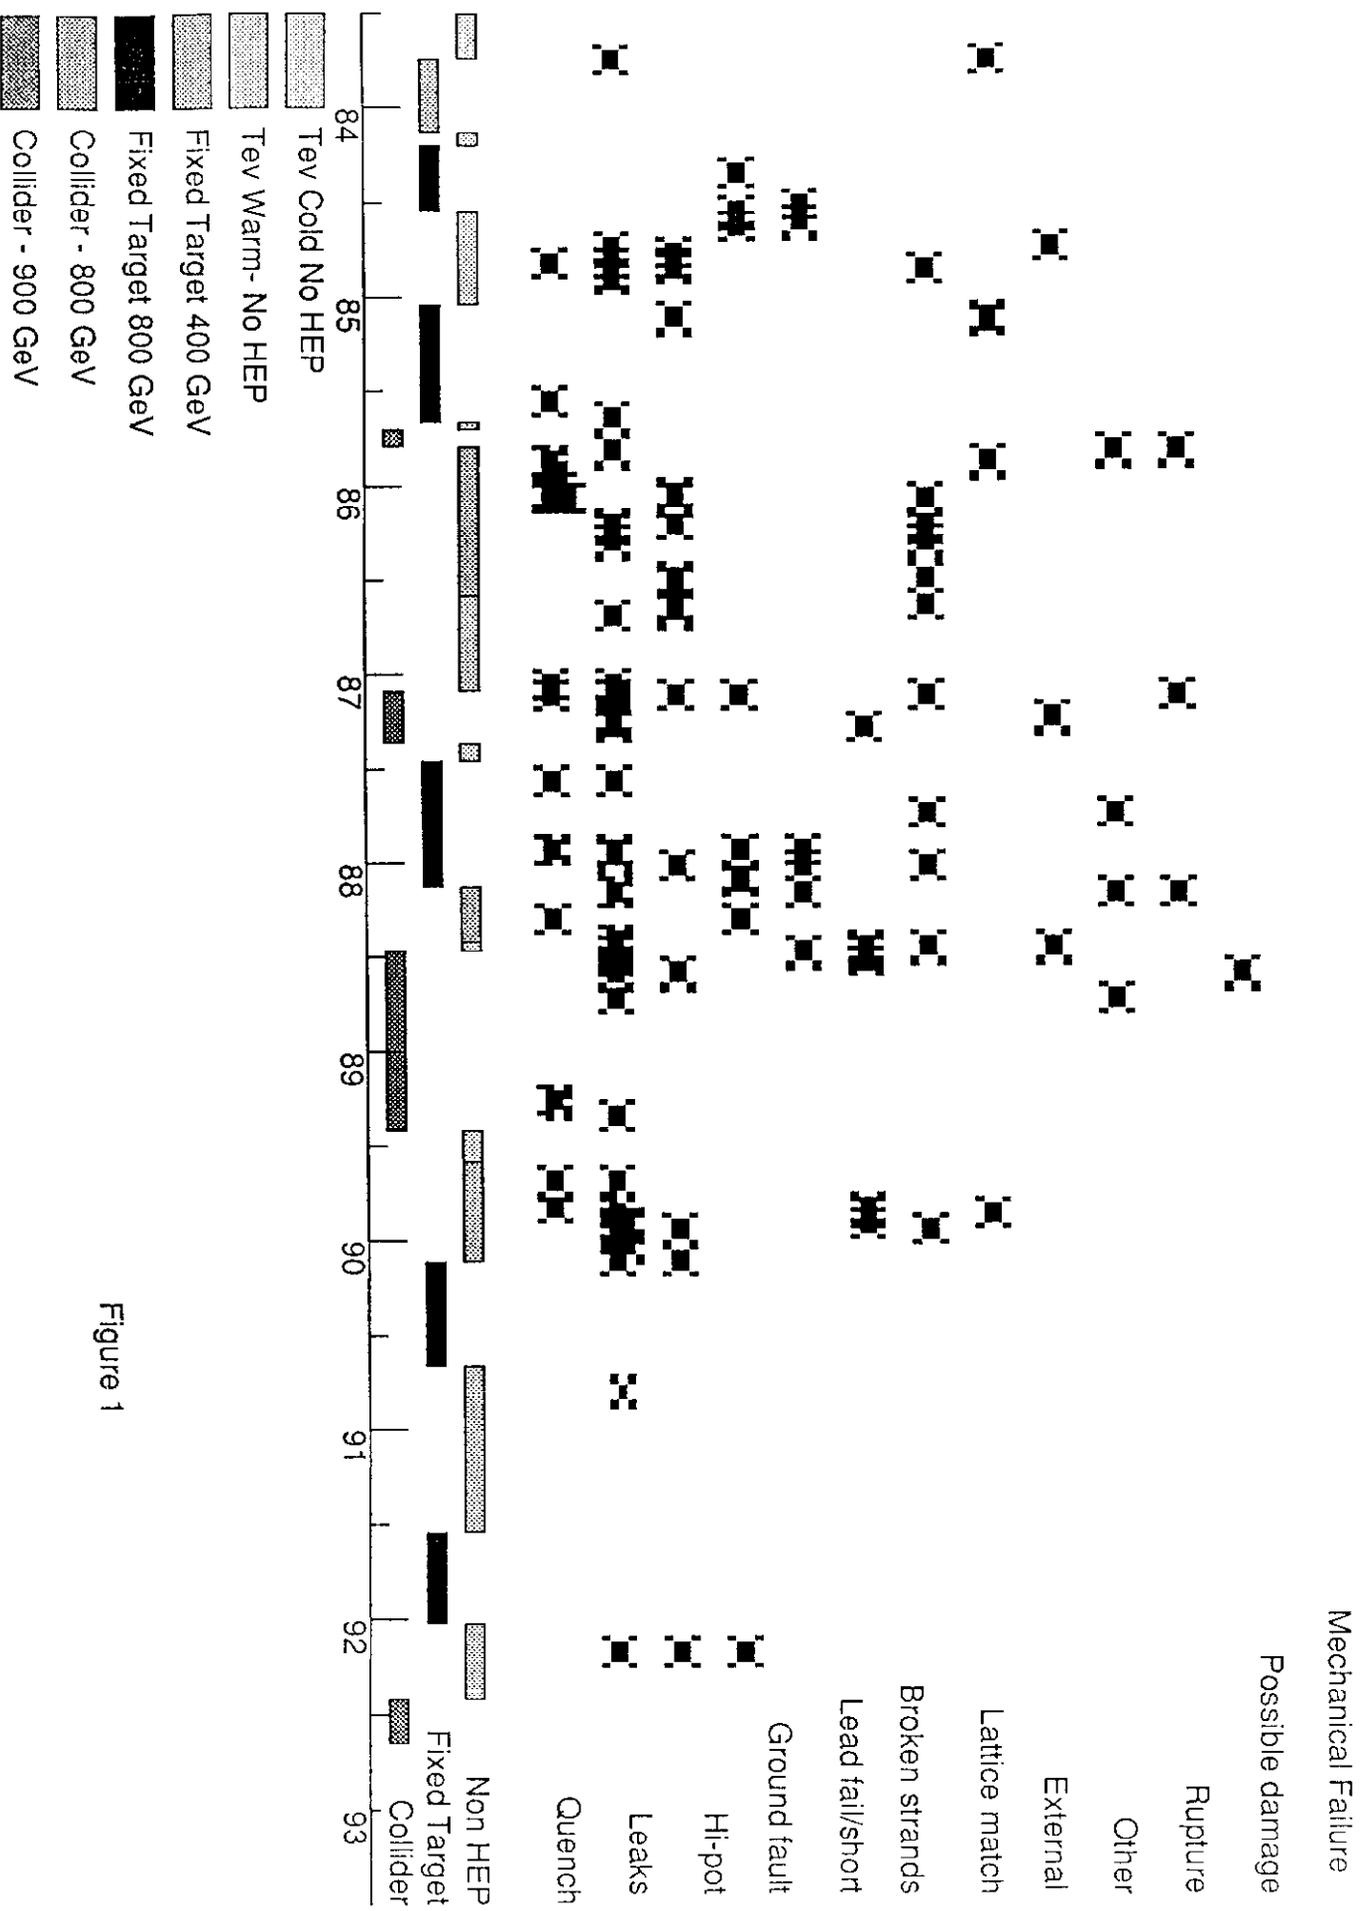
Figure 1

The reasons for magnet replacement are summarized in tables II and III and figure 1.

# Tevatron Dipole Failures as a Function of Time
