The Search for Air Overpressure During Blasting Operations

Phil Nesbitt, LBNF/DUNE – US, Mining Engineer Intern

FERMILAB-POSTER-21-030-LBNF

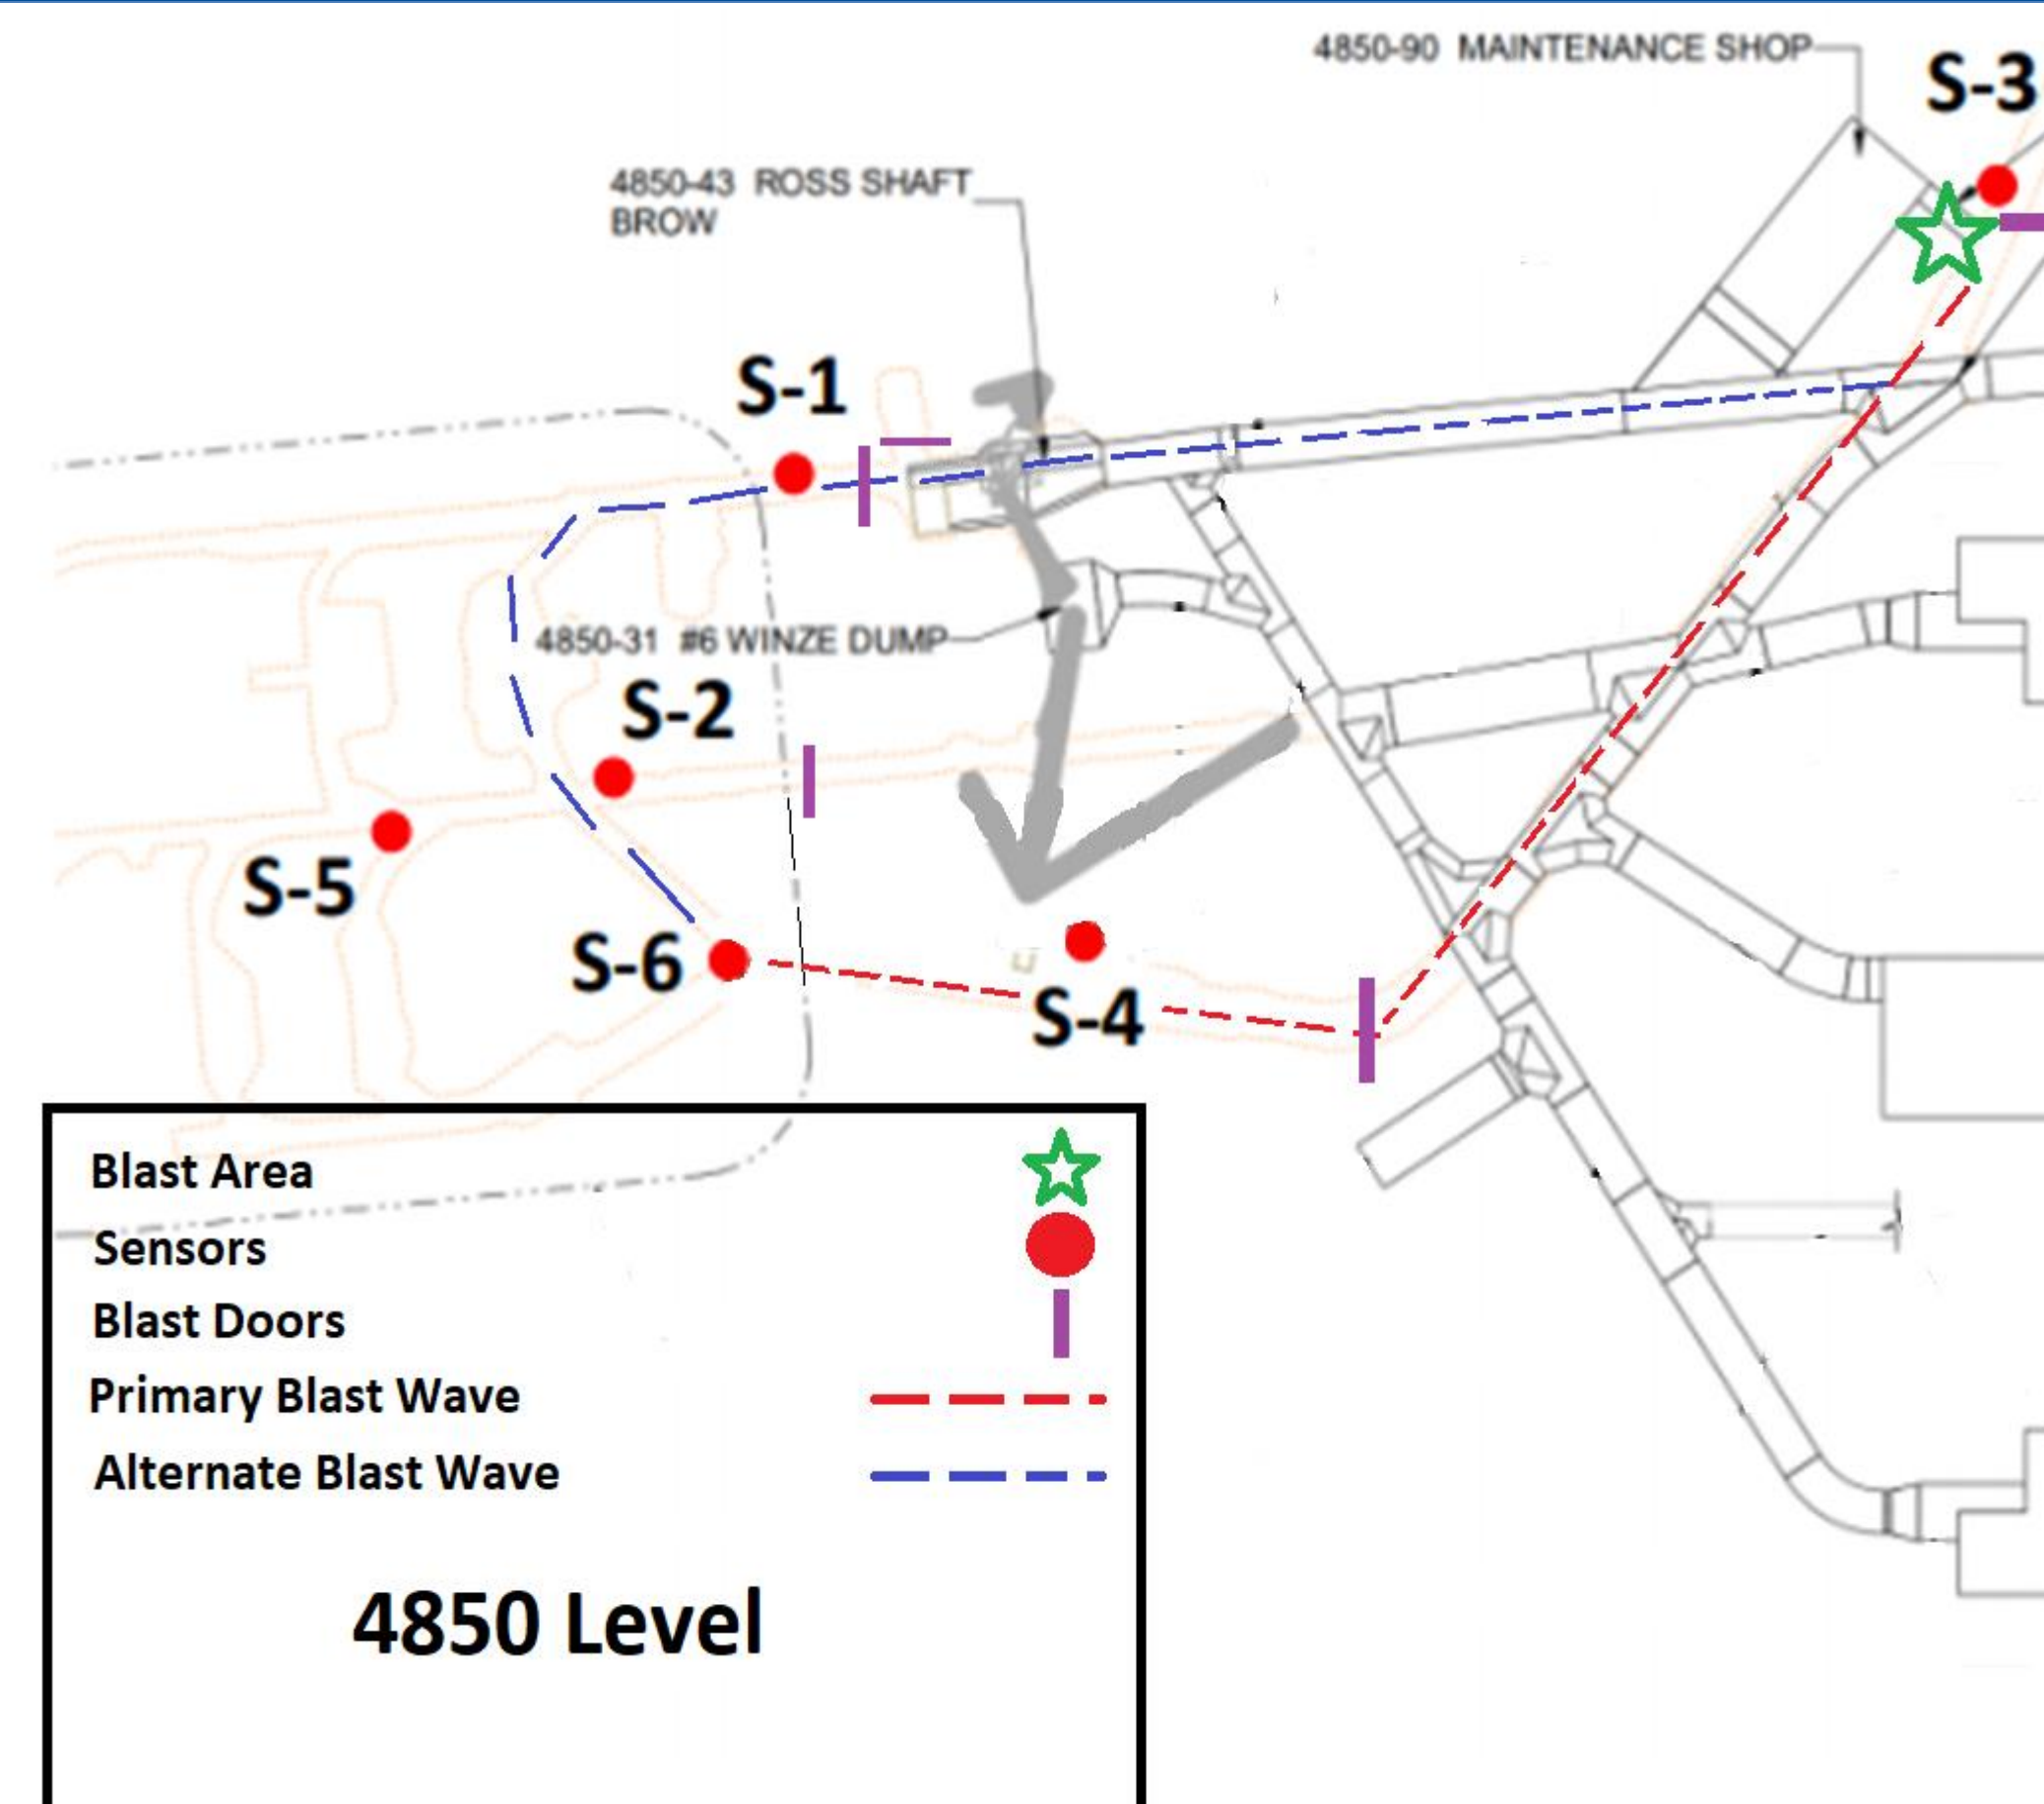
Seismic Sensor Layout on 4850 level

During blasting of the machine shop egress (4850-90A) which is located right next to sensor 3, air overpressure readings were recorded on sensor 6 which is located directly outside of CASPAR. These readings were not duplicated on any other sensor causing some confusion. Several sensors are positioned such that the soundwave would pass them before arriving at sensor 6 meaning energy should dissipate by arrival at sensor 6, not increase. Another consideration is the location of blast doors in relation to the various sensors.

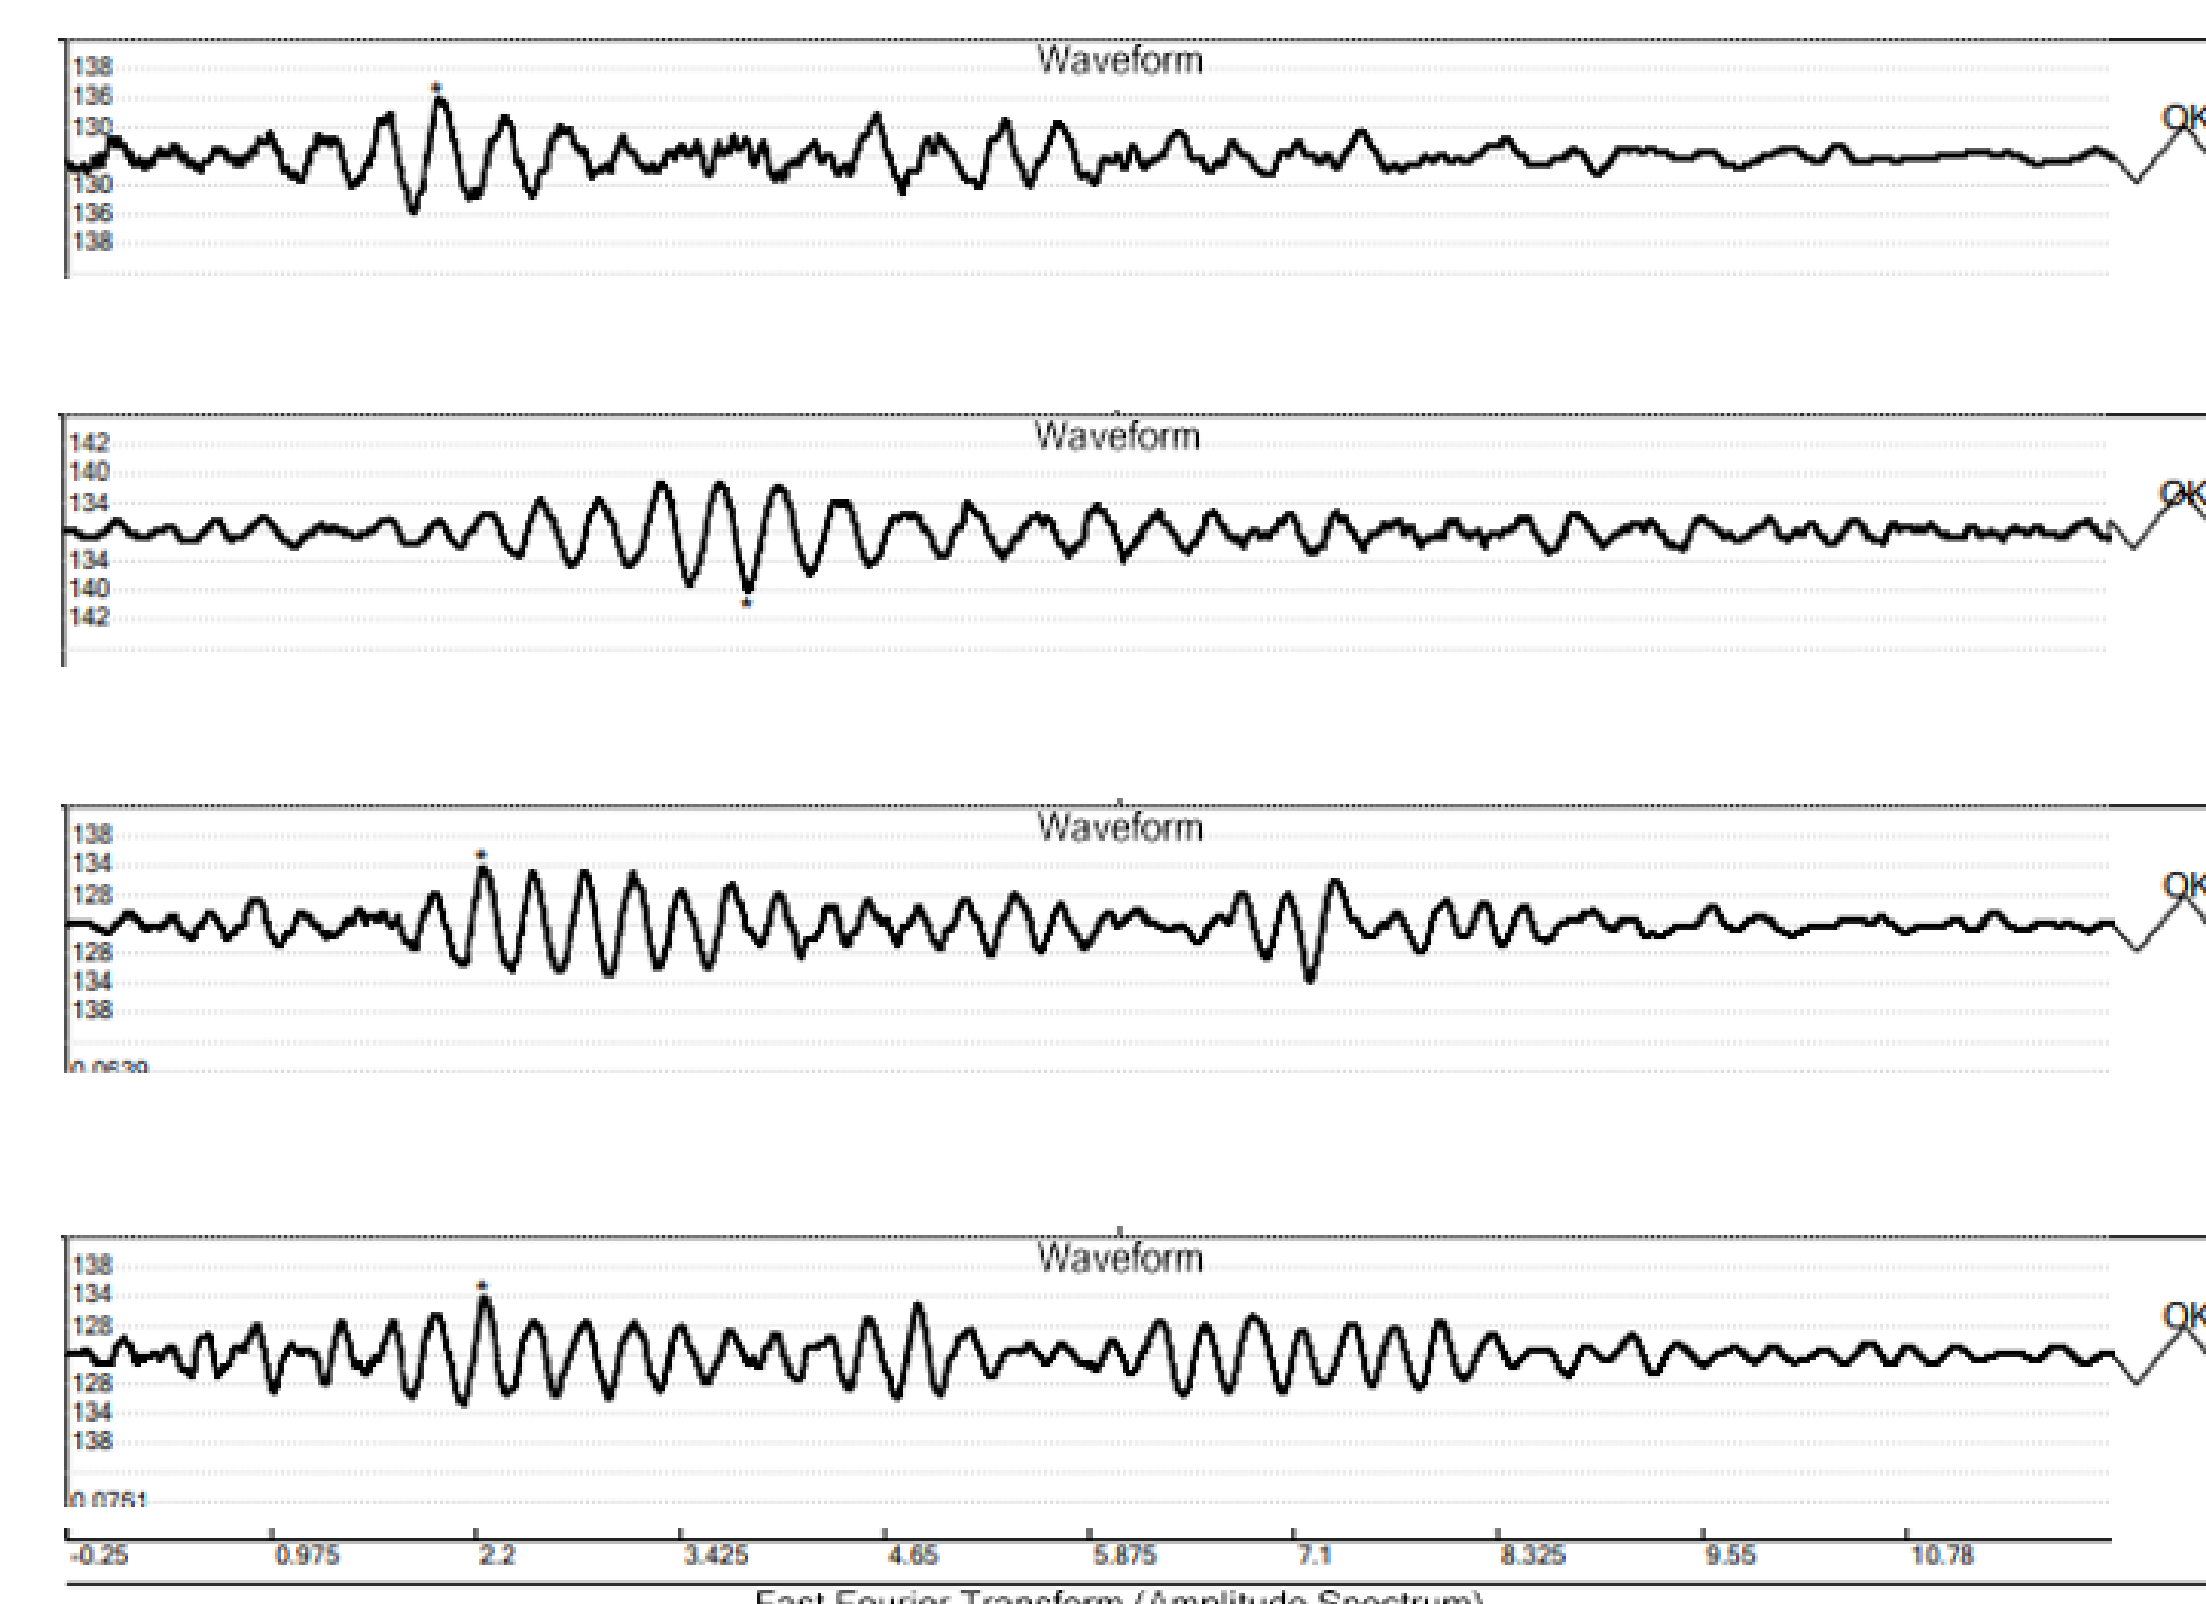
Analyzing the data, the overpressure acoustic range was between 1.5 and 7.2 Hz with most overpressures falling near the 3.5 Hz range. The average time the overpressure was recorded was 3.23 seconds. Acoustically speaking, a soundwave travelling in air from the blast, taking the most direct route, should arrive at sensor 6 within 1.9 seconds. That this time was almost doubled was a clue that multi-path sound propagation was occurring. Also, the possibility that different waveforms were reinforcing each other was tantalizing.

Acoustic Comparison for over-pressure readings on Sensor 6

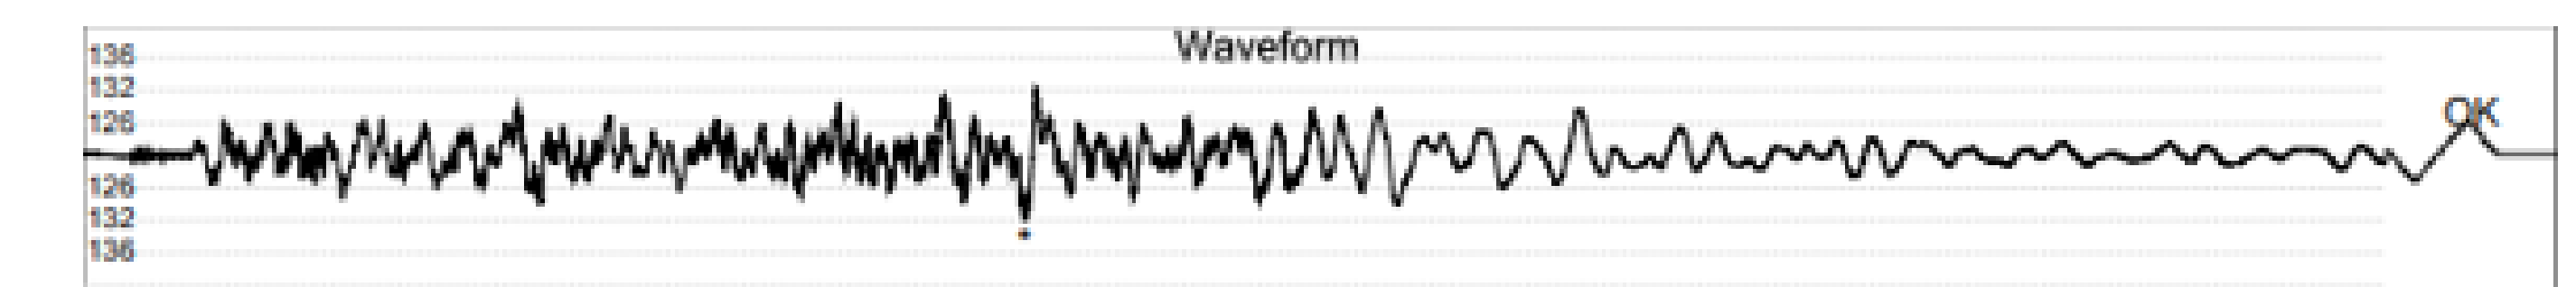
Post-Corrective action Acoustic reading demonstrating lack of sinusoidal wave.

Once the sensor was removed from the metal post, the sinusoidal nature of the soundwaves disappeared indicating that the post was likely resonating with the frequency of the soundwave causing a false overpressure reading. The airflow video showed a large volume of air was moving rapidly through the area indicating that air travel was likely flowing through several adjacent levels and returning through the #6 winze during the blast. This helped to explain why the sound took longer than expected to arrive at the sensor. It was determined that resonance was the most likely culprit. The microphone was replaced and remains mounted to the concrete wall. In all subsequent blasts, no overpressure has been recorded that was not attributed to the type and weight of explosives being used.

Another data point analyzed was the waveforms appeared sinusoidal. This is an indication that a resonance was present. In taking both the resonance and the multipath sound propagation as primary data points, an experiment was conducted where-by a video was recorded of airflow indicators which were installed in the vicinity of sensor 6 to determine the direction and intensity of the airflow after the blast. The next step was moving the sensor from the metal post it had been mounted to and attach it to the concrete wall for measurement during a subsequent blast.
