Turn to Turn Short in DSA321
 Masayoshi Wake
 12/12/90

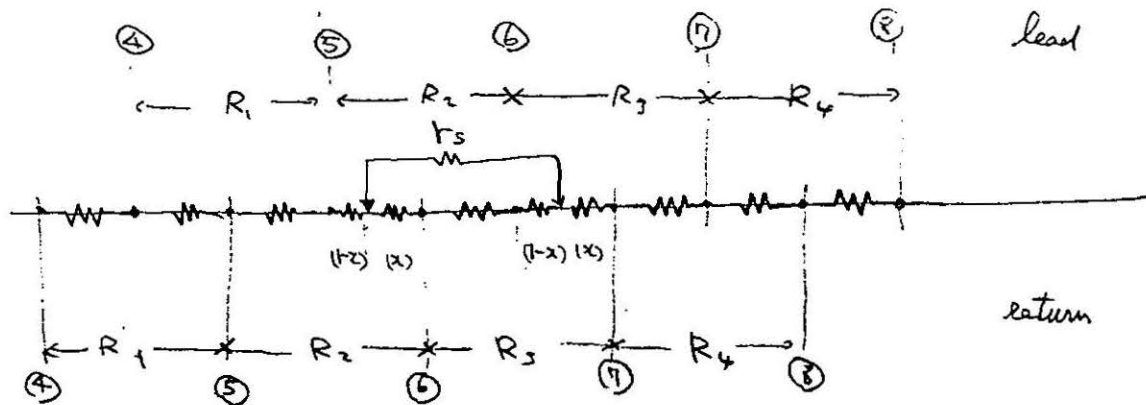
Electrical circuit of these points are represented in the following scheme.

The position of the shorted point with shorting resistance R_s can be found by this measurement. The averaged resistance per turn \bar{R} in the shorted area should be

if there were no shorts. Because of the shorts, the effective resistance of the shorted turn, R_e , is

because this area should contain a resistance of one normal turn.

\bar{R}	R_e	R_s
Lead End Measurement	6.44Ω	1.83Ω	2.556Ω
Return End Measurement	6.445Ω	1.855Ω	2.605Ω

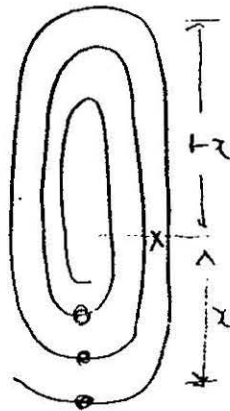
(A) $R_2 < R_3$

Suppose the position of short is at the x from one end and (1-x) from the other end, where $0 \leq x \leq 1$. The x is found in each of the following cases:

$$x = \frac{R_1 - R_3 - R_3 + R_4}{R_1 - R_2 - R_3 + R_4}$$

If we use the measured value the value for x is 0.258 for the return end measurement and 0.734 for the lead end measurement. Both measurements are pretty much consistent. Since the length of the coil is 54.4", the shorted point should be 13" from the center in the return end lead side of turn 14 and turn 13.

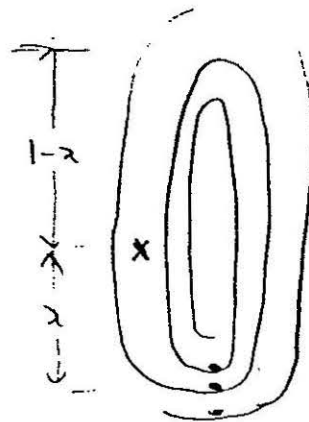
(B) $R_2 > R_3$

$$x = \frac{R_1 - R_2 - R_2 + R_4}{R_1 - R_2 - R_3 + R_4}$$
