Construction Review of DSA321

This report is a summary of a series of meetings which took place between 1-2-91 and 1-9-91. All problems and concerns involving the construction of magnet DSA321 (the first 50mm short model) were discussed. They are listed in the approximate chronological order in which they arise during magnet assembly.

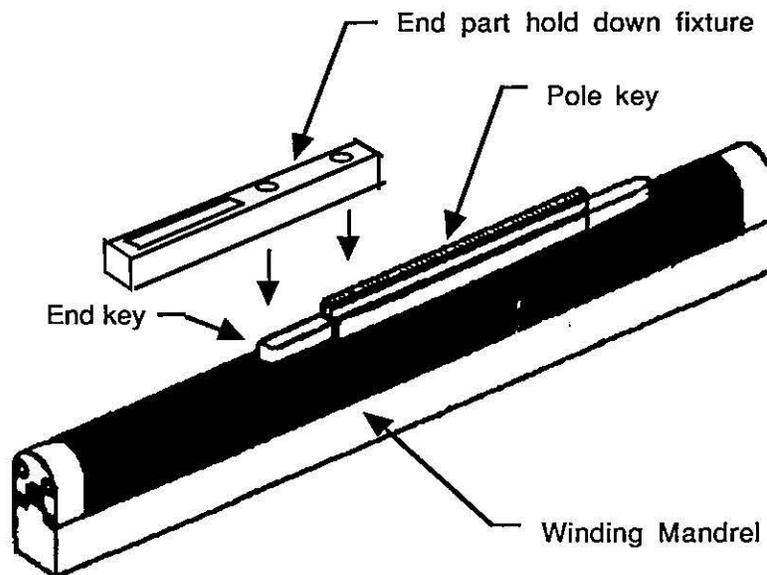
c.) During winding, a metal fixture is bolted to the pole keys on the winding mandrel as shown in Figure 1. It is used to hold the G-10 end parts down during winding. The fixture is so large that it interferes at times with the cable path. The operator must be careful not to nick the cable during the winding. Kerry Ewald will look into ways to reduce the size of the fixture without compromising it's function.

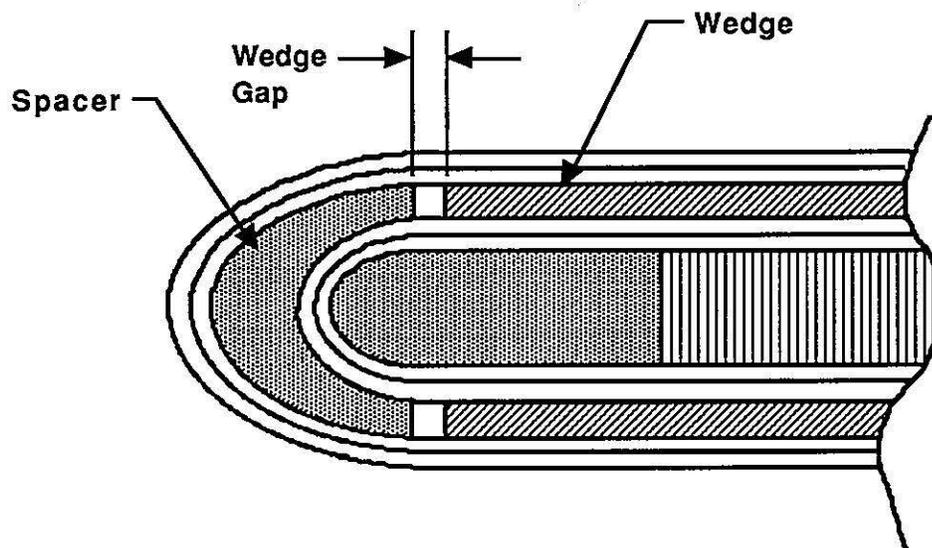
Figure 2.

a.) Coil ends are each approximately 3/16 inch too long. This results in poor and inconsistent conductor support. It also causes longitudinal gaps between wedges and end parts (as shown in Figure 2) to be excessively large.

There are several possible causes for this problem. Cable paths on end parts could be allowing too little space. Poor end preloading could also be contributing. The parts, being thicker than their 40mm counterparts, are much stiffer. As a result they are much more difficult to push into position. Friction between the parts and the glass tape on the cable is very high, impeding end preloading.

The temporary solution for DSA321 was to live with the unmodified end parts and increase the wedge length by an appropriate amount to fill the gaps between wedges and end parts. The long term solution will involve four steps:

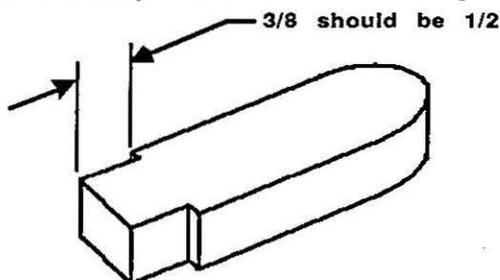
d.) Keys and end clamps are both relieved by a small amount to allow the kapton ground wrap to extend beyond the collar laminations longitudinally (into the area which is covered by the end keys and end clamps). A relieved key is shown in Figure 3. This is done to prevent the possibility of a ground short between collars and coil. The relief in the key is only $3/8$ inch while end clamp relief is $1/2$. The key needs to be changed to $1/2$ inch to conform to the end clamp. This will be done by Jeff Brandt.

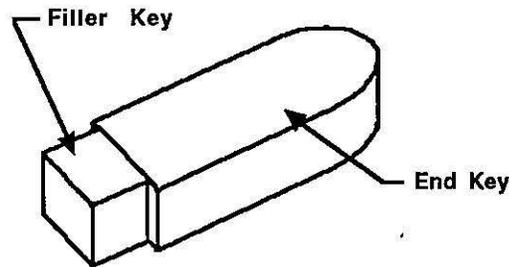
Figure 4.

e.) The key relief referred to in 4d creates an inconvenient situation for the magnet assembly crew. The key must be placed into the coil before ground wrapping takes place. The technician assembling the ground wrap must therefore force the ground wrap into the small space provided between the key and coil pole turn. The solution may be to separate the relieved area of the key from the rest of the key as shown in figure 4. The relieved area would be a 1/2 inch long straight section of G-10 key and could be put in place after the ground wrap is completed. This and other solutions should be considered.

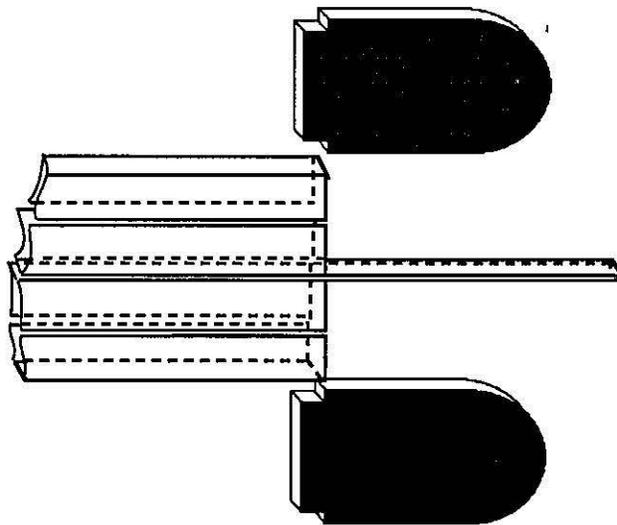
a.) All ground insulation was, by design, supposed to end 1/2 inch into the end clamp as shown on Figure 5. This does not allow for the outer coil caps to extend through the end clamp, causing an upper-to-lower coil short possibility to exist on the ends (although this same situation exists on the

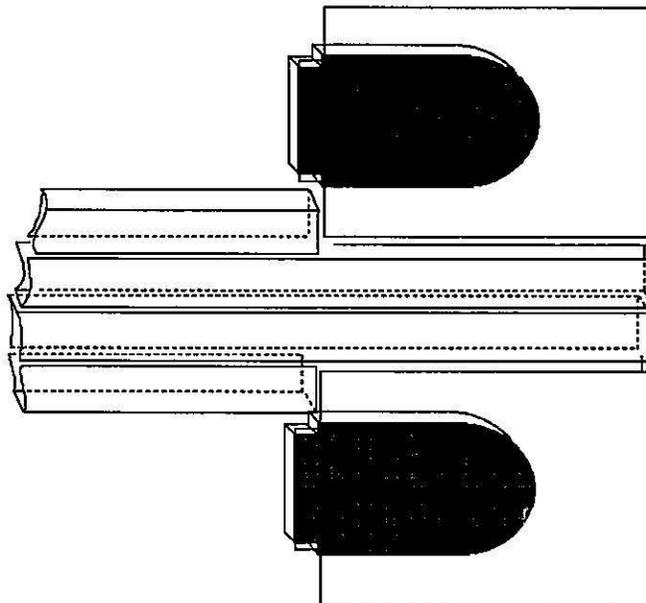
Tevatron without any problems). The outer coil caps on DSA321 were extended all the way to the end of the coil as shown on Figure 6. The extra radial space at the poles was filled in by .005 kapton. This creates a .005 inch interference fit radially inside the end clamp area. This is not thought to be a problem because preload in this area is traditionally too low. Kapton also provides a slip plane for the coils and end parts against the end clamps.

This system will continue to be used on SSC short magnets until heater strips are incorporated. At that time the entire end ground wrap system will be changed.

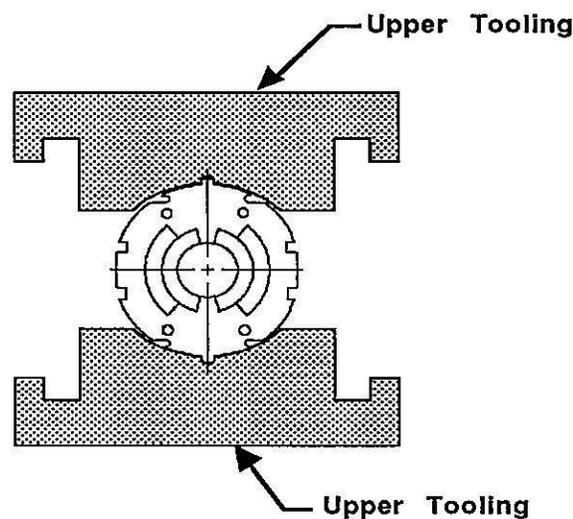
b.) The lower half of the collaring tooling was unavailable for DSA321. The upper half was split into two sections and used on both the top and bottom of the magnet as shown in Figure 7. The collaring tooling, after being split in two pieces, was only 36 inches long. As a result, the magnet had to be collared in two sections (incrementally).

The keys, instead of being pushed in by hydraulic cylinders, were placed in by hand. No problems resulted from the altered collaring procedure. Future magnets will be collared with the regular collaring tooling.

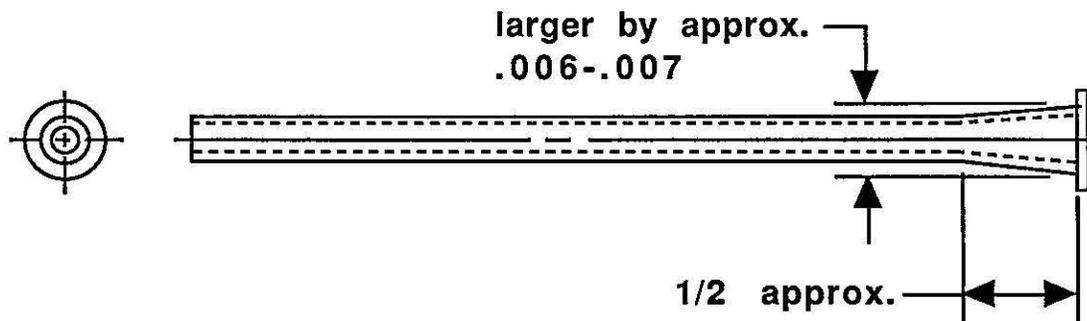
f.) Clearance between the collar pack pin and the hole in the collar lamination is very tight (.000 minimum thru .012 maximum by design). When the pins are manufactured the diameter near the flared end becomes slightly larger due to the flaring operation on the end as shown in Figure 8. This creates an interference fit between the pin and the collar for the last three or four spot welded pairs. The temporary solution has been to drill the holes in these pairs out slightly larger to fit the pins. A long term solution needs to be determined. Either the manufacturing process on the pin will need to be modified to prevent the pin from flaring or the collar lamination hole clearance will need to be increased.

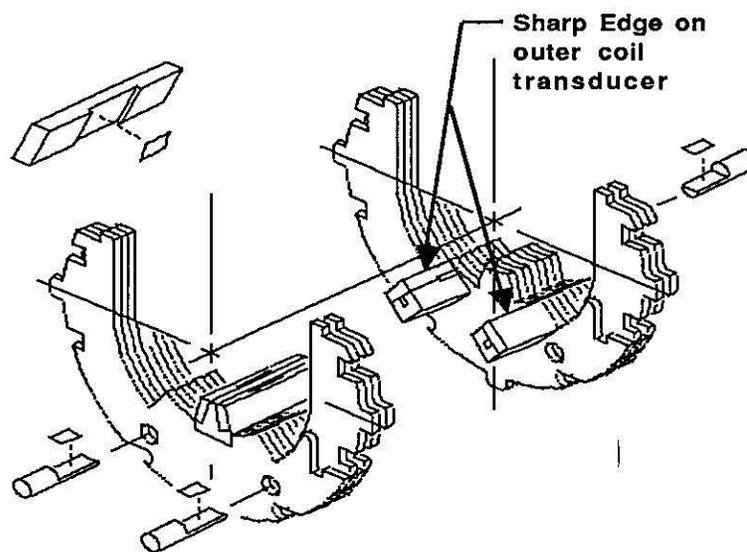
Figure 9.

b.) When the collared coil was disassembled due to the turn-to-turn short, a serious amount of damage to the ground wrap was observed in the strain gage area. The sharp corner of the outer coil transducer block (as shown in Figure 9) had cut into the kapton ground wrap layers. Two of the three layers were completely severed. This problem did not exist on the 40mm magnets because the transducer block, due to the different geometry, did not directly contact the ground wrap. The solution on DSA321 was to round the corners on the transducer block before reassembling the magnet. This may or may not be an acceptable long term solution. Two steps need to be taken:

- Collar DSA322 with the rounded corner outer transducers. Dissassemble and inspect for damage.
- Calibrate some transducers both with and without the rounded corners to see if the calibration is affected by the rework.

The results will determine whether this solution is acceptable for the 50mm magnets.

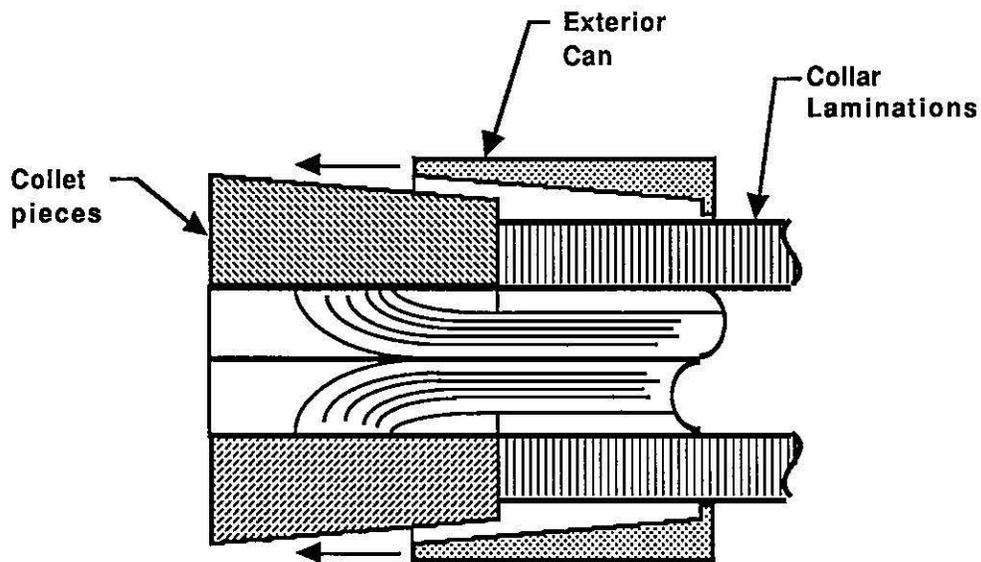
f.) The large exterior can of the end clamp must be driven onto the collet pieces from the inside "collared" area of the magnet toward the ends as shown in Figure 10. It is therefore necessary to slide this part onto the collared area of the coil before installation begins. When sliding the can onto the coil, there is a physical interference between the end clamp can and the inner-to-outer coil splice. The face plate of the end can must be slotted to allow the can to slide over the end without excessive bending of the splice

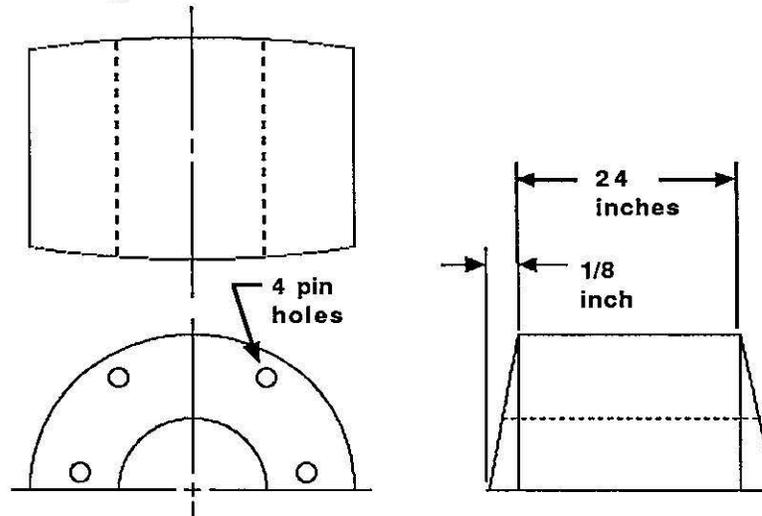
f.) The yoke packs, which presently have four pin holes, still do not retain a shape sufficiently parallel to meet the magnet requirements. Packs are "bellevilled" by as much as 1/8 inch on a 24 inch pack as shown in Figure 11. Several solutions are available. A fifth pin is possible. Welding of yoke packs is also being tried.

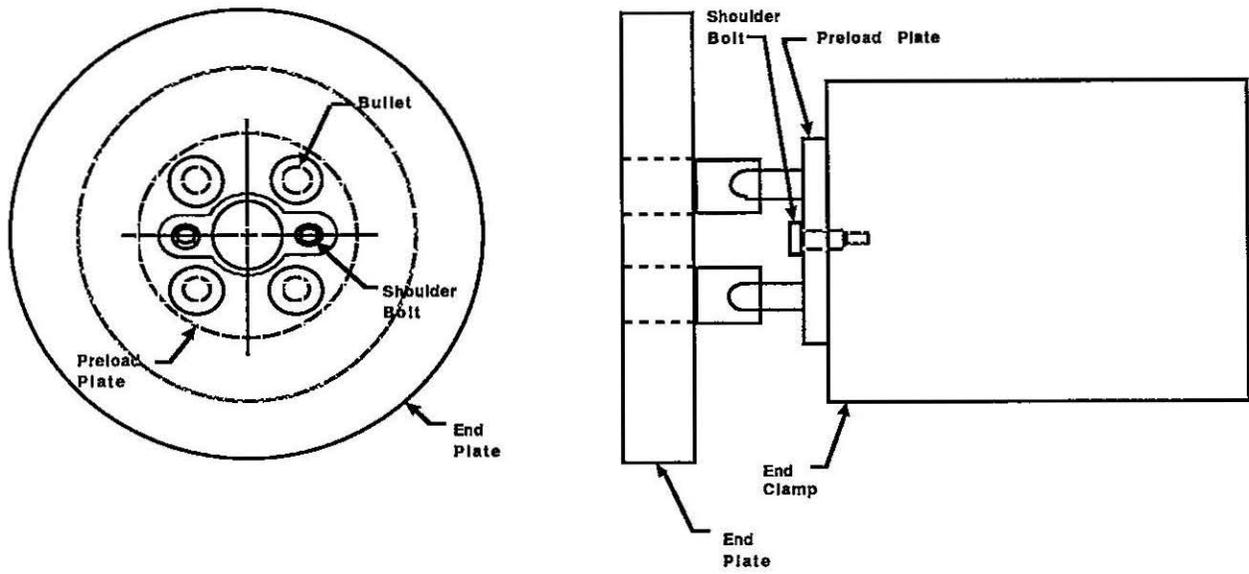
h.) The bullets are held onto the end clamp by means of a plate (called the preload plate) with two screws. The holes are by design placed on the vertical axis. On the 40mm magnets, the bullet/preload plate assembly was bolted firmly onto the end clamp. Alignment between the bullets and the end plate was done by adjusting the end plate at final assembly. This method will not work on the 50mm design because the end plates are welded to the skin and consequently not adjustable.

The 50mm solution is to drill oversize holes into the bullet preload plate. It is loosely attached to the end clamp by shoulder bolts through these holes before the endplate is installed. The bullet preload plate position is then adjusted to conform to the end plate after the end plate has been welded. The holes in the preload plate must be changed to the horizontal plane to allow access through the end plate. The assembly is shown in Figure 12.
