Wayne Koska
1-21-91

Failure of DC0303 During Impulse Test

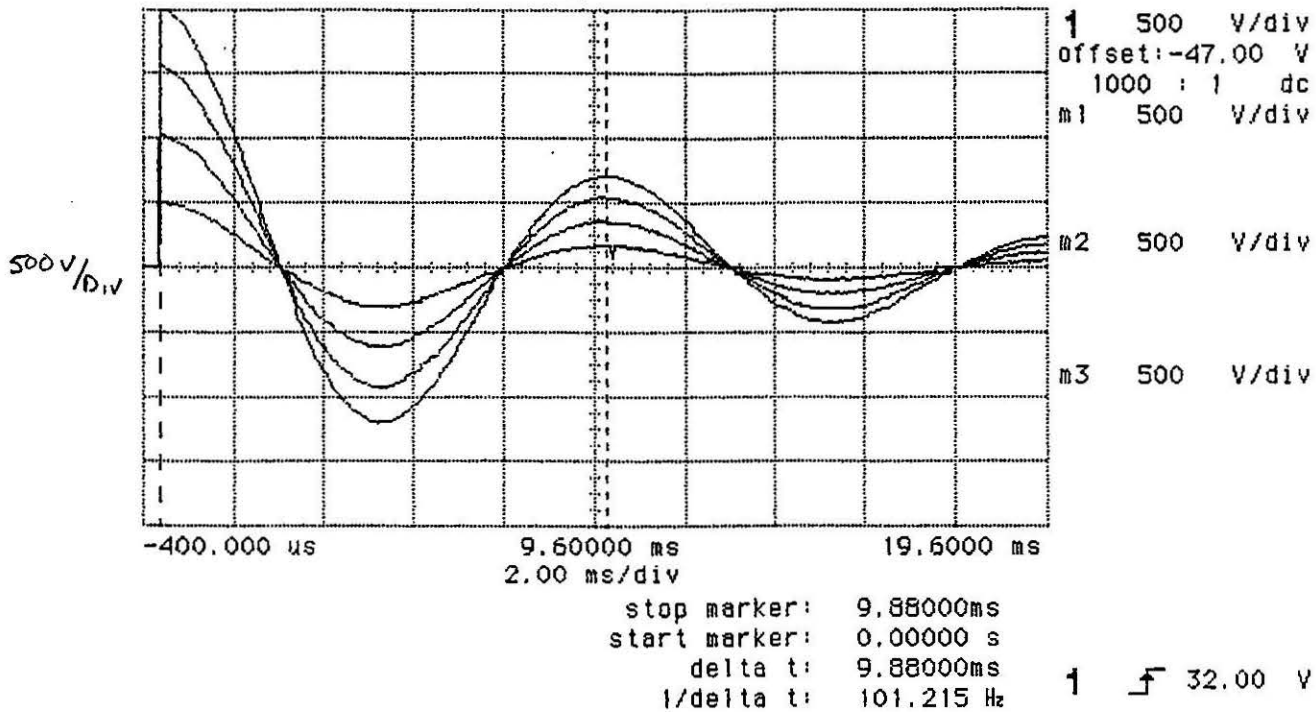
Figure 1

Collared Coil Assembly

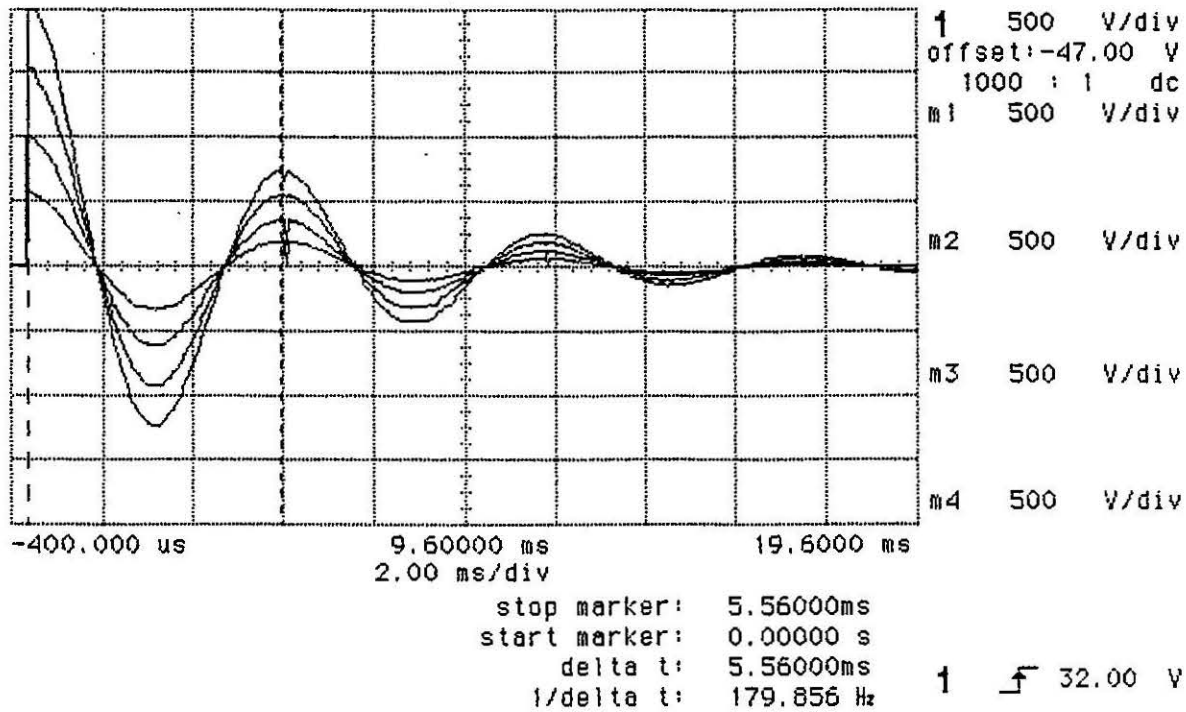
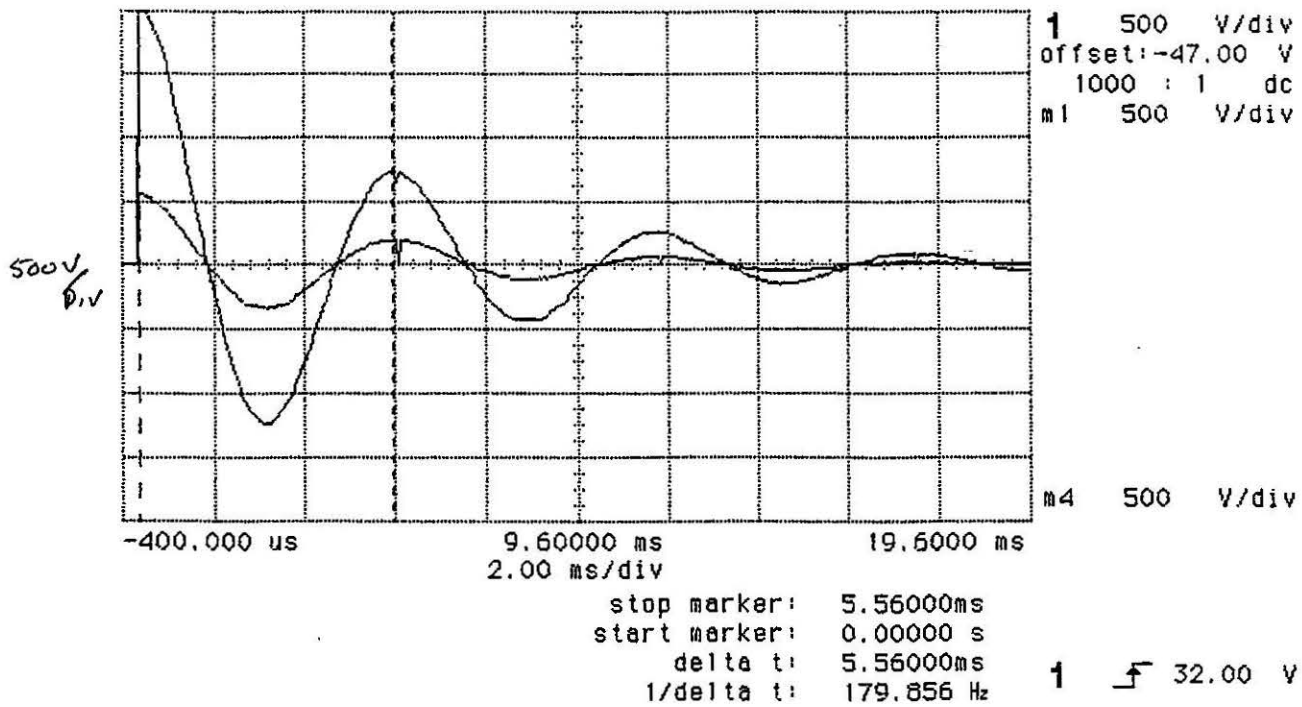
Figure 2

Upper Coils

Collared Coil Assembly

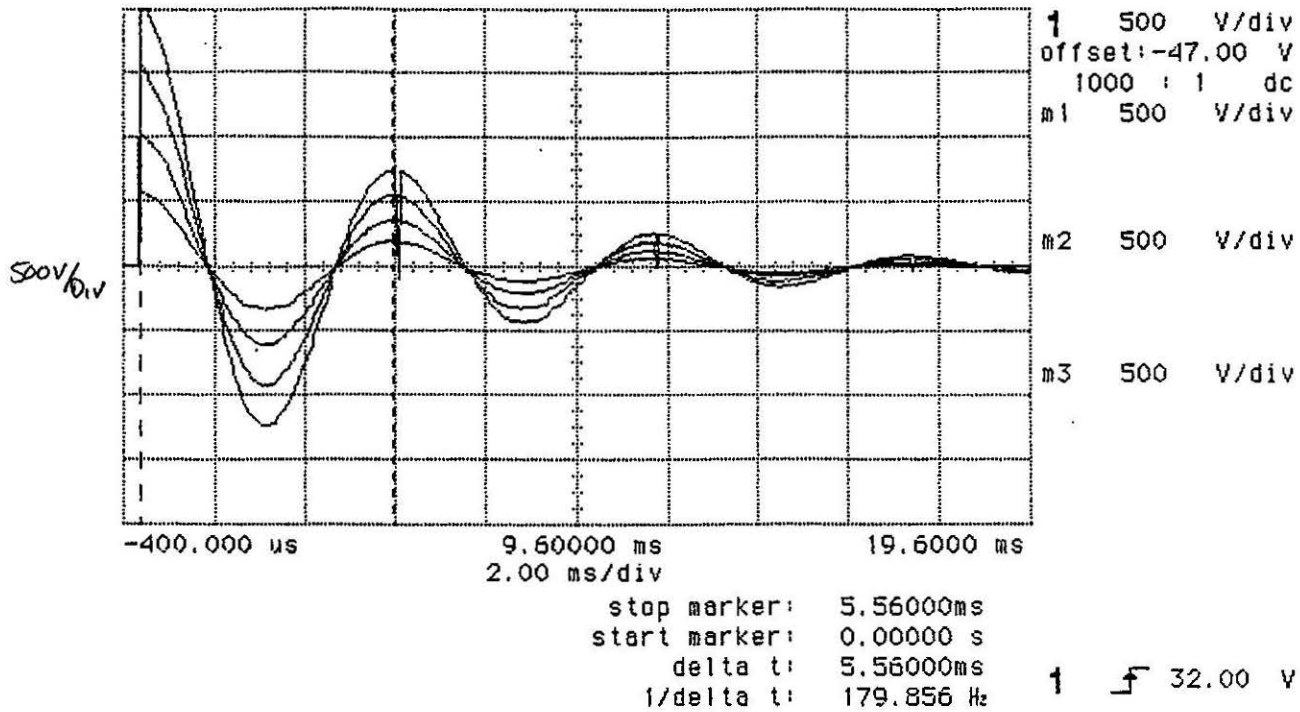
Figure 3

Lower coils

Collared Coil Assembly

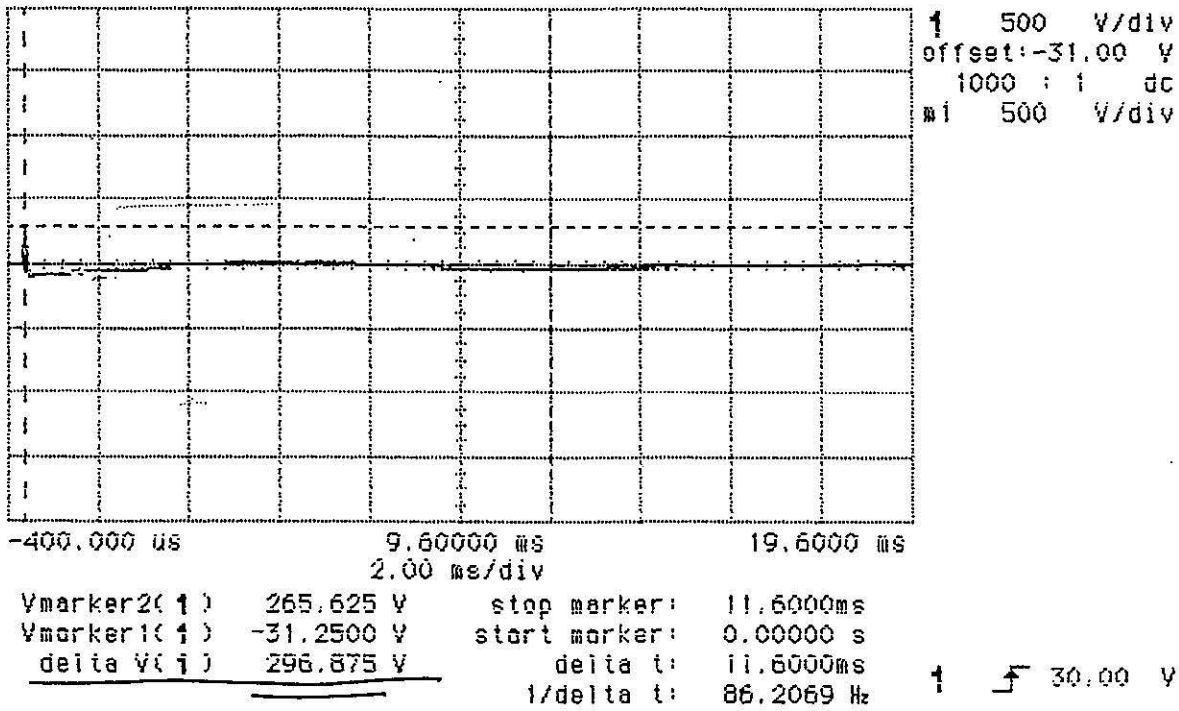
Figure 4

To summarize, an electrical breakdown occurred in DC0303 between the upper and lower inner coils across the mid-plane during impulse testing at 500 V. The magnet had successfully withstood D.C. hipotting across the mid-plane to 3000 V before the upper to lower splice had been made, and impulse testing, to a maximum of 2000 V, of the collared coil assembly.

Yoked Coil Assembly

Capacitor Voltage = 500 V
