**DC0305 Turn-to-Turn Short: Examination of  
Lower Inner Coil 17M - 1007 - R**

**TS-SSC 91-033  
S. Delchamps  
February 14, 1991**

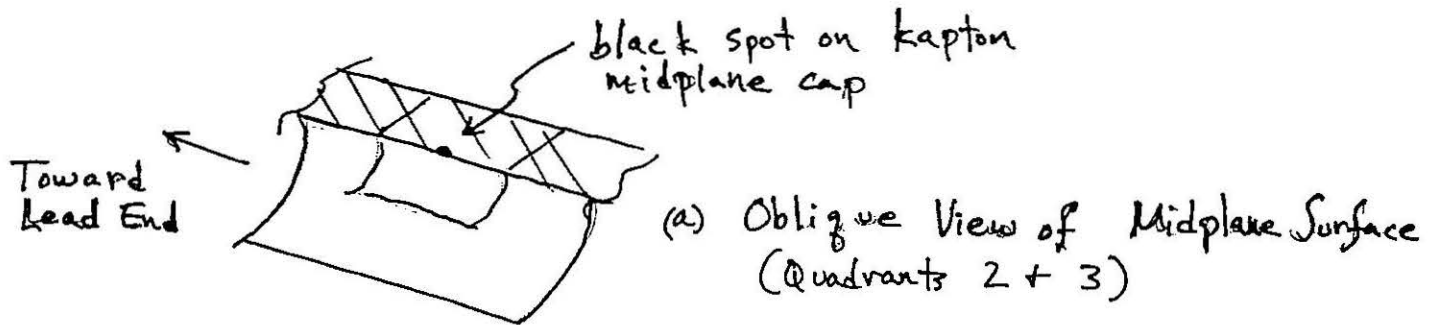
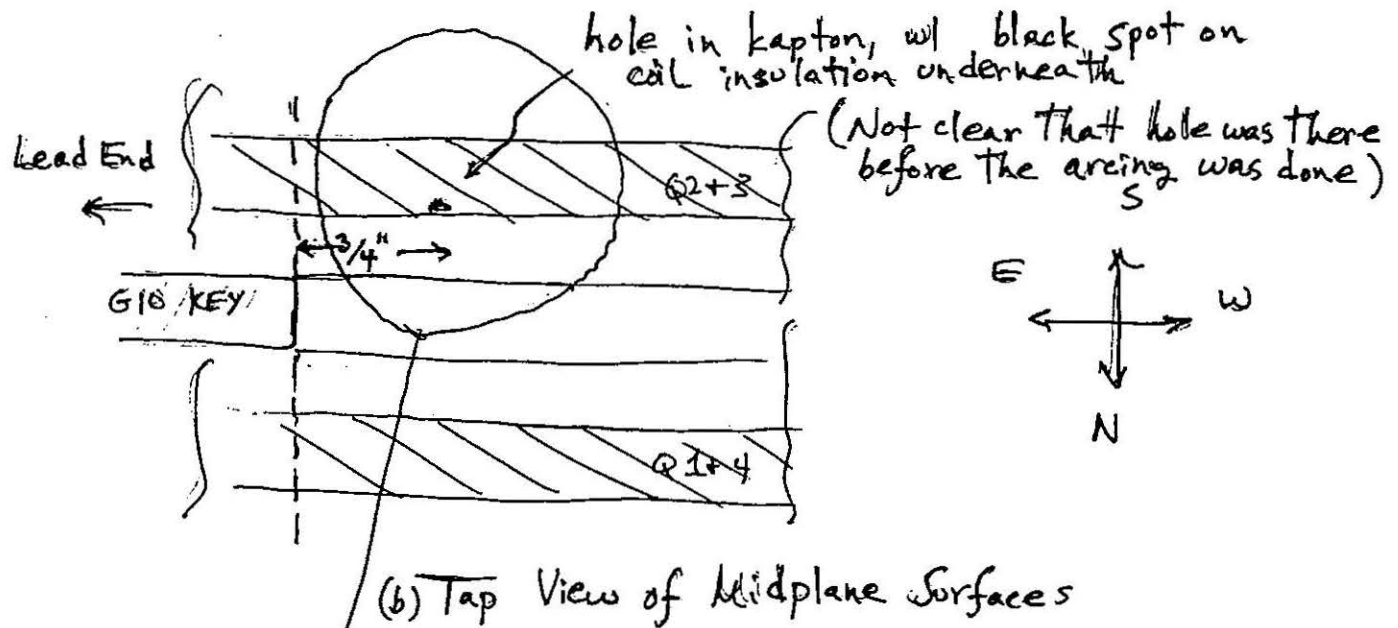
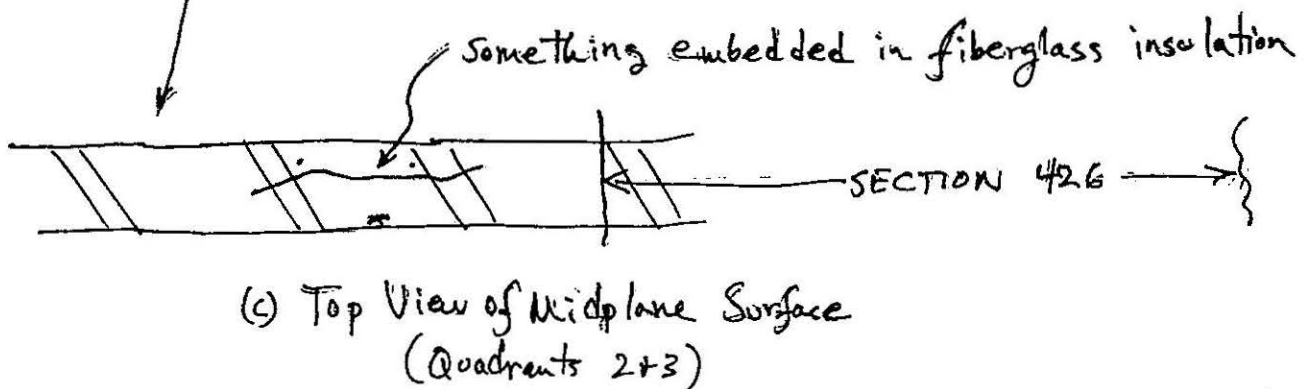
Figure 1

When the hipot test was done, one spot was found (in section 427 at the lead end of the coil) where arc-ing occurred. Once the arc-ing had taken place, a small hole could be seen in the kapton midplane cap. A small burned spot could also be seen on the coil insulation underneath the hole. This arc-ing was in the region at the very end of the collared portion of the magnet, where the midplane cap is seen to be scored heavily due to the higher load applied at the magnet ends by the keying press.

Closer examination revealed a fiber-glass-like filament embedded in the coil insulation; this filament later came loose and was saved. There is no indication that the filament had anything to do with the arc. (See Figure 1.)

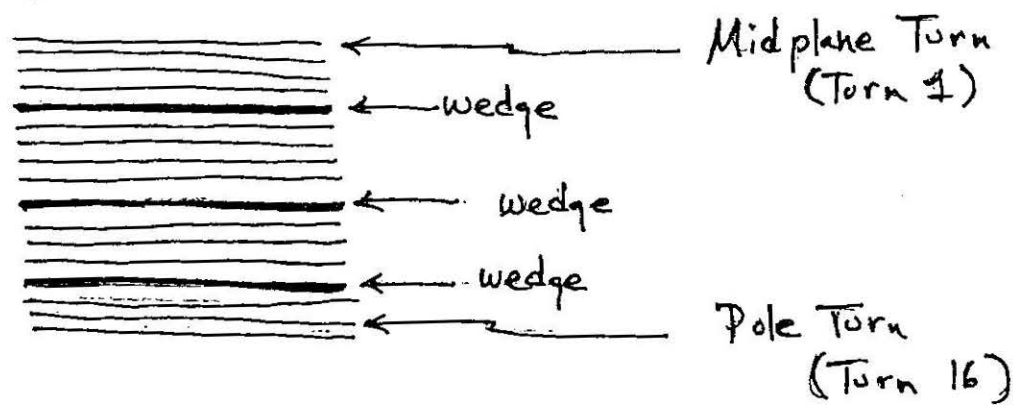
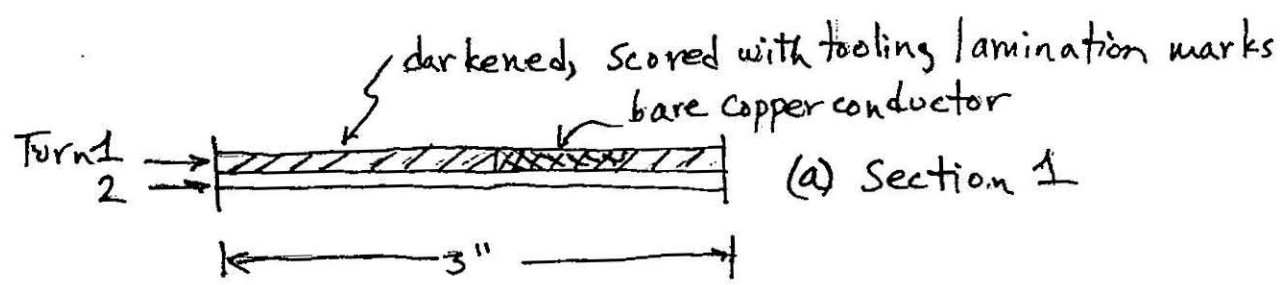
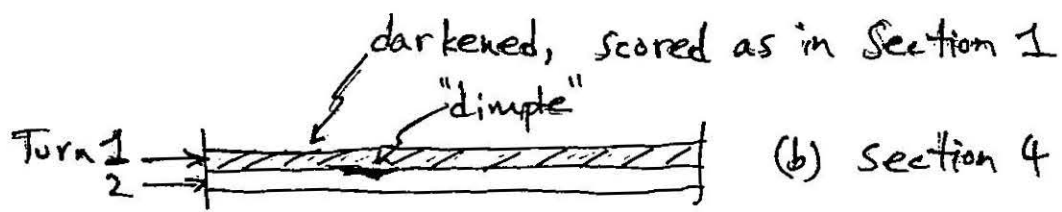
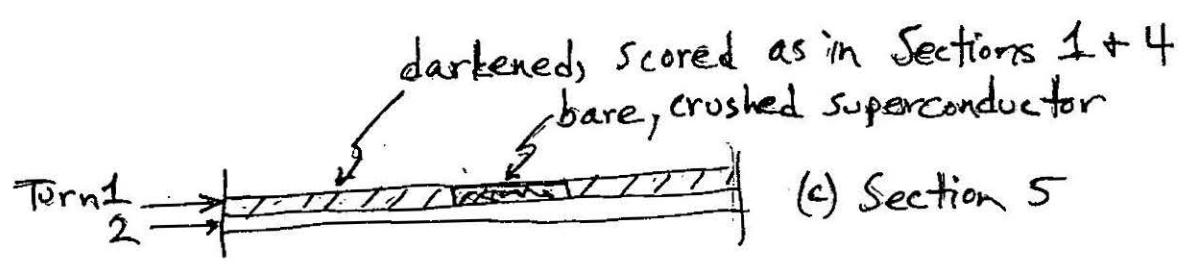
Figure 2

1) The inside edge of the midplane turn of section 1 was scored and darkened, and there were several bare conductor spots (see Figure 2a.)

2) The inside edge of the midplane turn of section 4 was similarly darkened (in fact, the whole region near the lead of the coil, that is regions 1 through about 10 was darkened and scored), and there was a dark dimple which appeared to press into the turn just below the midplane turn (see Figure 2b.)

3) In region 5, which however showed no evidence of shorting when pressed with the sizing fixture, there was scoring and blackening and a large patch of what appeared to be crushed superconducting filaments on the inside edge of the midplane turn (see Figure 2c.)

All of these features would appear to be related to the rewinding process and/or the re-curing process of the coil.
