TS-SSC 91-058  
March 29, 1991  
Masayoshi Wake

### DS0314 Inspection Memo

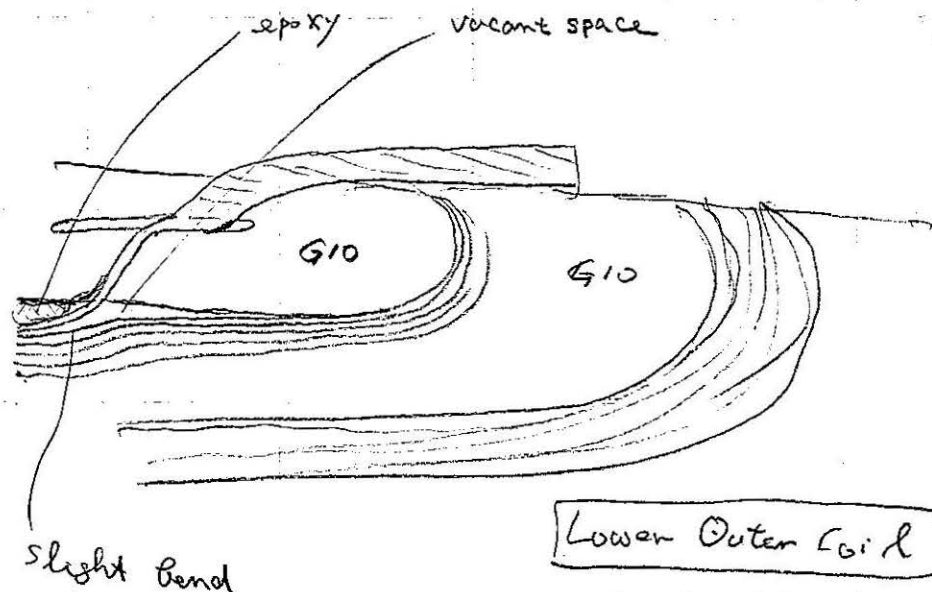
The end part of DS0314 was taken apart to find the cause of unexpected quenches in the lower outer coil near the land splice. A peculiar thing in this coil was a large gap between the coil and the G10. The gap was about 2 mm in the lead side while others had less than 1 mm gap. Actually, the G10 key was not pushed in to the proper position and had a tilt to the coil.

Since the next turn had a slight bend toward the midplane at this position, this may be caused by the too much epoxy to protect the voltage tap. A clod of epoxy at the voltage tap prevented the G10 key from properly pressing the pole turn and the land splice.

Since they have to use epoxy before the clamping, this could happen in any magnet. These epoxy should be used minimum amount and has to be dried with proper clamping not to create an obstacle for the closing of gaps. Use of some temporary end clamp might be necessary.
