To: E. G. Pewitt, Project Manager
From: ^{at} D. Tinsley, Project QA/QC Manager
A. Koca, QA Engineer *at*.
Date: November 18, 1991
Subject: Trend Analysis - 50MM Magnet Project

FNAL/SSC 50 MM MAGNET PROJECT

TREND ANALYSIS

10-28-91

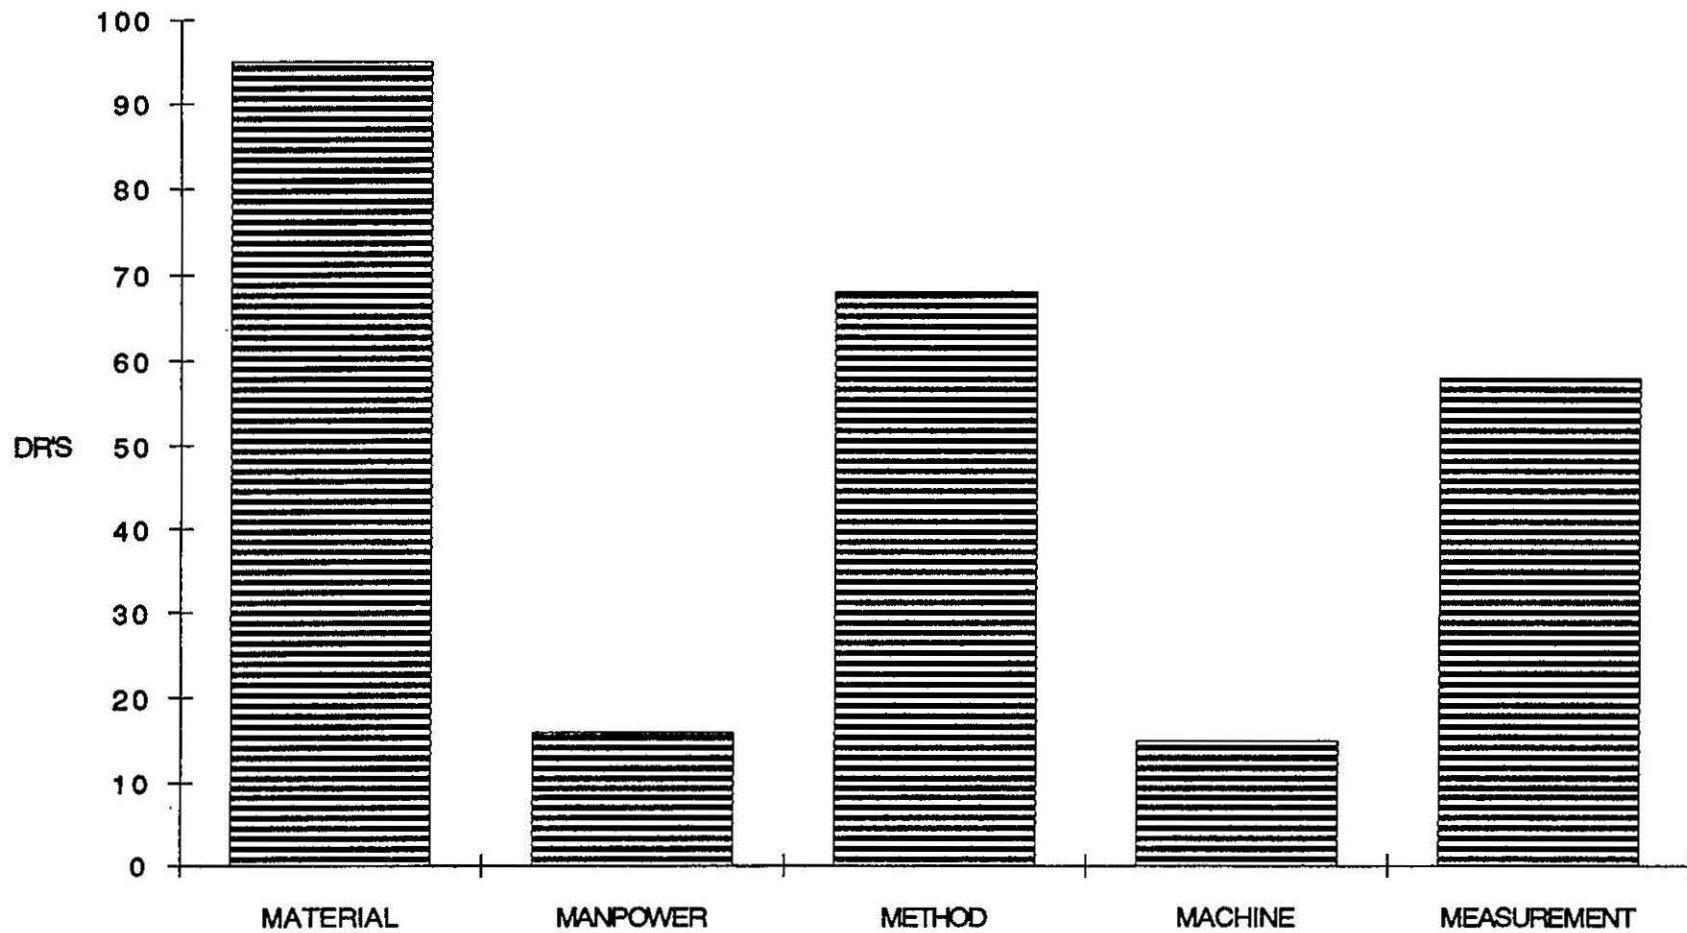
DISTRIBUTION OF 252 DISCREPANCY REPORTS FROM 3-21-91 TO 10-28-91
Magnets DCA 310 - 319 & 321

The area of Materials is the major problem area and appears to be consistent on the later Magnets. The area of Measurement is behind Methods, but is on the increase due to the amount of testing done as Magnets progress. This can be expected and seen on diagram "Distribution of 252 Discrepancy Reports from 3-21-91 to 10-28-91".

The major problems still lie in the areas of Materials, Methods and Measurement used in the fabrication and assembly of the 50MM Dipole Magnets as shown in the diagram "Distribution of 252 Discrepancy Reports from 3-21-91 to 10-28-91".

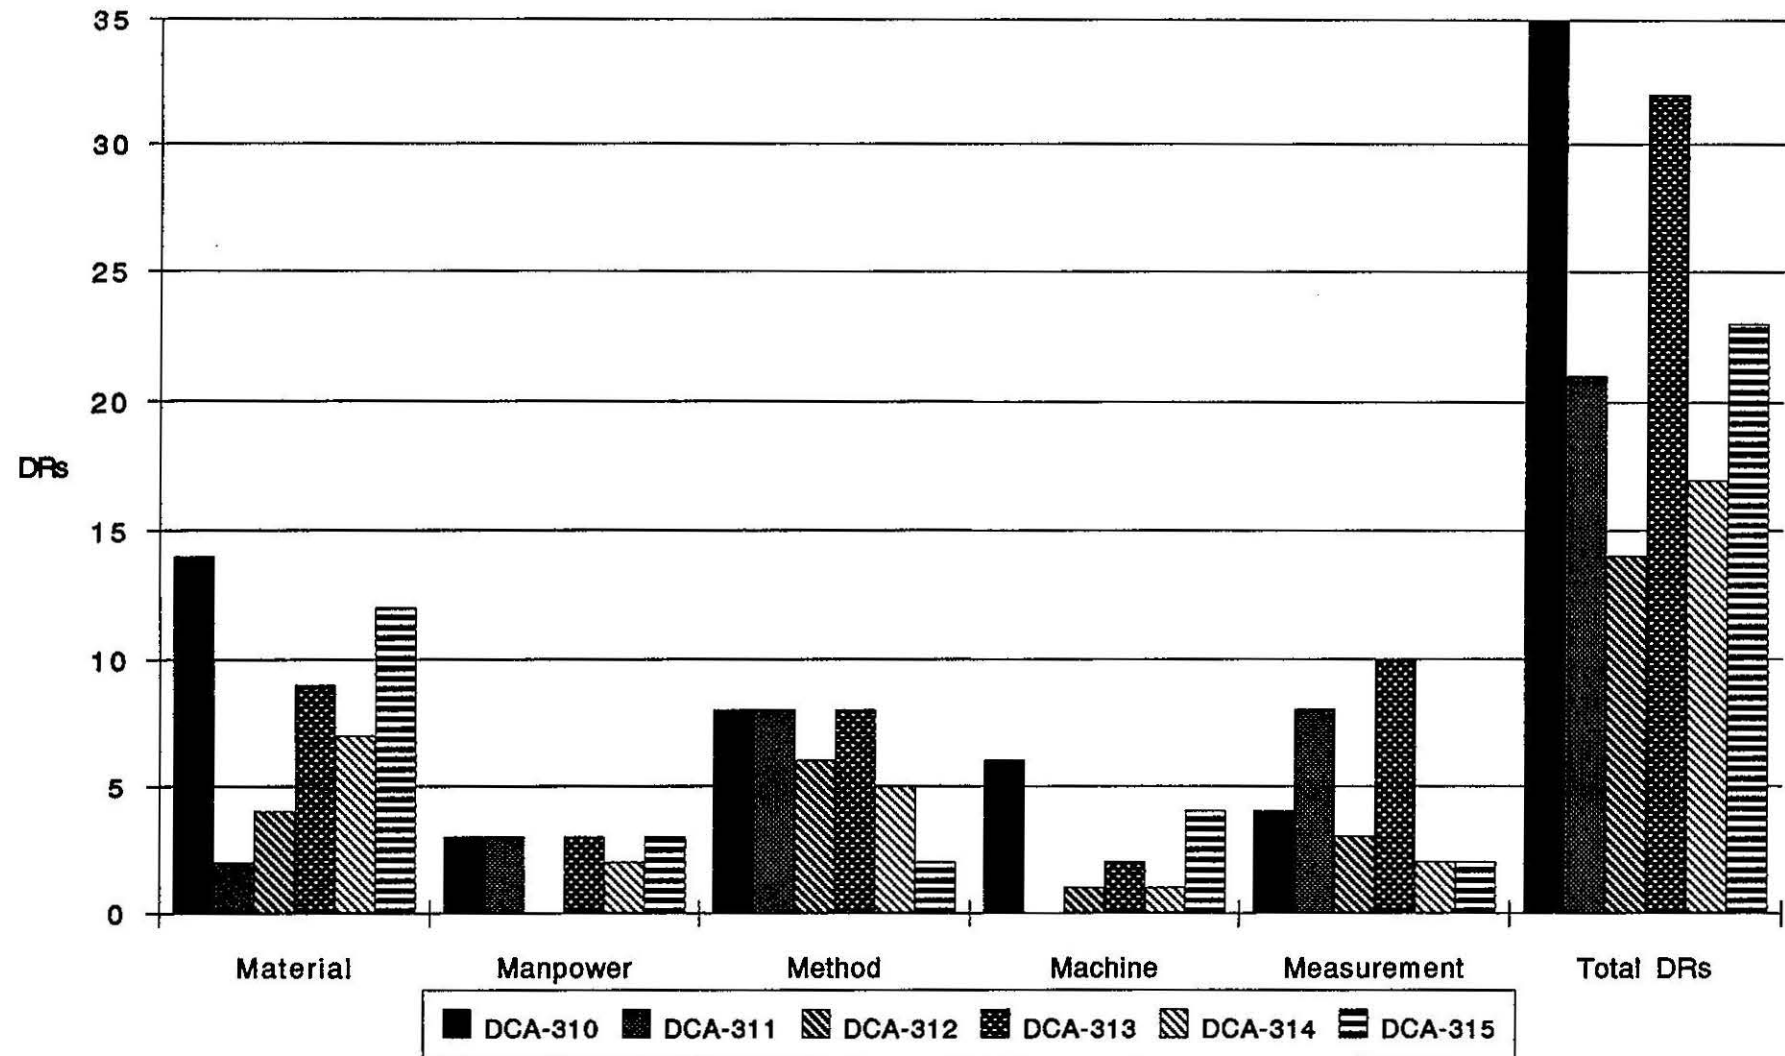
142 DRs FOR MAGNETS COMPLETED UP TO COLLARED COIL END CLAMP INSTALLATION
(10-28-91)

Magnets DCA 310 through 315 have completed the Collared Coil End Clamp installation stage and DCA 312 appears to have the least amount of problems, but the G.D. Magnet DCA 313 had an increase in DRs. The next Magnet, DCA 314 dropped in total DRs, but DCA 315 has shown an increase. This is shown in the diagram "142 DR's For Magnets completed up to Collared Coil End Clamp Installation (10-28-91)".
