TS-SSC 91-245  
12/30/91  
G. Tassotto

## LOCATION OF UPPER INNER LEAD TO GROUND SHORT IN MAGNET DCA315

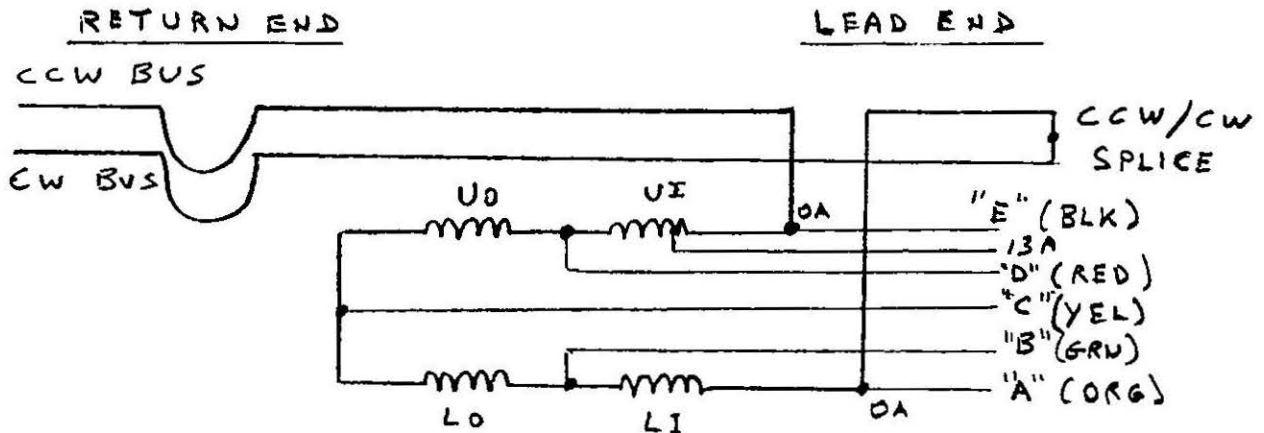
On Wednesday 11/27/91 technicians found what looked like a bus to ground short during an electrical checkout prior to end-dome assembly installation. FNAL magnet DCA315 is electrically connected in a CCW configuration. This means that, for the single magnet test, the magnet leads are connected to the bus as shown below. See also FNAL DRW# ME-167548 and # MB-292688 Rev. A.
