DCA318: Turn to Turn Short Location and Repair

**TS-SSC 091-246
S. Delchamps
December 16, 1991**

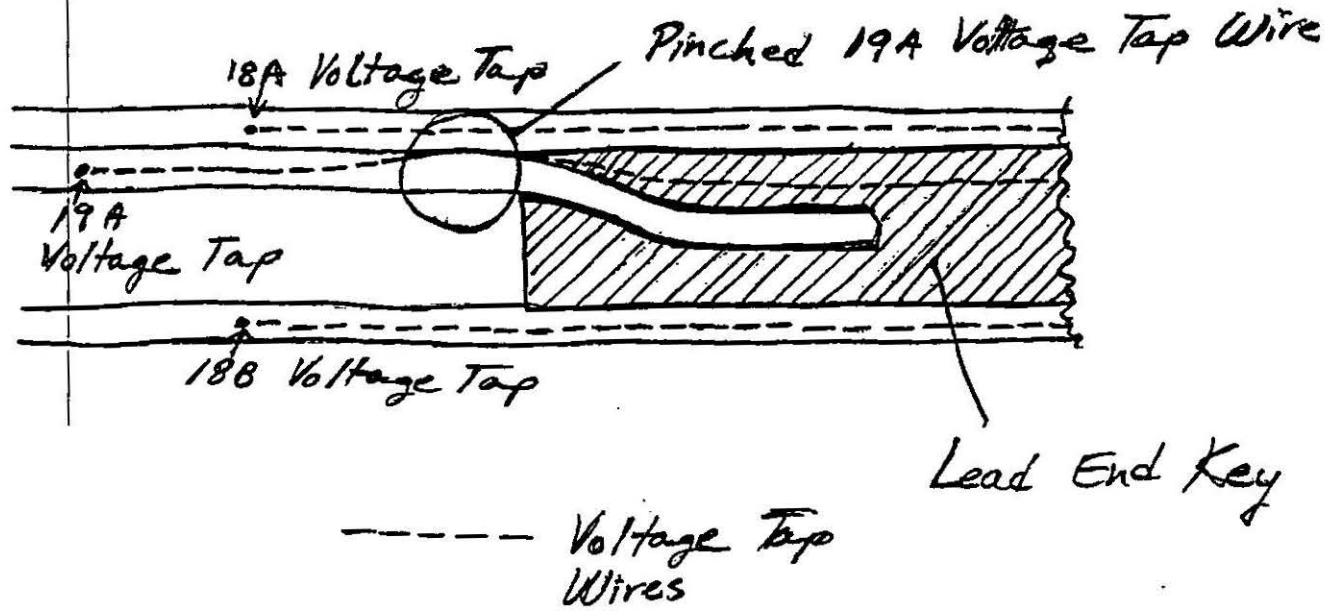
FIGURE 1

The collared coil assembly was taken apart, and coil 1017 was set up for inspection. Examination with a microscope of the outside surface of the coil showed no obvious signs of damage. However, when the inner surface of the coil was examined, it was found that the 19A voltage tap wire had been crushed between the 19A turn and the 18A turn, as shown in Figure 1. This accounted for both the short between the 19A and 18A turns, and the odd behavior of the 19A voltage reported in Reference 2.

The crush occurred because the 19A voltage tap wire had not been routed in the usual manner, on the surface of the preform turn all the way onto the key surface, but rather straight out. This allowed the wire to fall into the uncemented gap between the preform and 18A turns.
