**DCA312 Open Voltage Taps:
Correction to Discrepancy Report 374**

**S. Delchamps
TS - SSC 92-012**

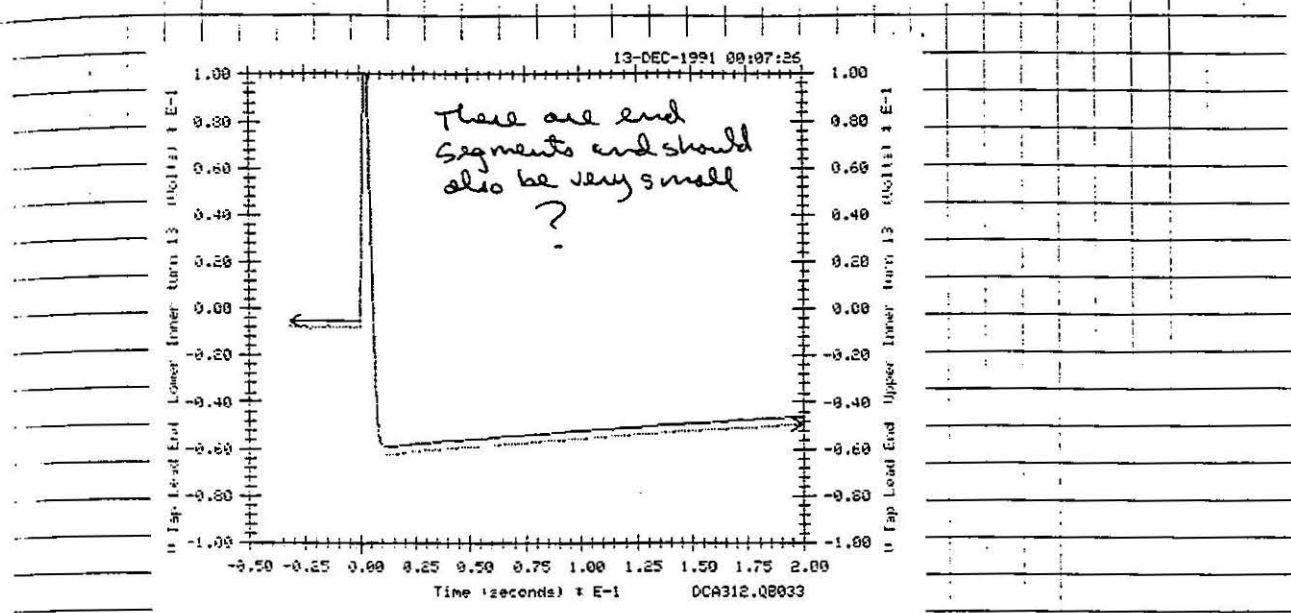
check the resistance between taps at the breakout box in the ACR

find the following open taps (see next page)

LI 14B	UI 14B	All these taps functional OK in the first TC 1000 A dump!
LI 15B	UI 15B	
LI 16B	UI 15B	
LI 17A
