FERMILAB-TM-1931

Screw Compressor Bearing Failure at C0#4

Carl Pallaver and Terry Cross

April 1995

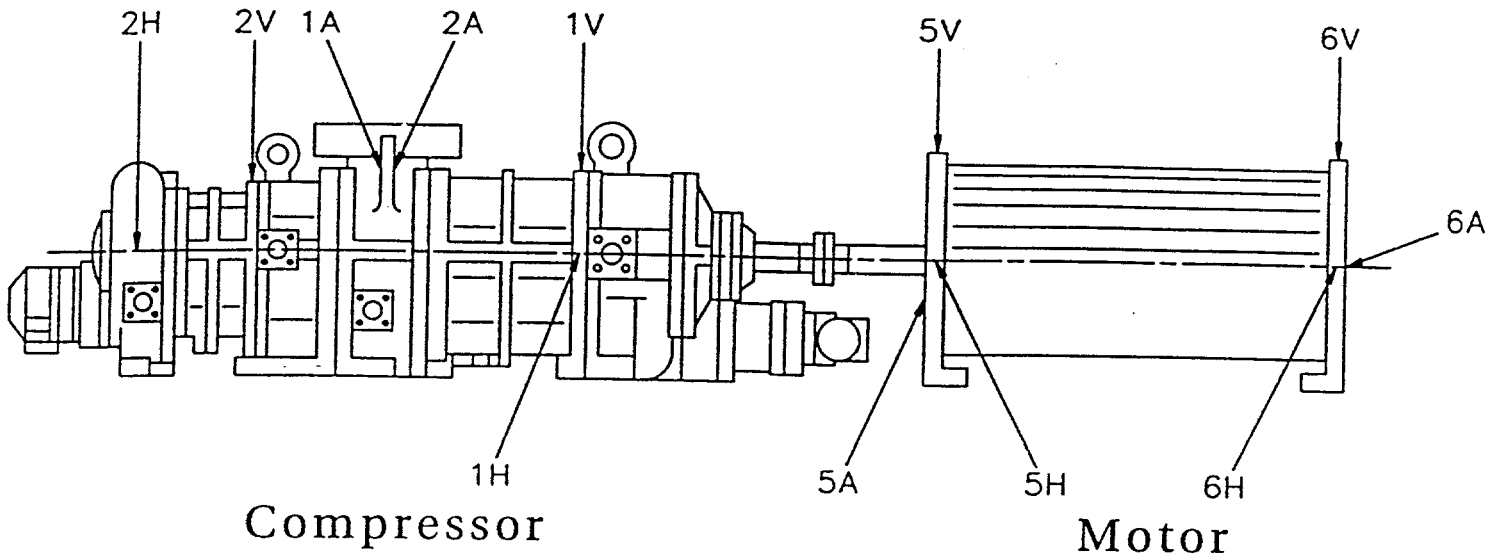
Compressor C0 #4 adjoins our service building and has thermocouples on each thrust bearing outer race, total of 4. These temperatures are read continuously and registered on a chart recorder. On December 21, 1994 at 1000 hours we observed an increase in noise level on this machine with 35,000 registered operating hours. There are 3 other compressors in this building which mask out most noise and makes it difficult to pin point the problem. At 1500 hours we took spike energy and amplitude readings on all four machines within the building. The results are shown below.

12/21/94	Spike Energy	Spike Energy	Amplitude
Compr.	Position 1A	Position 2A	Position 2A
C0#1	0.17	0.15	0.08
C0#2	0.13	0.10	0.09
C0#3	0.14	0.10	0.08
C0#4	0.38	0.41	0.10

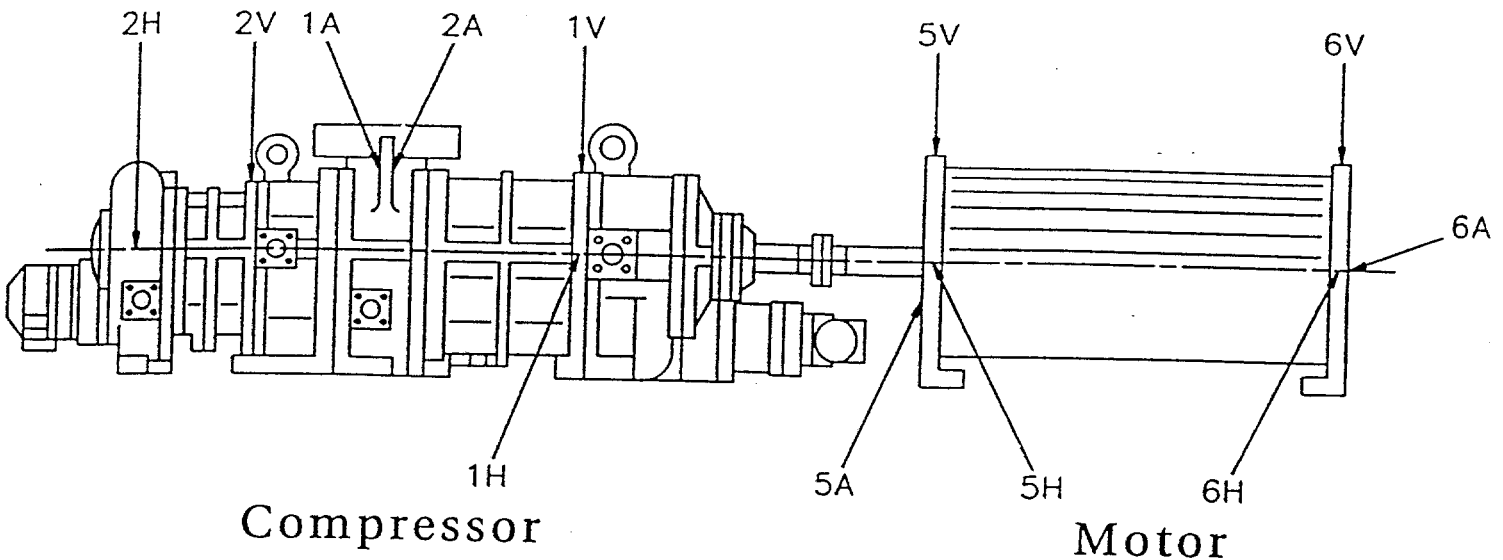
On December 22 at 0400 (13 hours later) the shaft probe shut C0 #4 compressor down. At 1000 hours we cleared the control panel and started the machine. The position 1A spike energy read 12.0, amplitude 0.09, the shaft probe shut the machine down within 5 minutes. At 1300 we cleared the control panel and started the machine again. Within a minute, the shaft probe shut the machine down. This machine was replaced. Our inspection of the noisy machine confirmed a bad 2nd stage thrust bearing.

Compr. 12/22/94	Spike Energy	Amplitude	Ultrasonic Freq.	Machine
	Position 2A	Position 2A	Position 2A	
C0#1		0.10	4.96	Fully Loaded
C0#2		0.10	4.83	Fully Loaded
C0#3		0.04	5.18	Fully Loaded
C0#4	1.20	0.12	2.94	Fully Loaded
C0#4	1.20	0.12	3.54	Unloaded
