MQXFA11 shipping incident report

US-HiLumi-doc-4341

Date: 08-08-2022

US HL-LHC Accelerator Upgrade Project MQXFA11 shipping incident report

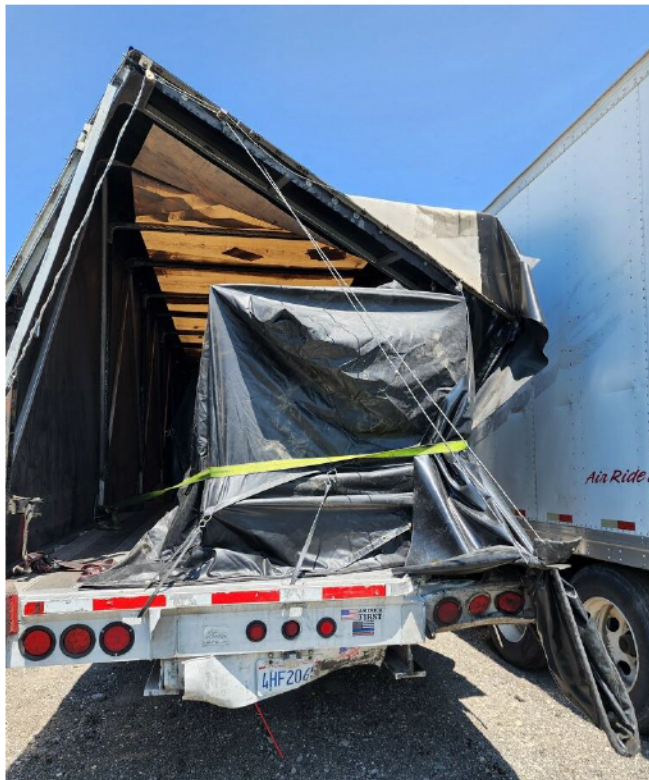
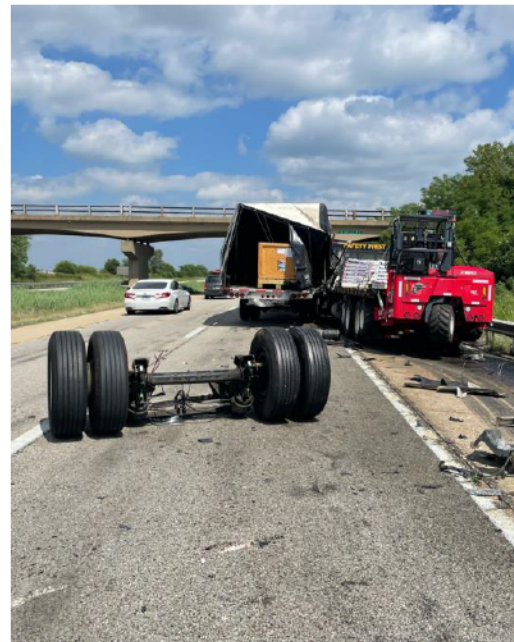
The truck transporting the MQXFA11 magnet from LBNL to BNL was involved in an accident on 7/20/22. It was rear ended by another truck. Drivers were not injured.

The main hit took place on the right back corner (see Fig. 1). During the incident the truck rear axle as displayed in Fig. 1 (right panel).

Figure 1: Pictures of the truck taken right after the incident.

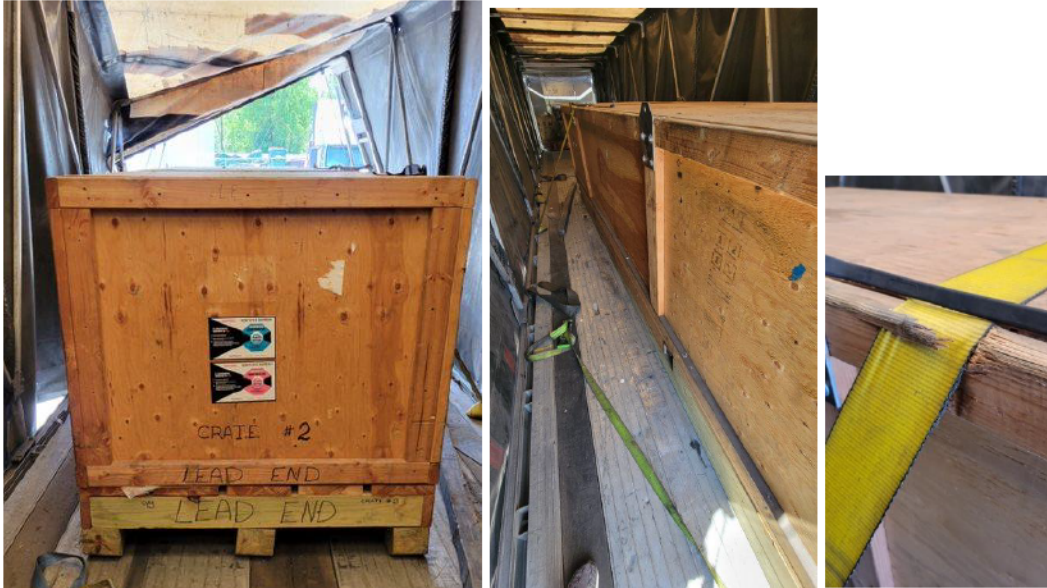
Figure 1: Left to right: Photo of the lead end of the crate/magnet taken after the incident from the cab end of the trailer; The yellow sling was found close to the metallic tab; detail of the yellow ling after the incident

The rear end of the crate was found shifted toward the passenger side of the trailer. One of the slings was broken and the crate moved backward 6-7' according to the position of the undamaged sling (see details in Fig. 1).

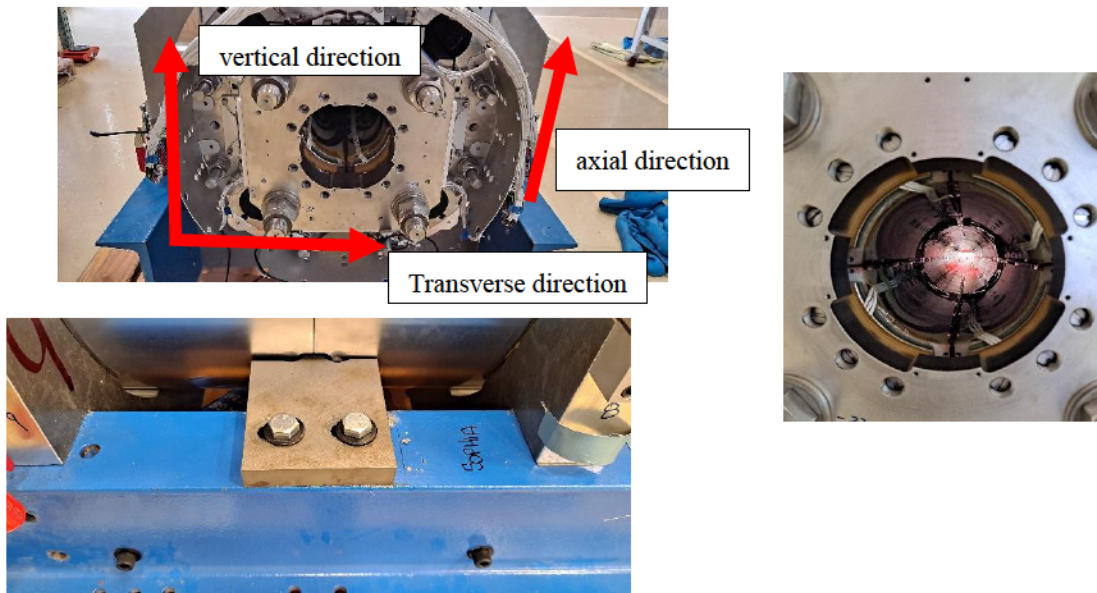
The magnet was found in very good conditions. In Fig.2 pictures of the end plate, the bore and the longitudinal stopper are displayed. There are no signs of damage.

Figure 2: Photos of the return end, magnet bore, and longitudinal stopper taken at FNAL during the visual investigation

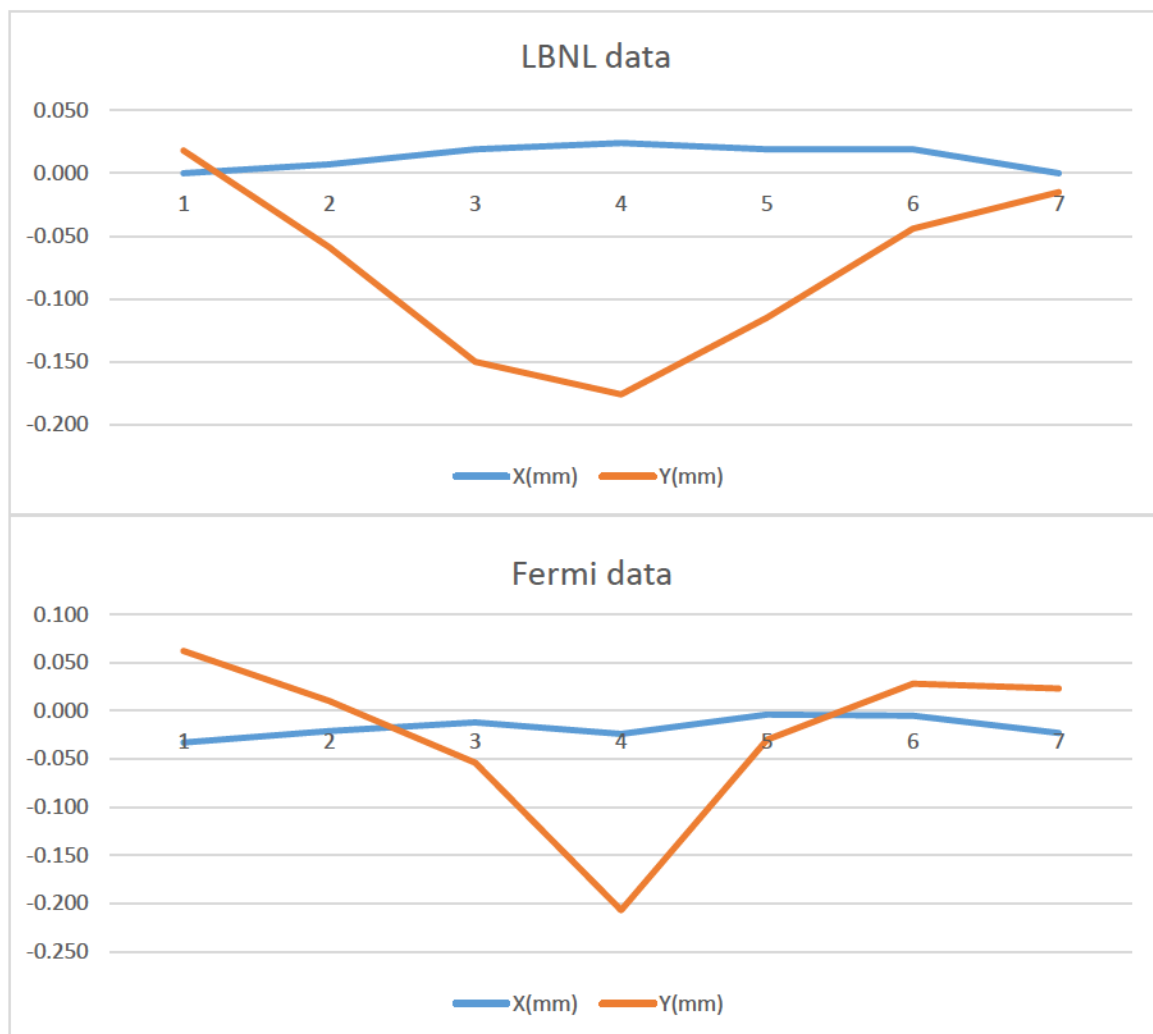
Finally, a metrology survey was performed to check the MQXFA11 straightness. The measurements are taken longitudinally in seven points. It is worth noticing that the measurements were taken with the magnet sitting on a table at LBNL and with the magnet sitting on the shipping fixture at FNAL. X and Y values indicates a point on the magnet circumference along the transverse direction and the vertical direction as defined in Fig. 4. Data taken at LBNL and FNAL are show in Fig. 3. The general behavior of the data is in good agreement as well as the maximum deflection along y.

Figure 3: Measurements of magnet MQXFA11 straightness along the vertical and transverse directions taken at LBNL and FNAL.

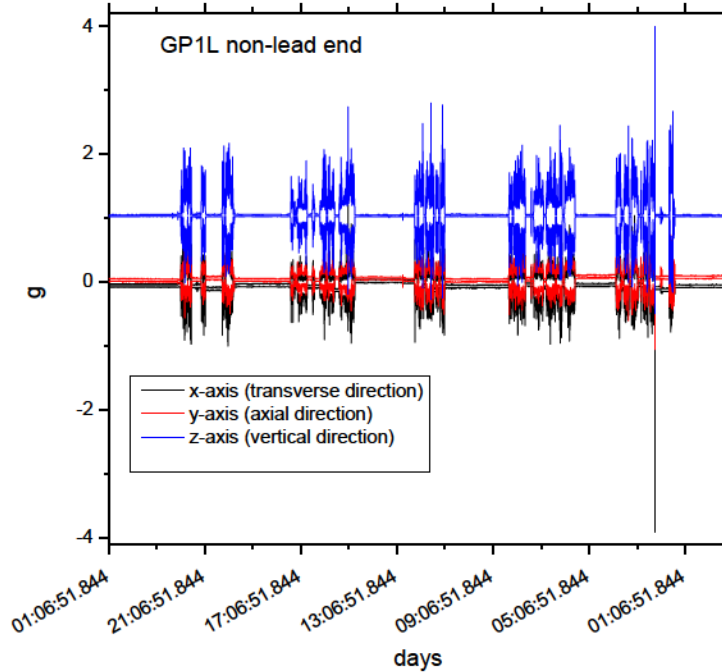
In Fig. 5 and 6, the lead end and the non-lead end shock snapshots of the entire trip is shown. The truck incident corresponds to the highest peaks observed in the two plots. it takes place on July 20th at 18:50 UTC. No data saturation is observed over the entire trip. The highest shocks (a little bit over 4g) are observed in the vertical and transverse

Figure 5: Snapshot of the shocks collected with the device installed on the non-lead end clamp

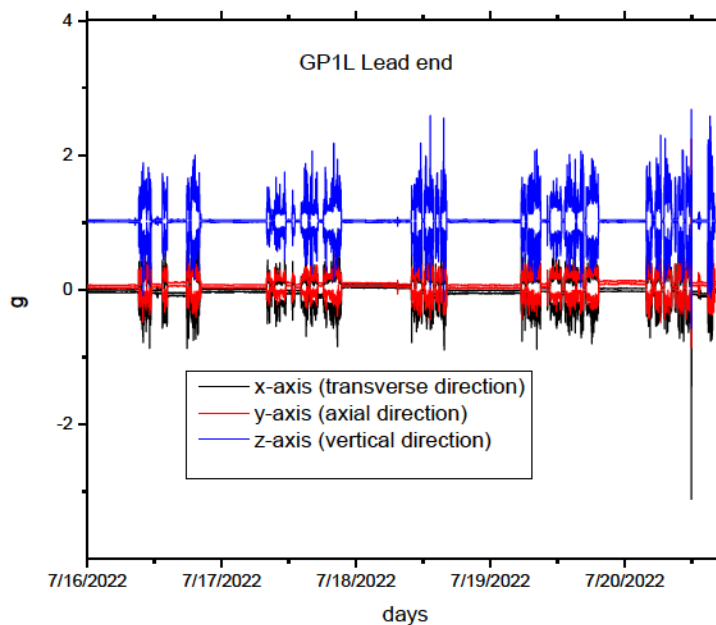
direction in the non-lead end device. No vertical high shock is observed on the lead and device.

Figure 6: Snapshot of the shocks collected with the device installed on the lead end clamp

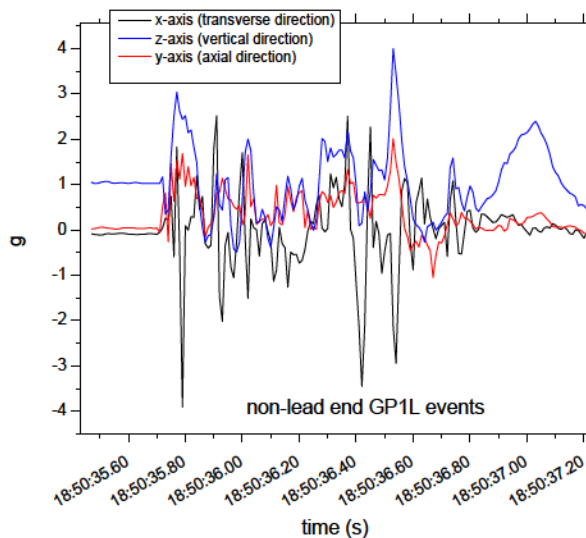
When $g > 3g$ it is possible to record event with the GP1L device. The data are collected 0.3 s before and 0.7 s after the event. Each event is 1 sec long. Only two events above 3g were recorded during whole trip. Those events recorded the shocks during the accident. They occur one after the other in a two second timeframe. The two events are plotted together for each device (lead end and no- lead end) in Fig. 7 and Fig. 8. No shocks above 4g are recorded. Highest shocks are along the transverse and vertical direction which is consistent with the fact that the non-lead end of the crate moved a few inches away from the driver side

Figure 7: Two second event recorded by the non-lead end device. Event data are recorded when shocks are above 3 g.

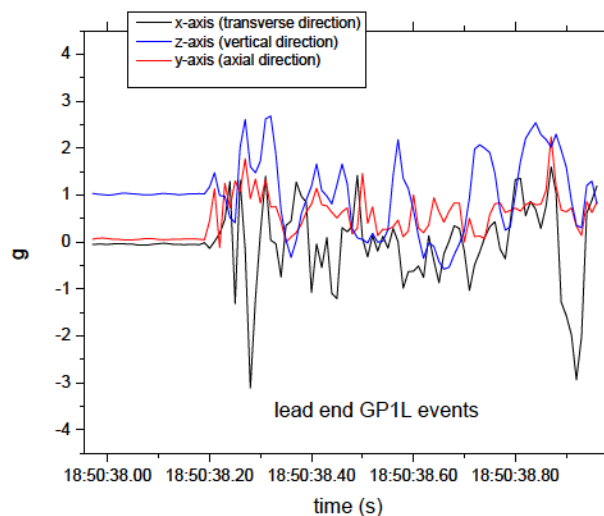
Figure 8: Two second event recorded by the lead end device. Event data are recorded when shocks are above 3 g.

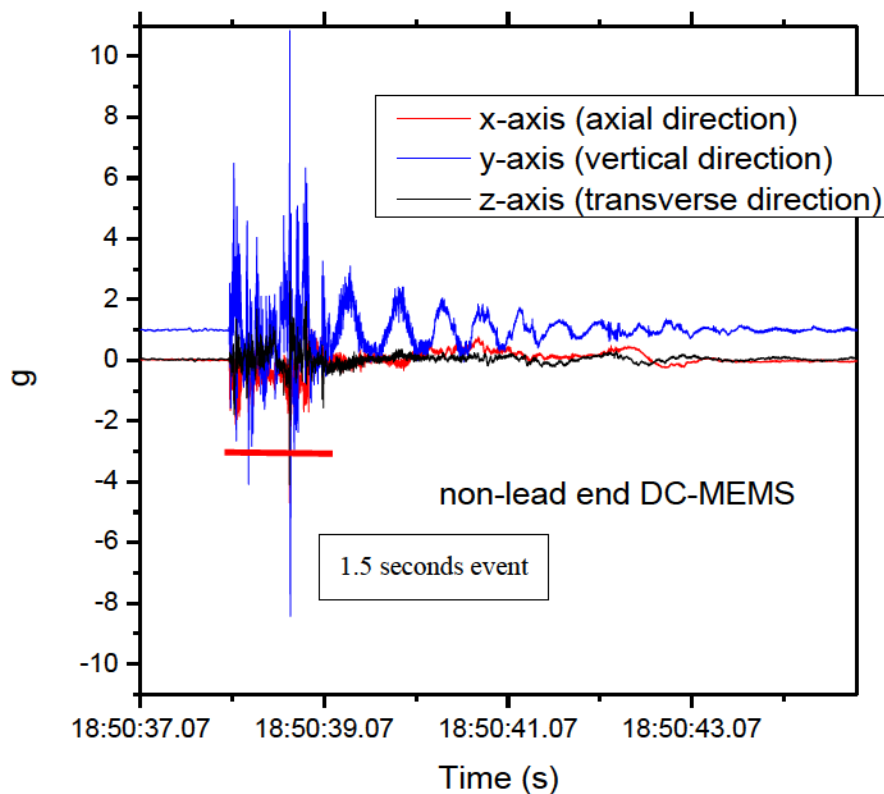
Each data set is 10 min long so the incident was captured in one data set. In Fig. 9 there is a snapshot of the shock vibrations collected during the accident with the DC-MEMS. The data are in good agreement with what is observed with the GP1L. Shocks above 3g cover a 1.5 s time window. The large oscillations observed afterwards are consistent with the incident dynamic and the detachment of the truck axle. The highest observed shock reaches 9 g along the vertical direction.

Figure 9: Shocks during the truck accident recorded by the DC-MEMS device installed on the non-lead end clamp

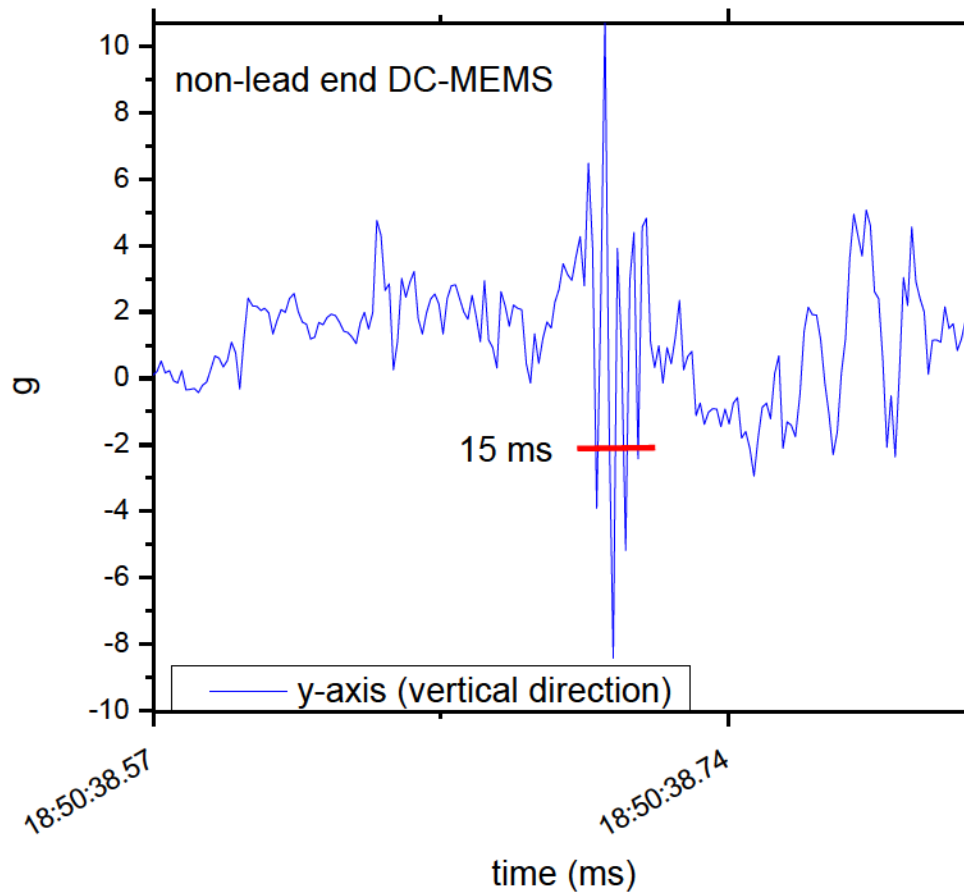
In Fig. 10 there is a zoom view of the highest recorded shocks. It is a high frequency oscillation that lasts around 15 ms. The highest peak (10g) is 2 ms long. The oscillation

frequency is around 500Hz. This event could not be properly captured by the GP1L since its sample rate is around 10 ms.

Figure 10: Zoom of the highest shocks region recorded during the truck accident by the DC-MEMS device installed on the non-lead end clamp

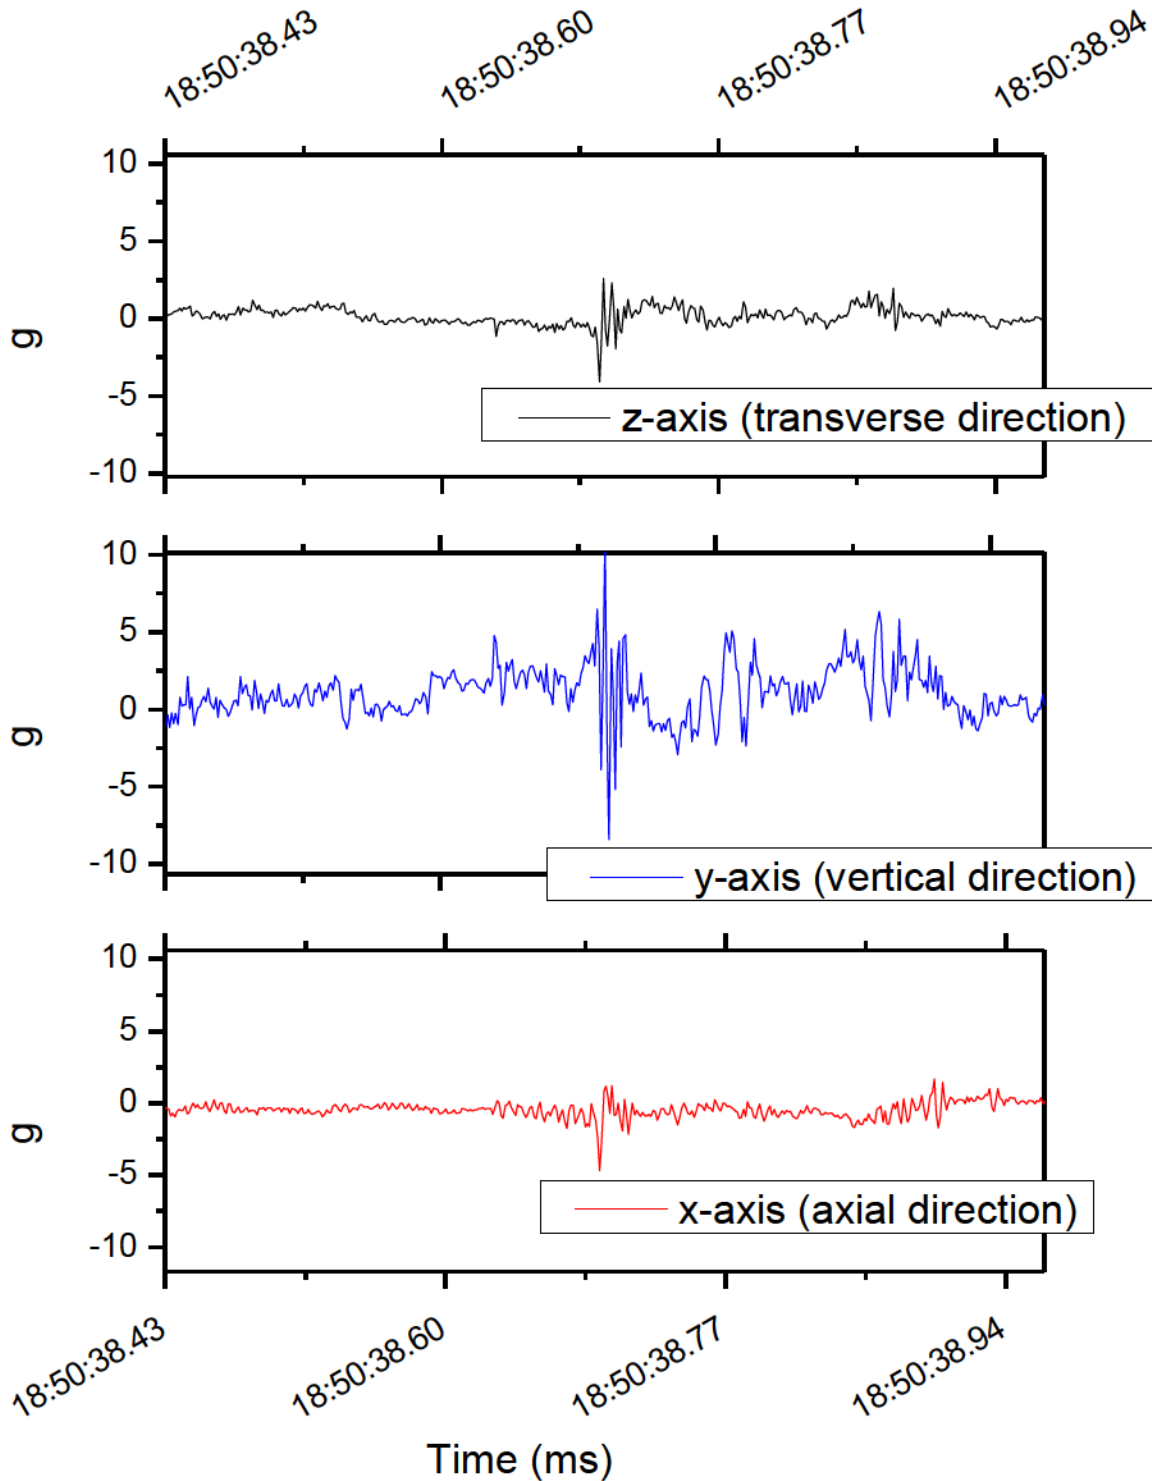
In the Fig.11, a shock data snapshot that covers 50 ms around the incident time is displayed for each DC-MEMS accelerometer direction. No shocks above requirements (5g) are observed along the transverse and axial direction.

Figure 11: Shocks data for each direction recorded by the DC-MEMS. No shocks above requirements are observed over the axial and transverse direction

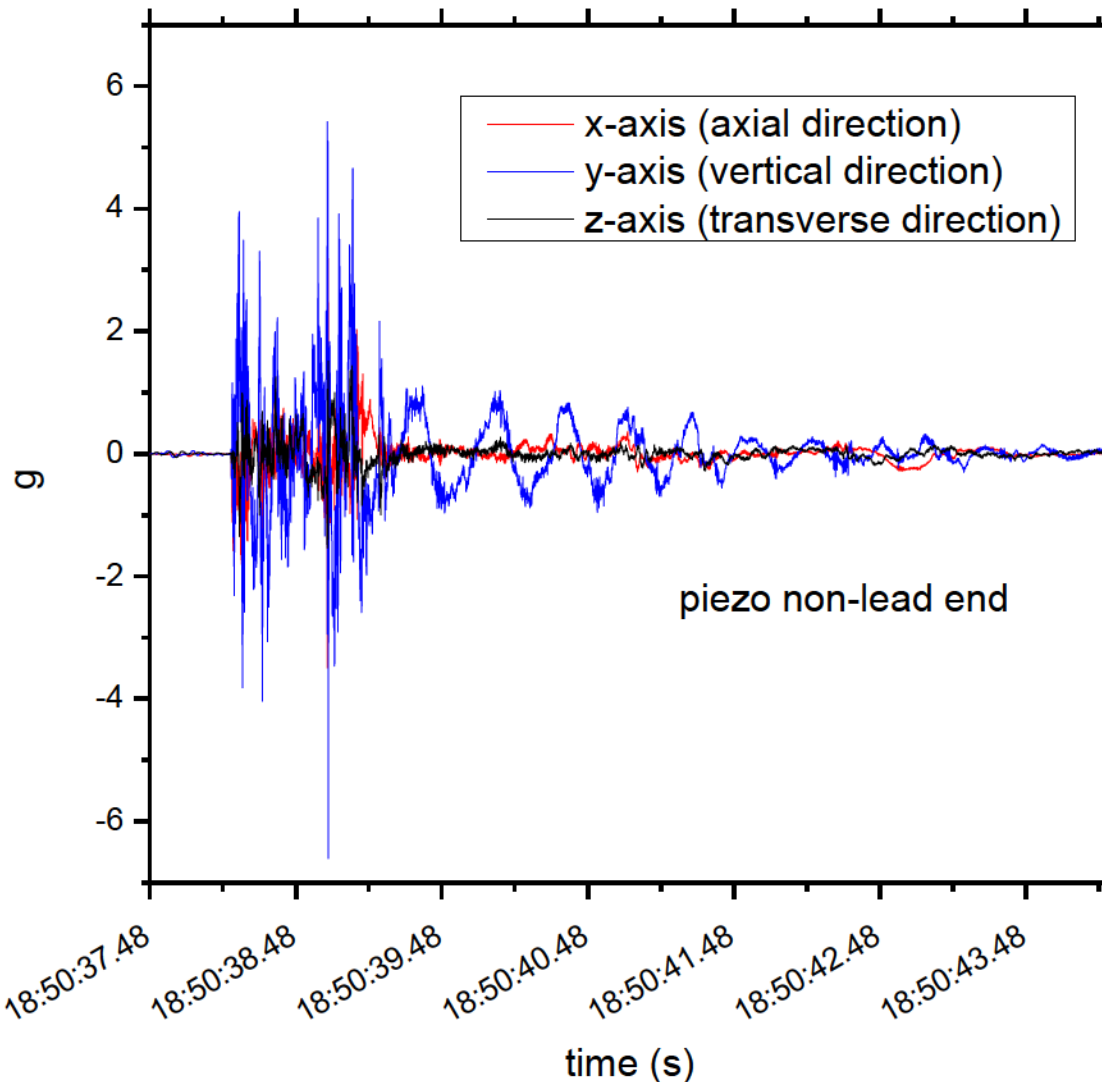
In Fig.12, the data collected with the piezo are shown. The highest shock is slight above 6 g in vertical direction. The difference between the Piezo and the DC-MEMS highest shocks value can be understood considering the actual bandwidth of those sensors. Sampling at 1000 Hz with the piezo, correspond to an antialiasing filter of 1/5th of the sample rate. The effective bandwidth is up to 200 Hz.

The DC-MEMS has a rough anti-aliasing filter, so data maybe be aliased. The anti-aliasing filter cutoff is 1/2 of the sample rate (500 Hz). The piezo-electric data are considered more reliable.

Figure 12: Shocks during the truck accident recorded by the Piezoelectric accelerometer device installed on the non-lead end clamp

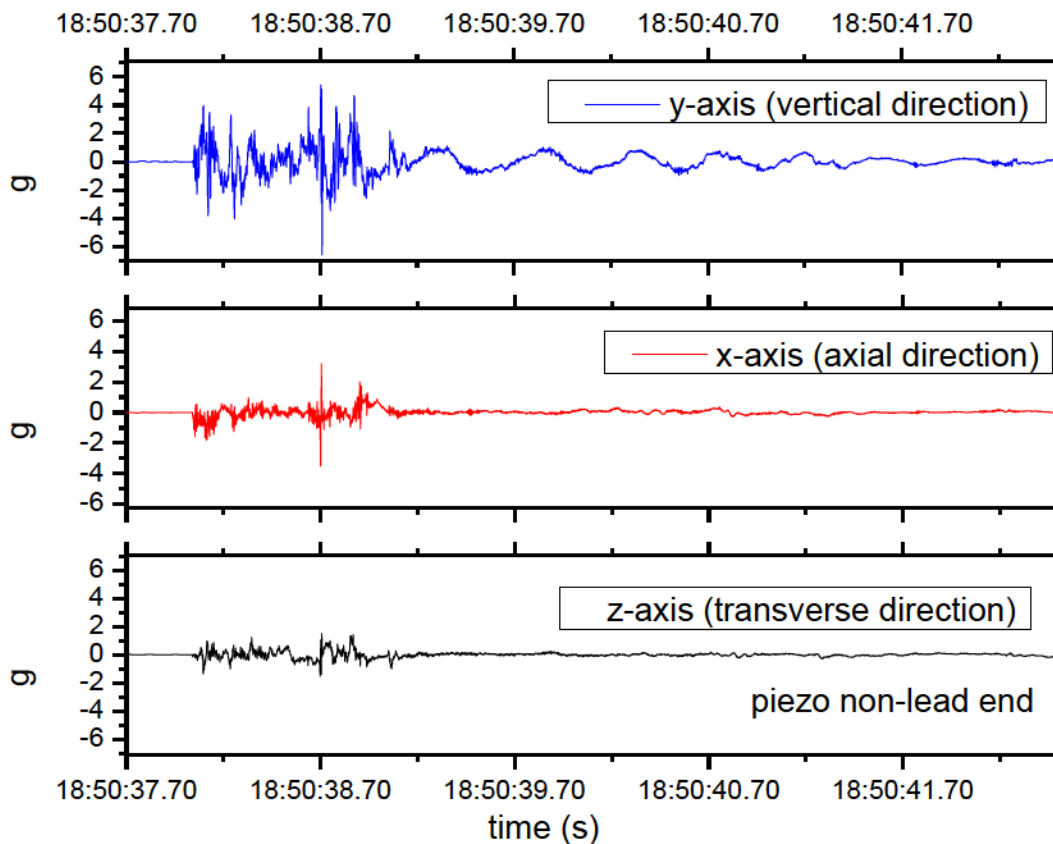
In Fig. 13, a shock data snapshot of 5 seconds is displayed for each piezo accelerometer direction. No shocks above requirements (5g) are observed along the transverse and axial direction.

Figure 13: A five second snapshot of the shocks collected with the piezo devices. Shocks above requirement are observed only along the vertical direction

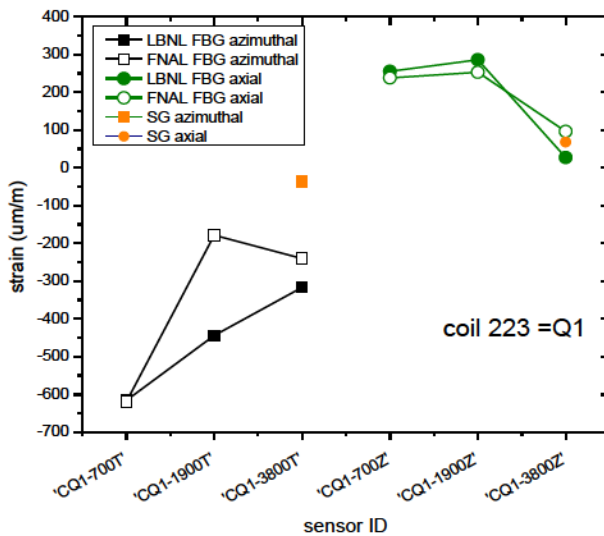
data collected at FNAL are in good agreement with what have been observed before shipment. There is only the azimuthal strain value measure at position 1900 on coil 223 that displays a significant deviation.

Figure 14: Comparison between azimuthal and axial strain data of coil 223 pole collected at LBNL and FNAL

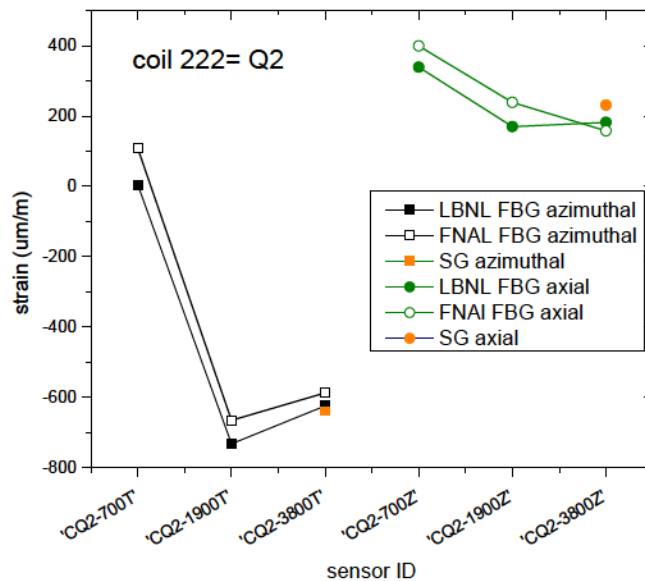
In Fig.14 and 15, a comparison between the FBG axial and azimuthal strain measured at LBNL and at FNAL is presented. The strain gauge data are also displayed. The strain

Figure 15: Comparison between azimuthal and axial strain data of coil 222 pole collected at LBNL and FNAL

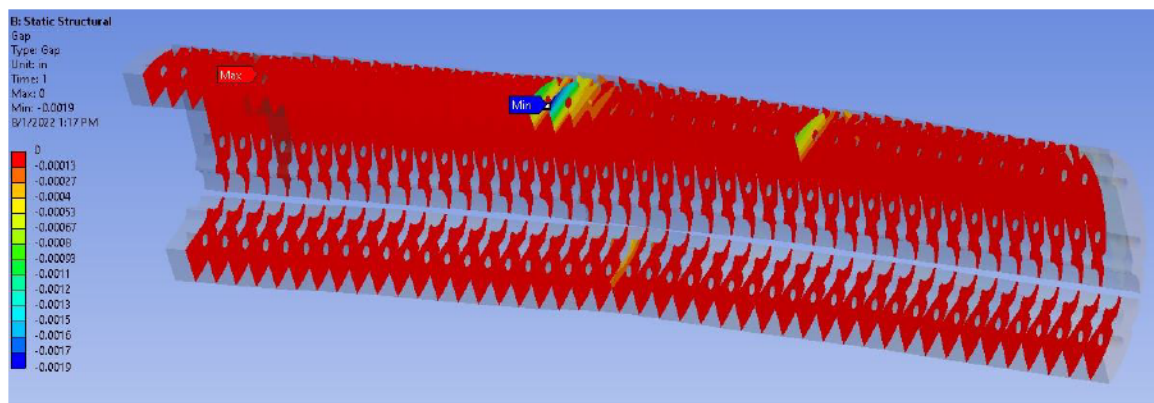
A very small gap between yoke blocks starts to form at 15g as displayed in Fig. 16. The size of the gap is 0.0019 in (48 μ m).

Figure 16: Yoke block gap forming with 15 g vertical load

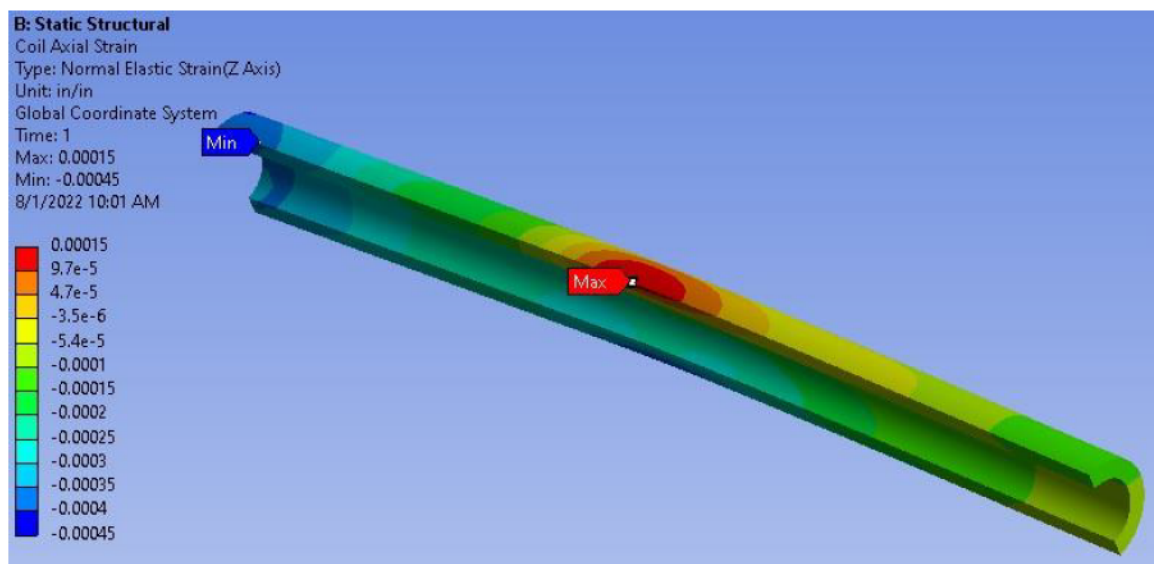
The maximum coil tensile strain is found in that area and it is around 150 microstrain, which is well below the threshold requirements (500 microstrain).

Figure 17: Tensile strain endured by the magnet structure

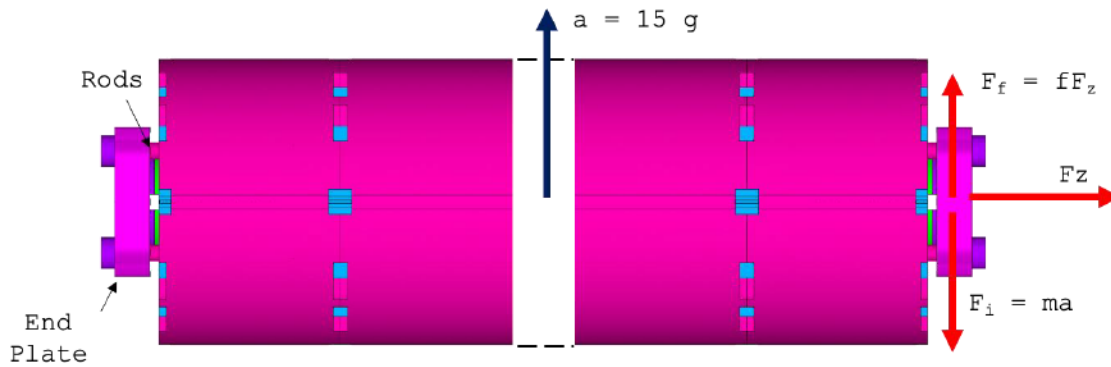
The magnet longitudinal prestress is applied by stainless steel rods, bolted to two end plates. The end plate transfers the load to the magnet via bullets. A longitudinal prestress of 0.7 MN is applied at room temperature. The relative motion between the magnet and the end plate is prevented by friction. With a conservative friction coefficient of 0.1, we can assume that the end plate system will be able to sustain an in-plane (x-y) force of 70 kN before slipping with respect to the magnet. We can also assume, conservatively, that the whole magnet underwent a vertical acceleration of 15 g during the accident. The total weight of the longitudinal loading system is equal to 203 kg, which correspond to an inertia force of 30 kN. Comparing this to the frictional force available we can compute a safety factor as follows:

$$\eta = \frac{F_f}{F_i} = \frac{fF_z}{ma} = 2.34 \quad (a)$$

Figure 18 – Schematic of the magnet and end-plate system under the inertia forces due to the accident.
