**D-Zero Solenoid Quench Investigation:**  
**Observations, tests, and commentary**  
**Fall 2004 - Spring 2005**

D-ZERO ENGINEERING NOTE # 3823.111-EN-576

March 24, 2005

Russell A. Rucinski, Richard P. Smith

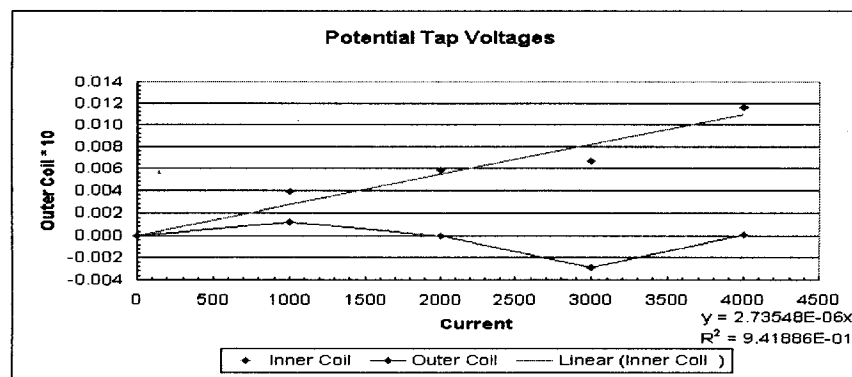
5. The electrical resistance of the solenoid coil, chimney, lead system was deduced on Jan. 5, 2005 from recorded potential tap voltages at 1000 A, 2000 A, 3000 A, and 4000 Amperes. Averaging of the signals was necessary. It was concluded that one or both inner coil conductor joints is behaving ohmically such that at 4600 Amperes, the heat generation would be 5.9 Watts. [An earlier attempt to measure the coil, chimney, and lead resistance on Dec. 9, 2004 concluded no resistance present. These earlier measurements were less sophisticated with only one sample point chosen from a noisy fluctuating signal.] Graph and analysis of this point by Rich Smith.

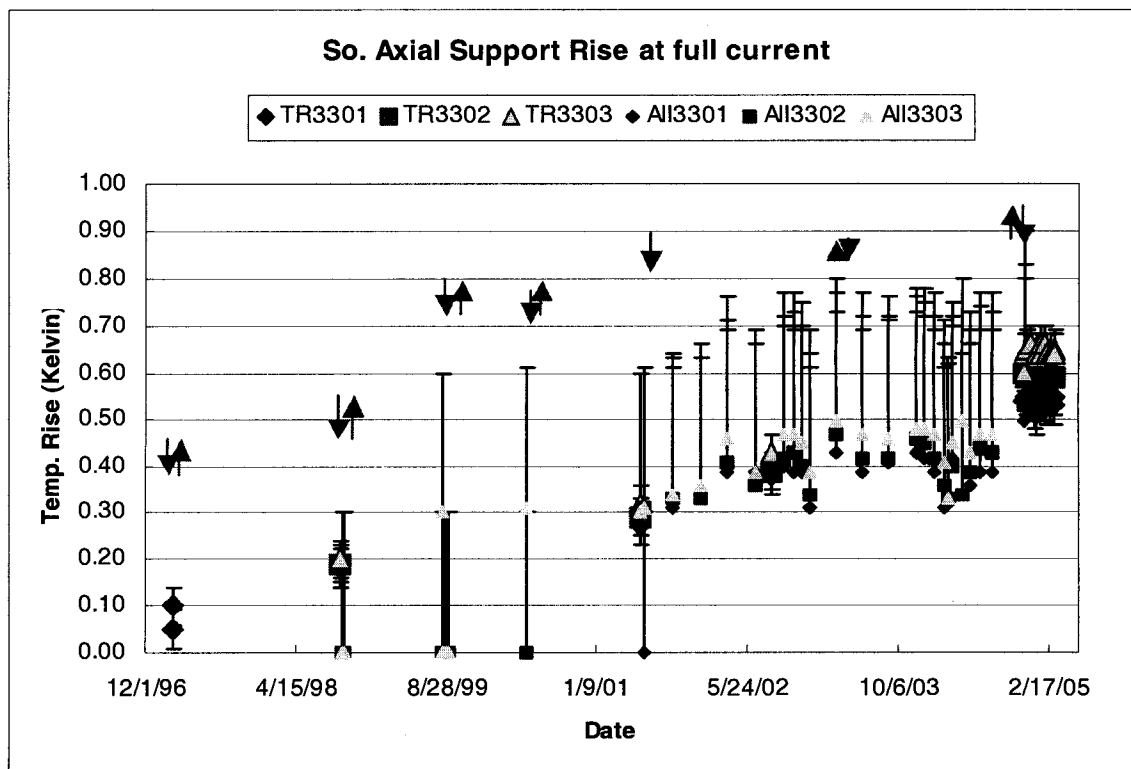
6. A temperature rise of 0.53, 0.58, and 0.64 Kelvin has been observed on the south end of the coil support cylinder when the solenoid is at full current. The temperature sensors are attached to three axial support links spaced around the perimeter of the coil and are located mid-way between cooling coil tube runs. The center and north end of the support cylinder see no ( $< 0.04$  K) temperature changes between the zero and full current condition. This behavior was historically researched. It was found that small temperature increases (0.1 K) at full current were present when the magnet was operated for the first time at the Toshiba factory. The magnitude of this temperature increase has increased with time. The arrows on the graph below represent all cool downs and warm ups of the solenoid.

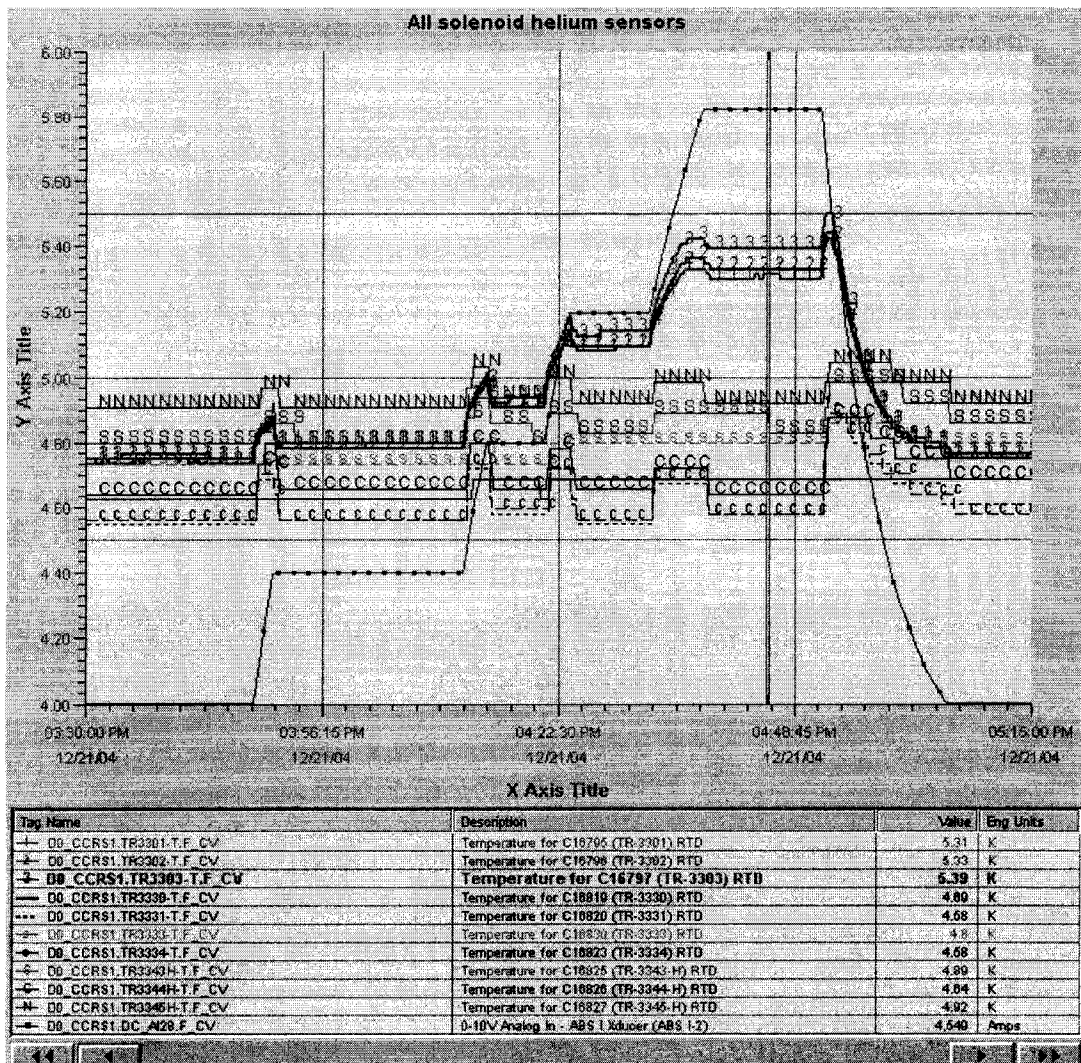
7. The temperature rise of the axial support links is directly related to solenoid current. The graph below demonstrates the rise in temperature with step changes being made to magnet current (red line with rectangular markers). The vertical scale is temperature in degrees Kelvin except for magnet current, which is 0-5000 Amperes. Axial temperature sensors TR3301, TR3302, and TR3303 increase during charging and remain elevated. It is inconclusive if the rise is linear or quadratic.

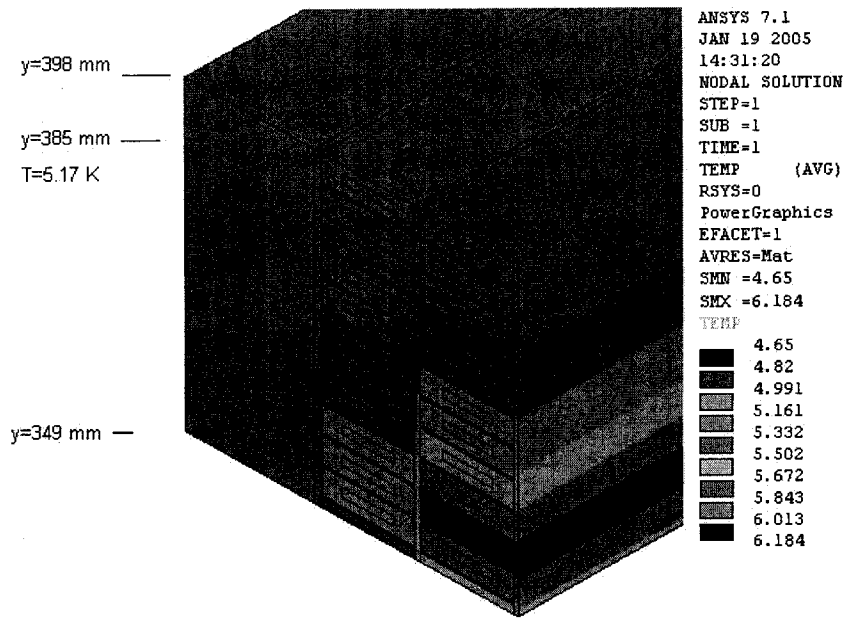
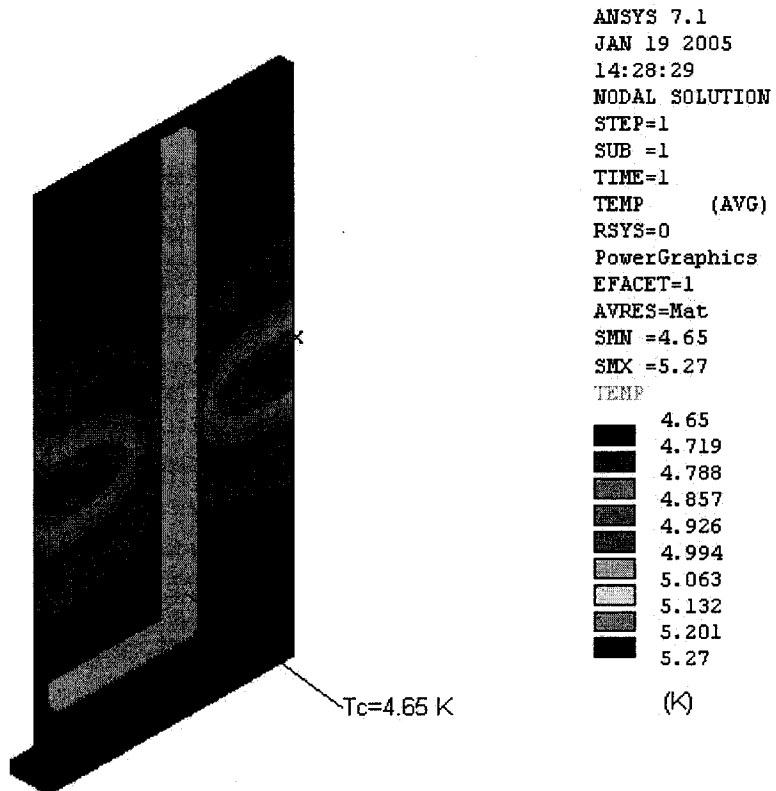
Ang Lee has made a FEA (Ansys) modeling of the solenoid assuming a 5W heat load in the conductor grading joint near the S end of the inner layer (a distance of ~349 mm from the S end of the coil), and predicts the temperature to be observed on a S axial support bracket welded to the outer support cylinder (a distance of ~385 mm from the S end of the coil). He ignores any heating in the bracket due to heat conduction down the axial support link, and he assumes the surface of the outer support cylinder beneath the cooling tube is fixed at 4.65K.

He obtains a temperature at the bracket of 5.17 K, 0.49K warmer than the cooling tube. This is quite close to what Russ observes when the coil is energized and we measure ~5W loss in the inner layer of the coil as given by the potential tap data.

Attached is a plot of Ang Lee's model, showing the outer support cylinder and cooling tube segment -- the coil is "unrolled" in phi and a 30-degree segment in phi X about 500mm long in the axial direction is modeled. The yellow region in the plot shows the path of the cooling tube on the support cylinder. In the second plot is shown a detail of the conductor winding at the heated turn (y=349 mm) and the temperature (5.17K) on the outer support cylinder at y = 385 mm (Ang's y is the coil axial direction) where the support bracket thermometer is. Ang repeated his calculations for a cooling tube temperature 0.1K lower and finds the same temperature difference to the axial support bracket, and about 86% of that temperature depression at the suspect turn. This is good news for the plan to install a cold compressor.

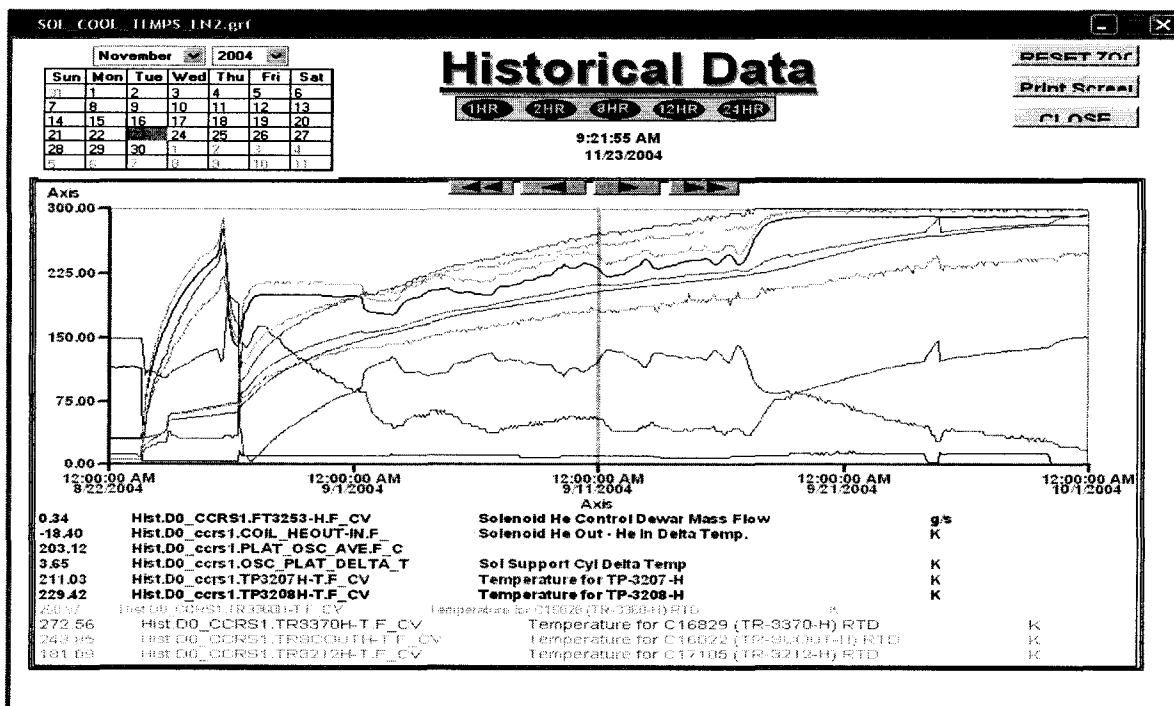
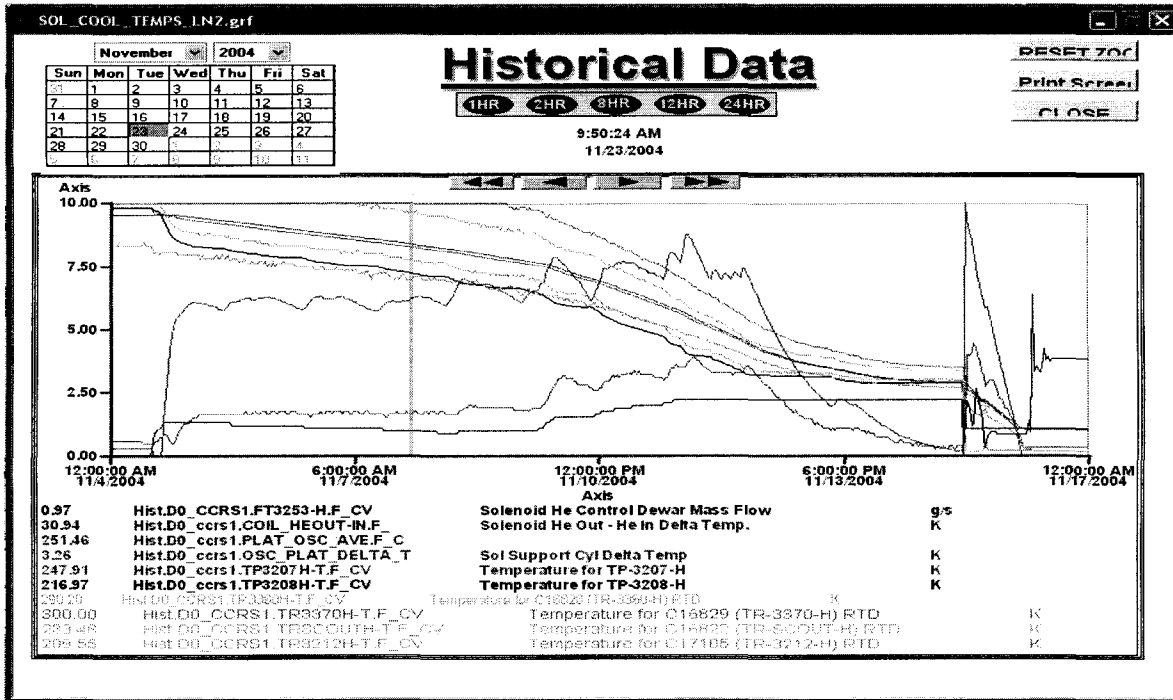
10. The solenoid remained cold between Feb. 2003 and August 2004. It was then warmed to room temperature starting August 23<sup>rd</sup> 2004 and was re-cooled to operating point on Nov. 15<sup>th</sup>. All temperatures in the solenoid system were above ice temperature, 273 K for 39 days during this warm up. Coil/Support cylinder reached 286 K, Ln2 shield reached 288 K and were under full vacuum pressure conditions. These conditions should be adequate to have eliminated any cryo trapped moisture from the vacuum space. The heat load before and after the fall 2004 warm up cycle increased by 5 watts or less. Warm up and cool down rates and restrictions were observed. In fact, the rate of warm up and cool down for this last cycle was much slower and controlled than all other past thermal cycles.

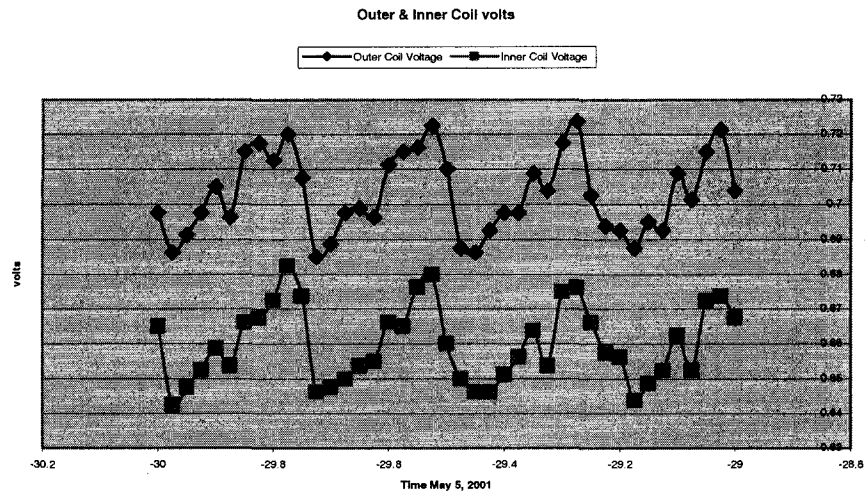
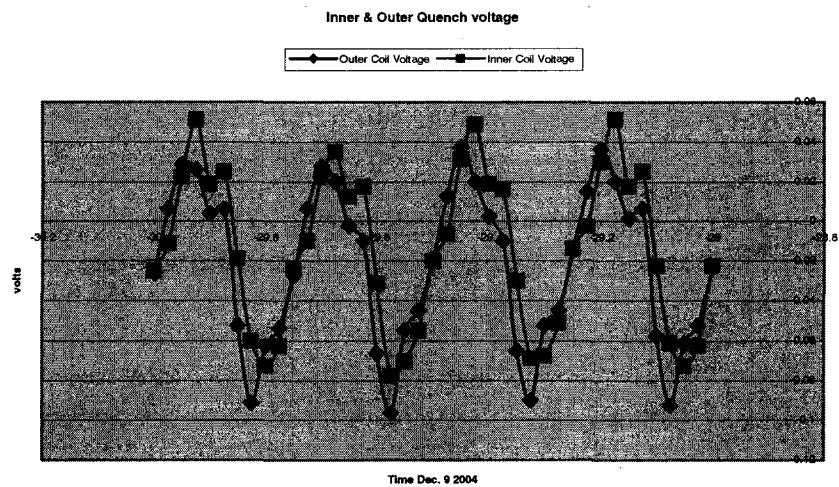
14. The inner and outer coil voltages are fluctuating with a larger magnitude 0.12 volts versus 0.03 volts in 2001 at 4 Hz. Others have calculated the heating effect to be only 0.0002 Watts. A heat load of this type would input heat uniformly along the support cylinder where it would have little effect on temperature. The toroid magnet also experiences voltage fluctuations. It is believed that these fluctuations appeared only after the fall 2004 shutdown. Therefore it is possible that it is a result of major electrical infrastructure work done during the fall 2004 lab shutdown.

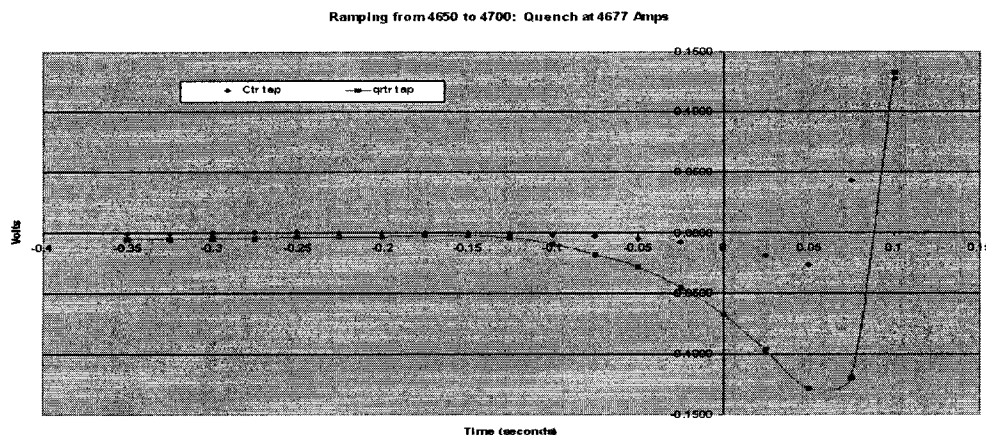
### 1 1/26 quench – Quarter tap voltage

16. A comparison of the polarities of the bridge unbalance voltages created by the increasing resistance in the coil as the quenches progressed from the beginning indicates that the initiation site could not be in the North end of the inner layer, but could be in either the South end of the inner layer, or in the outer layer. It was noted that the ratio of the quarter tap imbalance voltage at quench to the center tap imbalance voltage is 4. The ratio should be 2 based on the design. This ratio discrepancy has not been resolved.

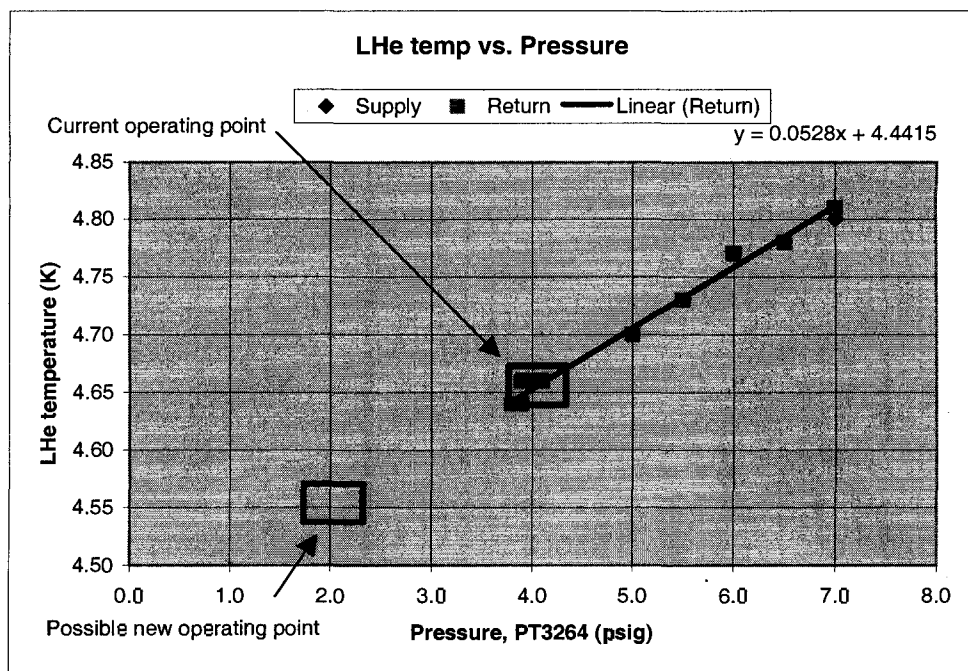
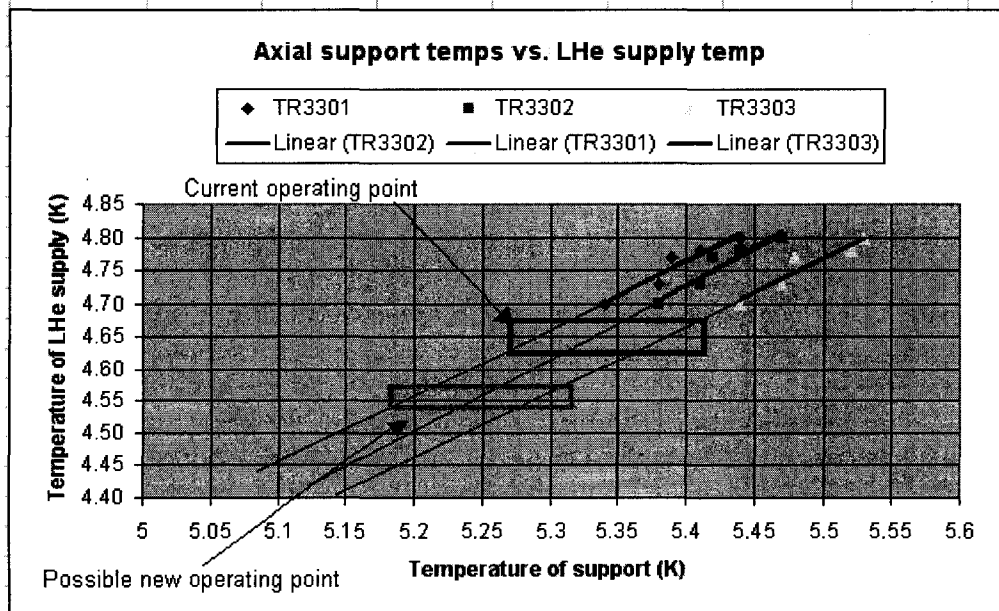
20. Tests were done to determine the temperature relationship of the solenoid supply and return temperature versus the control dewar pressure. This helps estimate the potential decrease in coolant temperature when the refrigerator upgrade with cold compressor is put on-line. It is anticipated that we can easily lower the coolant temperature by 0.10 Kelvin. The components are being designed to achieve much more (0.3 K?) if necessary. Although it is possible to operate the control dewar sub-atmospheric, we will attempt to do so only if necessary.
