REPAIR OF ZGS RING MAGNET COIL DAMAGED CONDUCTOR SECTIONS*

J. A. Bywater, R. C. Niemann,** V. J. Sevcik, R. B. Wehrle
Argonne National Laboratory
Argonne, Illinois 60439

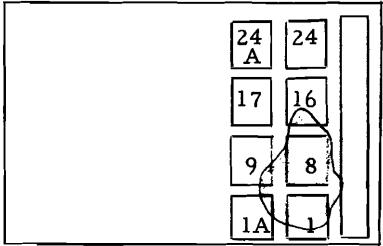
b. Number of conductors involved	Major damage to five conductors (turns 1, 8 and 16 in outer row and 1A and 9 in second row).	Major damage to two conductors (turns 16 and 24 in outer row).

e. Amount and location of hole plugging caused by molten copper forced through the cooling hole	Turn 1 was plugged at both upturned ends. Turn 8 was plugged at the short straight section (SSS) end a distance of 12.192 m from the fault.	Turn 16 was blocked in the crossover tubing at the long straight section (LSS) end. Turn 24 was blocked at the short straight section end 10.06 m from the fault.

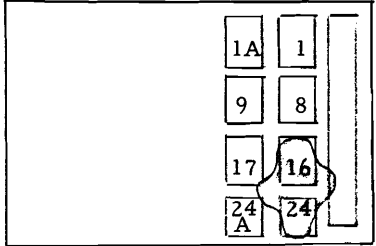
On the Octant No. 3 coil, two conductors; i. e., turns 16 and 24 in the outer row, suffered major damage with copper conductor material completely melted over a distance of approximately 15 cm.

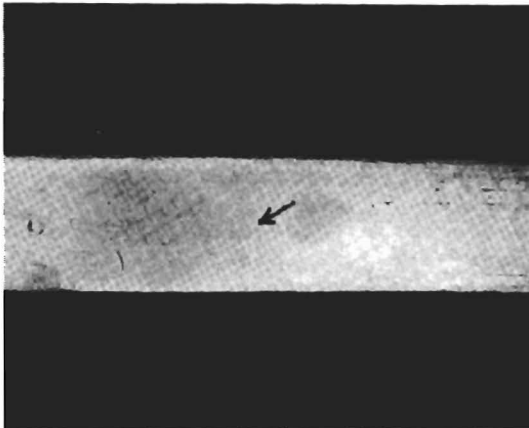
Figure 11 Completed Joint

Completed joints (see Figure 11) were inspected visually as well as electrically and hydraulically. Outward appearance compared favorably with test joints previously tensile tested to 2/3 of the strength of an unjoined conductor. Electrical resistance across the actual joints increased less than 4% of the actual resistance of an unjoined conductor section (see Figure 12). The joints were also checked for water leaks by helium mass spectrometer followed by a hydrostatic test as previously mentioned.
