REINSULATION OF THE REPLACED SECTIONS OF THE DAMAGED ZERO GRADIENT SYNCHROTRON RING MAGNET COIL*

T. H. Benham, J. A. Biggs, J. A. Hoffman, F. W. Markley, A. McKamey
Argonne National Laboratory
Argonne, Illinois 60439

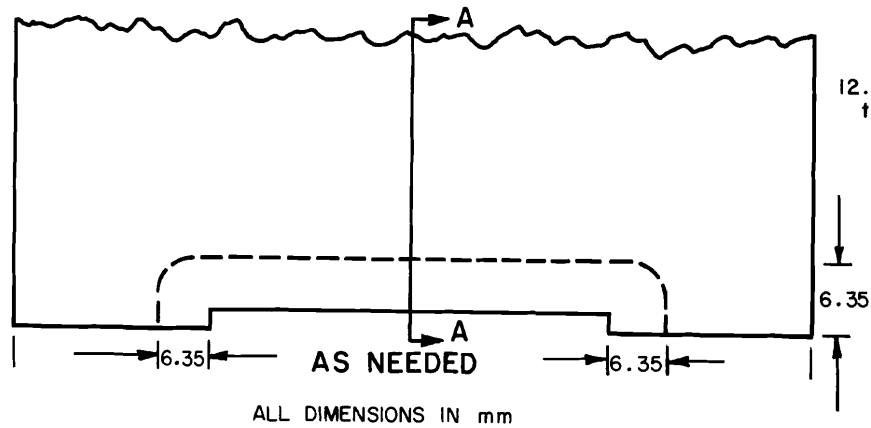
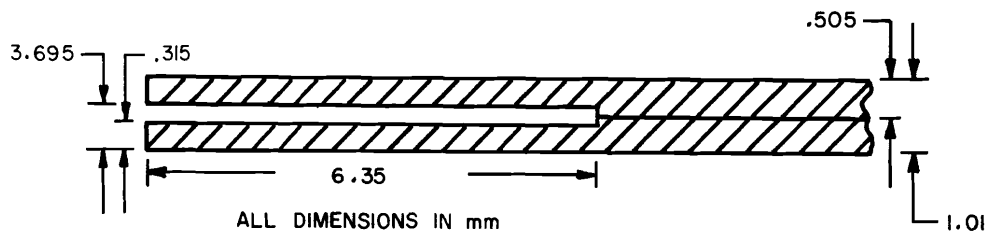
FIGURE 1

Lapping the joints between old and new layer insulation presented an interesting challenge that required the development of special equipment and procedures to grind a 0.38 mm wide, 6.35 mm deep slot into the center of the old 1.01 mm thick G-10 layer insulation. The slot was filled with a piece of 0.25 mm thick G-10, and pieces of 0.38 mm thick G-10 that butted against the old layer insulation were bonded to its top and bottom to provide the needed lap at layer insulation joints. (Figure 1 shows a top and a section view of a typical layer insulation slot. Figure 2 shows a cross section of a typical layer insulation repair.)

TOP VIEW OF A TYPICAL
G-10 LAYER INSULATION SLOT

First, a 0.38 mm wide, 0.18 mm deep slot was made in the insulation, and its position was checked with the microscope. If adjustments were necessary, they were made. Next, the slot was made 0.18 mm deeper, and its position was rechecked with the microscope. If no adjustments were necessary, the slot was made 0.36 mm deeper. Otherwise, the slot was made deeper in increments of 0.18 mm until no further adjustments were necessary. In increments of approximately 0.36 mm, the grinding process was repeated - inspecting the slot after each pass of the grinding spindle - until a 0.38 mm wide, 6.35 mm deep slot was made in the insulation. The grinding equipment was then moved to another coil location, and this procedure was repeated until all the affected insulation had been slotted.

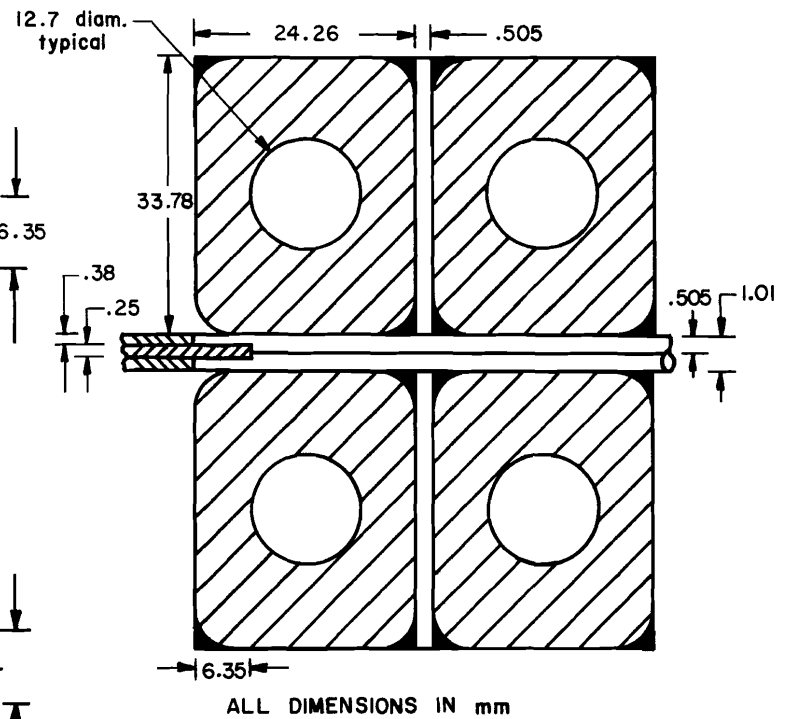
FIGURE 2

CROSS SECTION OF A TYPICAL
COIL LAYER INSULATION REPAIR

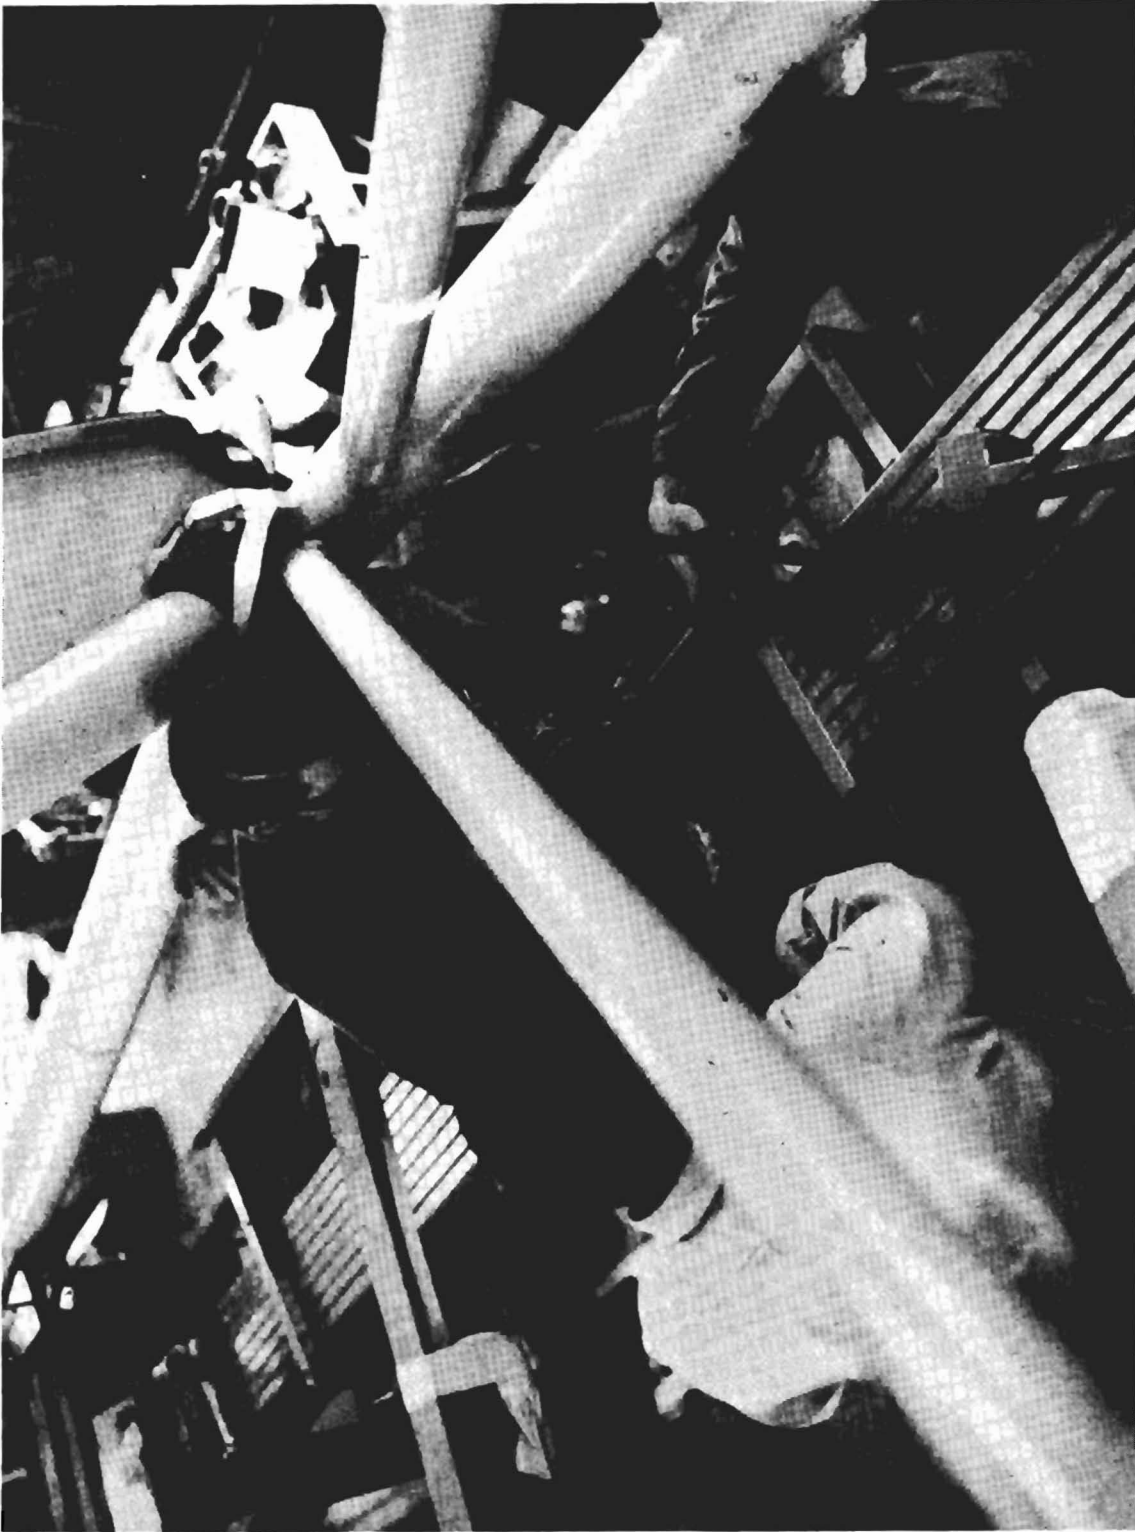
FIGURE 3
LAYER INSULATION SLOTTING EQUIPMENT IN USE

(perpendicular to the top or bottom of the coil), and the Z direction (perpendicular to the side of the coil). (Figure 3, a photograph, and Figure 4, a schematic drawing, show the slotting equipment in use.)

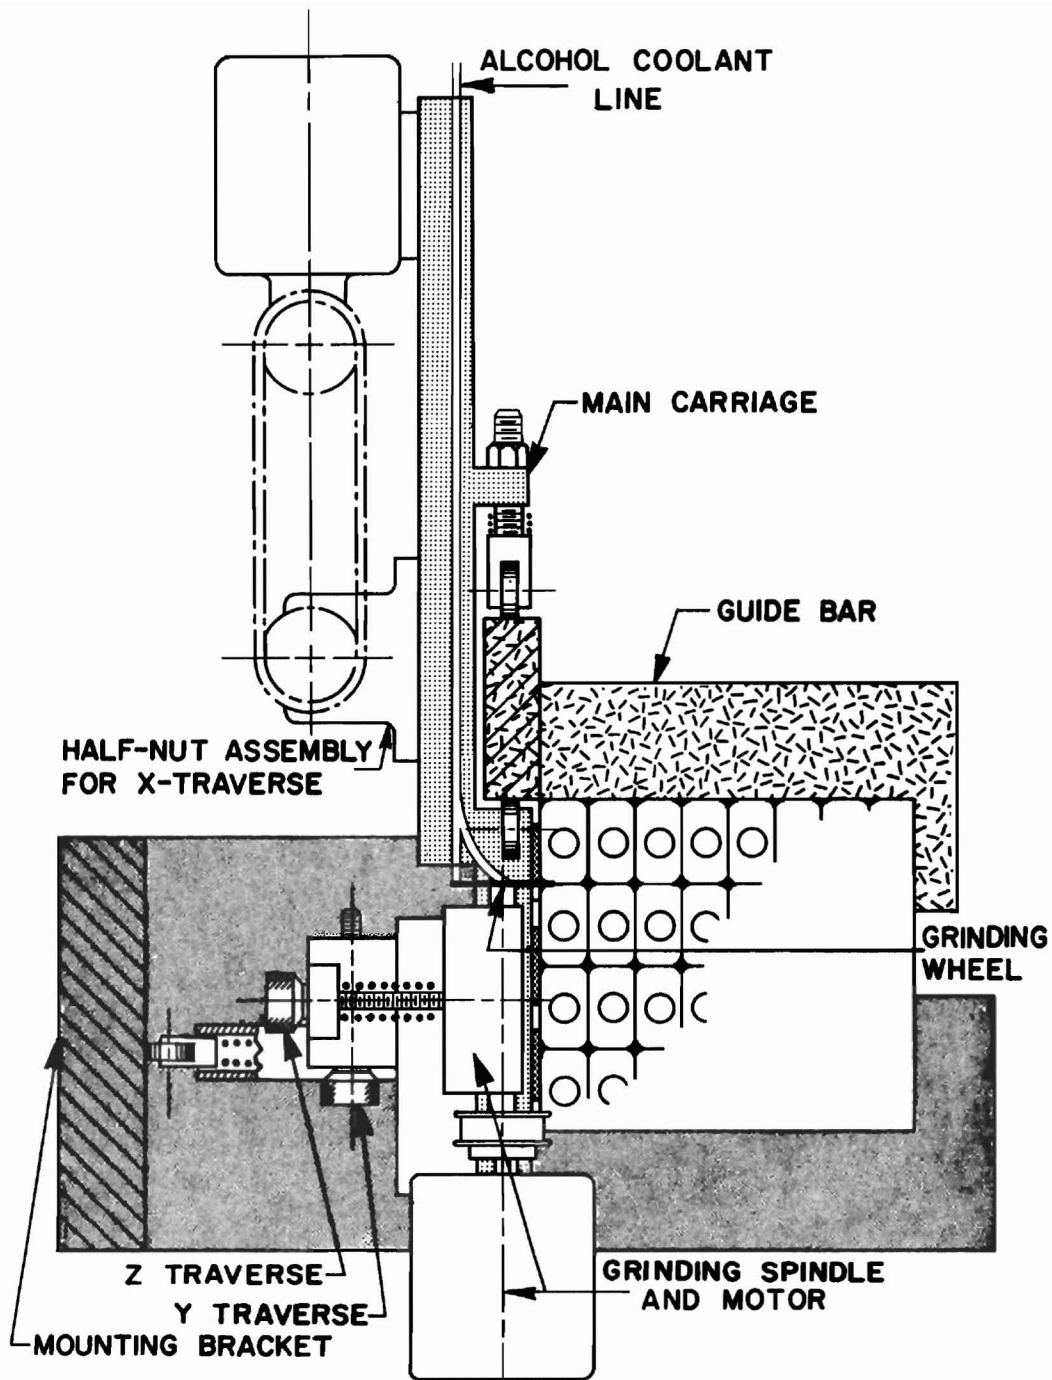
FIGURE 4
SCHEMATIC OF LAYER INSULATION SLOTTING EQUIPMENT

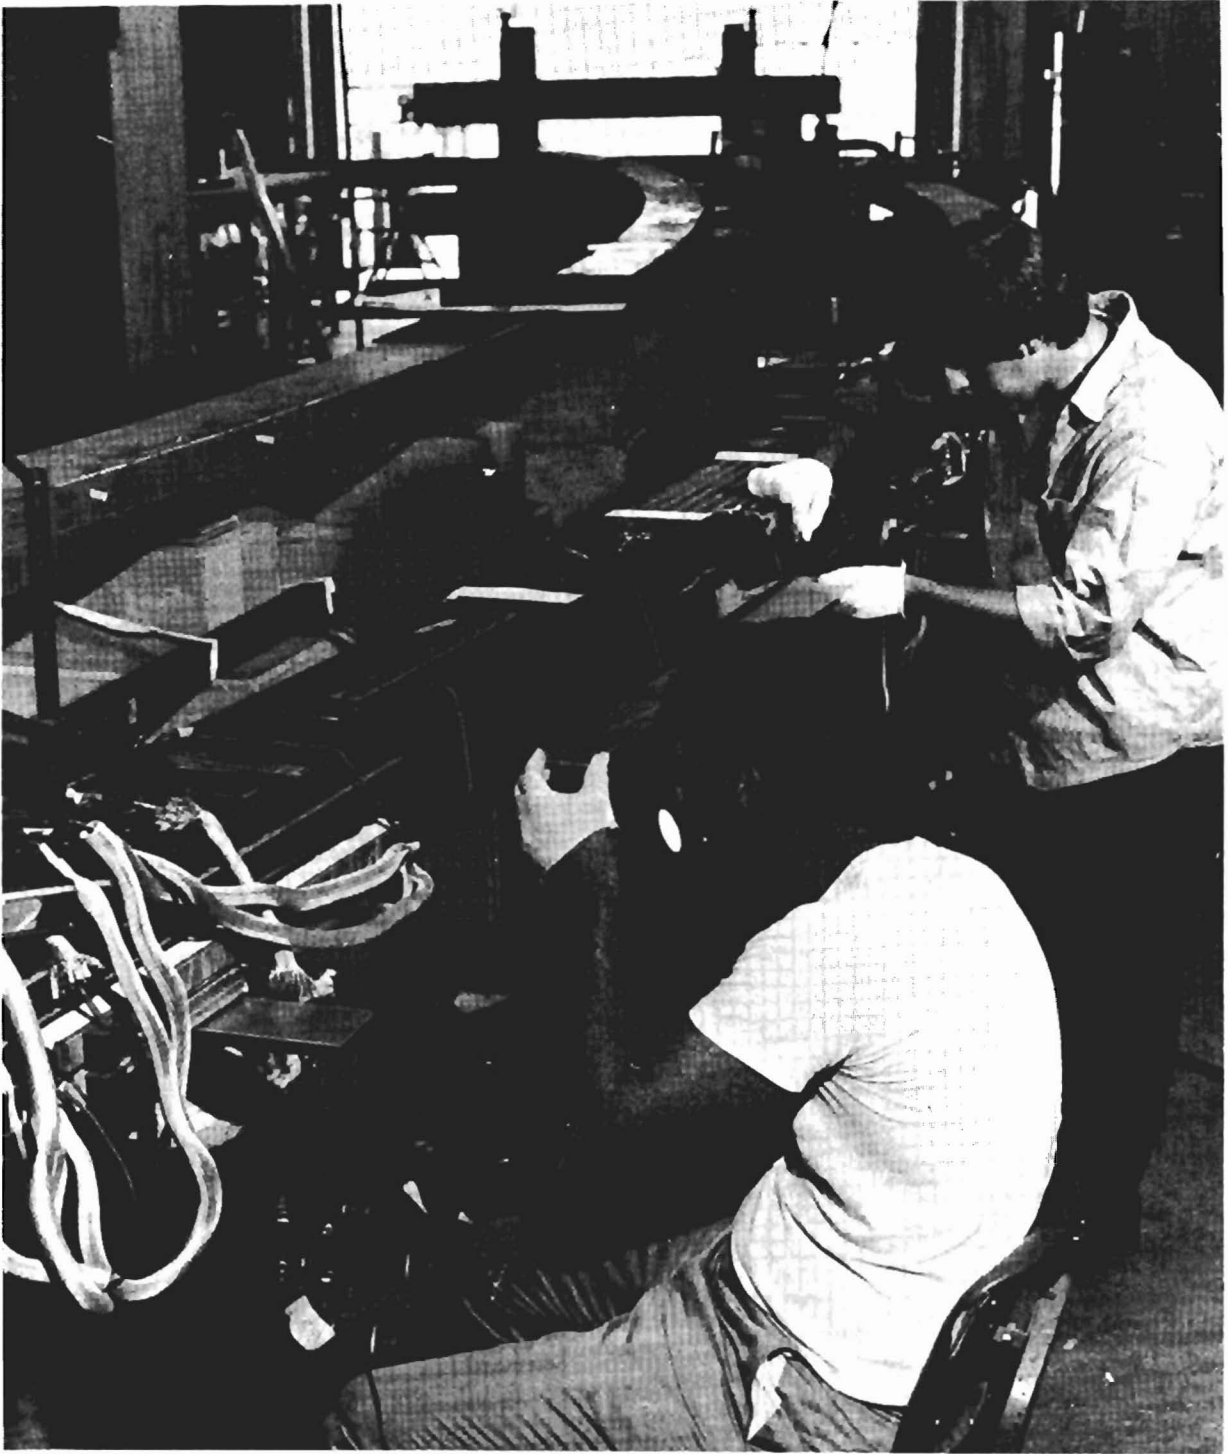
FIGURE 5
INSTALLING INSULATION AROUND REPAIRED
CONDUCTORS

the repaired conductors had their surfaces relieved specifically for a wrap of 0.127 mm thick polyimide film, the wrap was applied and the layer insulation installed (as shown in Figure 5) after the conductors had been relocated into the coil.

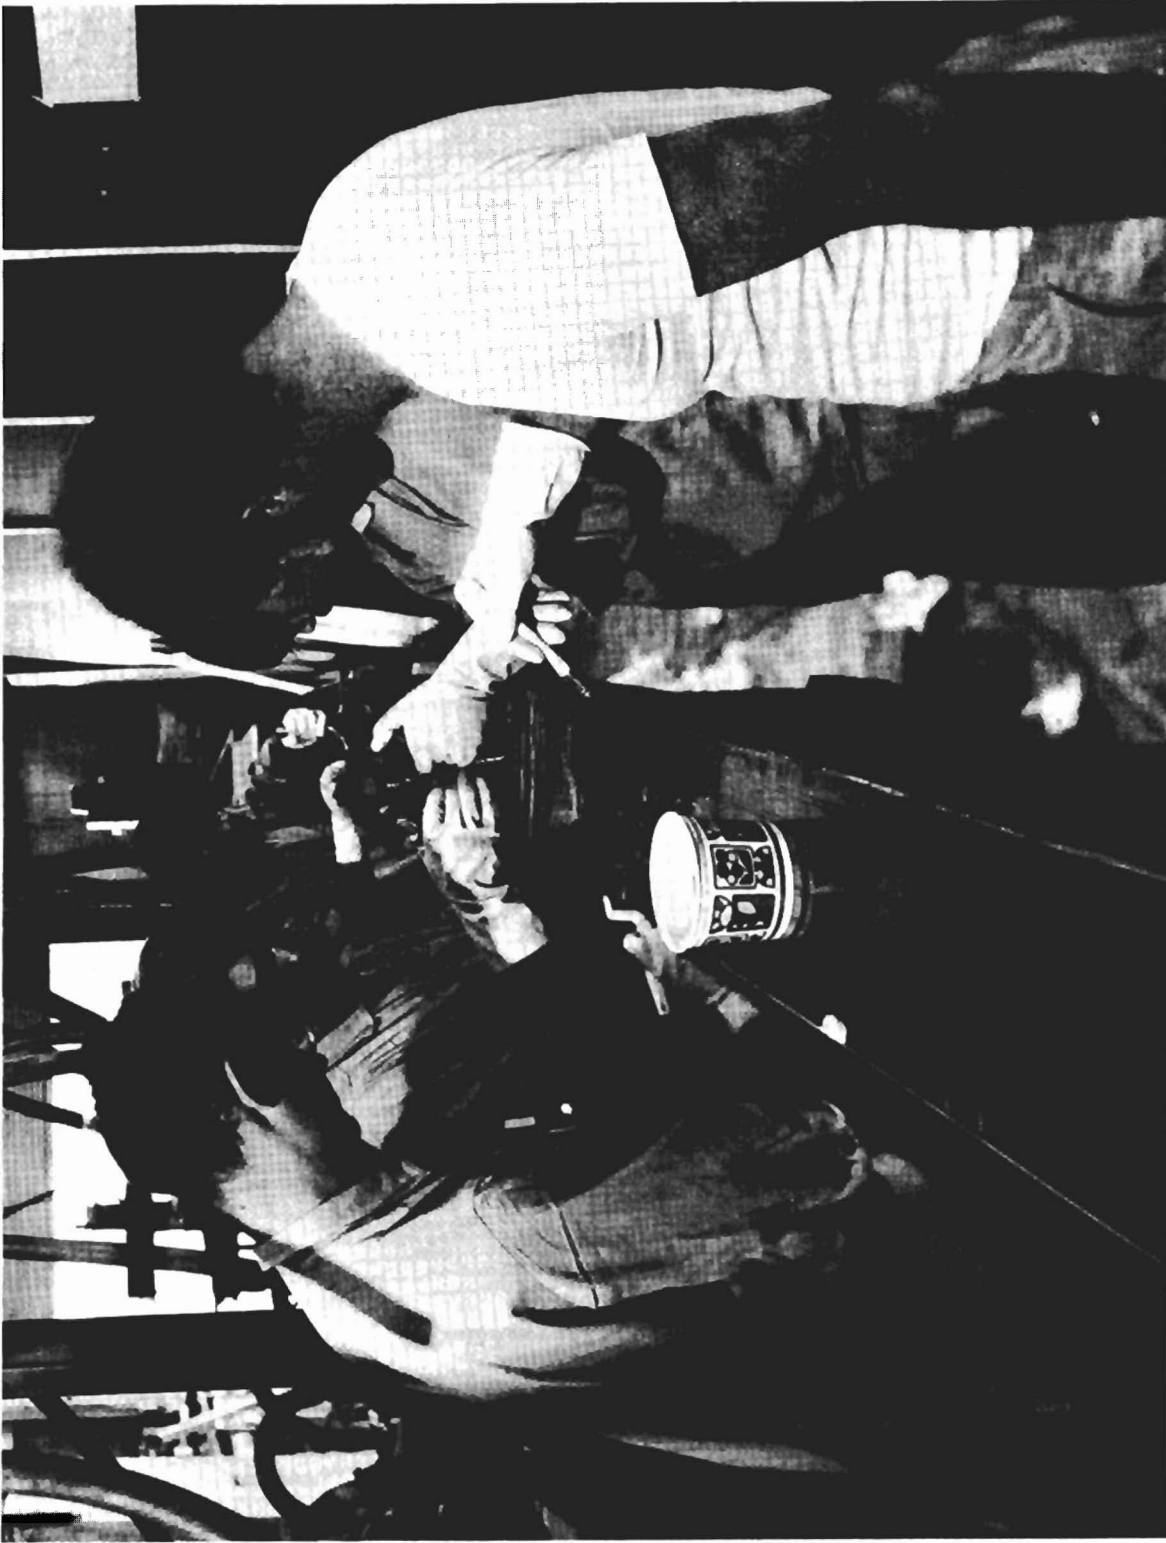
FIGURE 6
WRAPPING THE IMPREGNATED CONDUCTORS WITH POLYIMIDE FILM

Seventy-two hours after the first impregnation was completed, the fixture was removed; the impregnation was carefully inspected; and the epoxy voids, if any, were repaired. The impregnated conductors were wrapped with half lapped 0.127 mm thick "Kapton" polyimide film (Figure 6) for added insurance against an impregnation failure. The remaining insulation and the anchor plates were installed, and the coil ground wrap (of the fiber glass tape used to wrap the impregnated conductors) was applied. The impregnation fixture and equipment were reinstalled for the second impregnation (as shown in Figure 7).

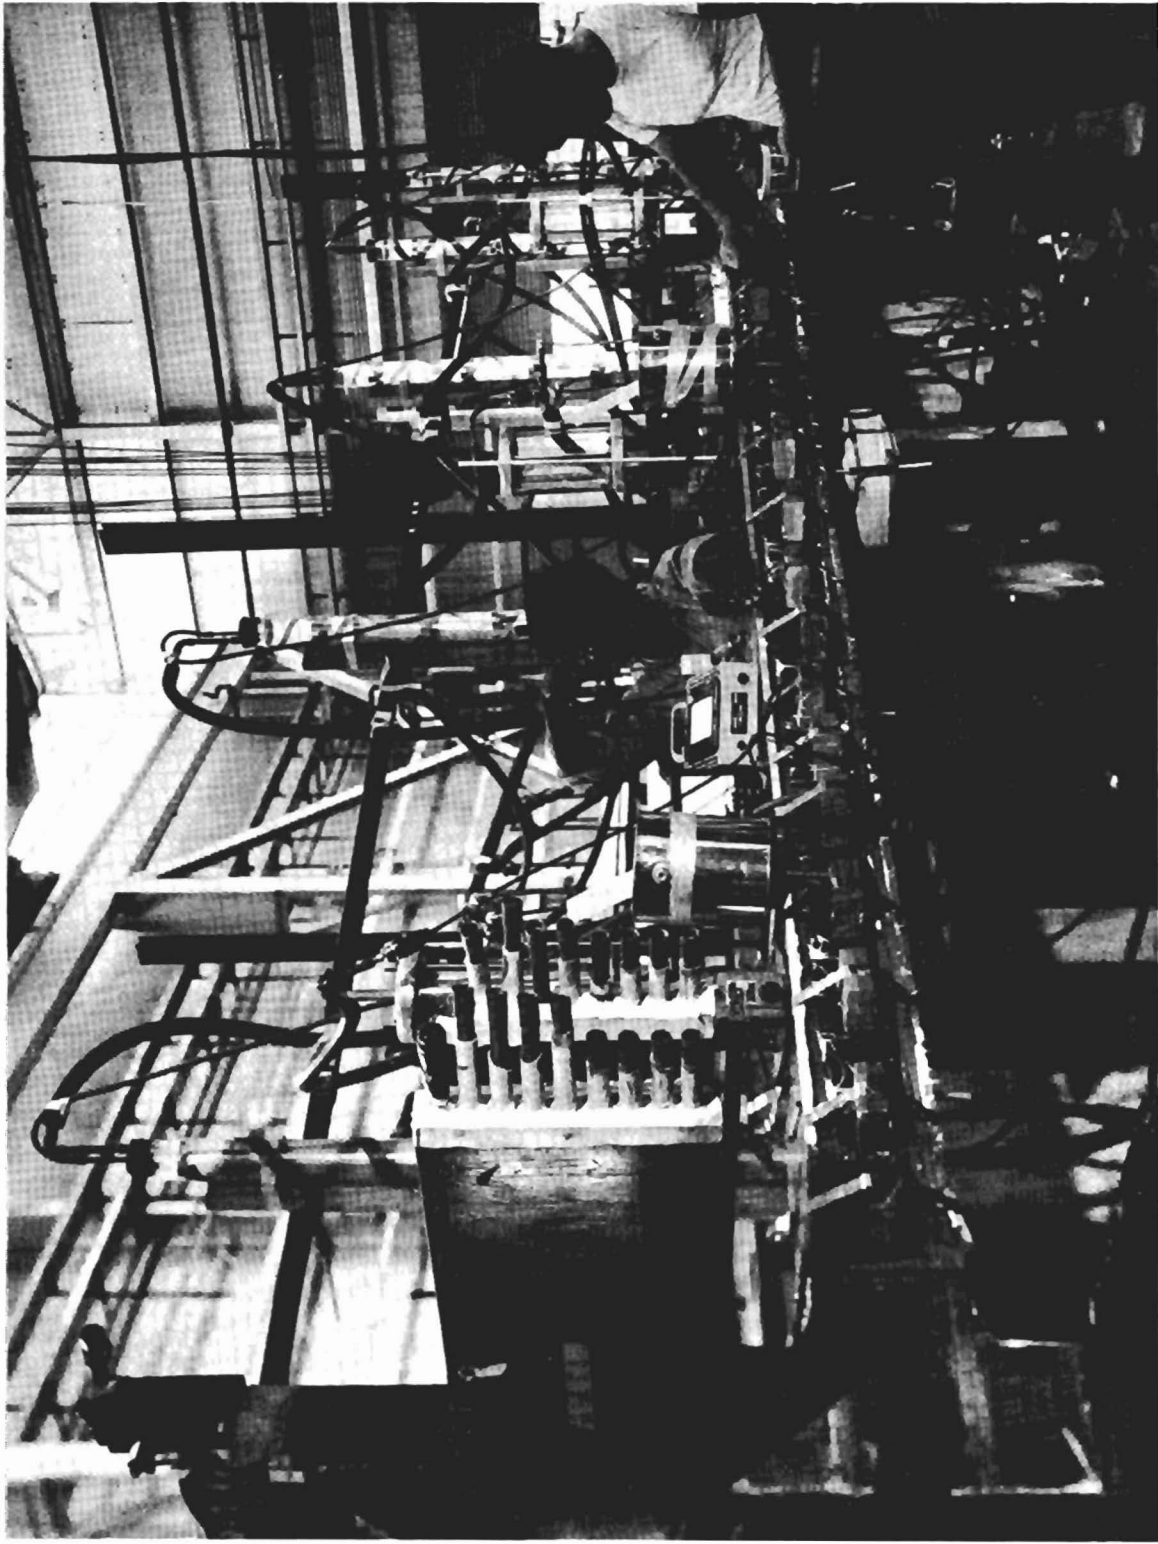
FIGURE 7
INSPECTING AND SEALING COIL IMPREGNATION FIXTURE

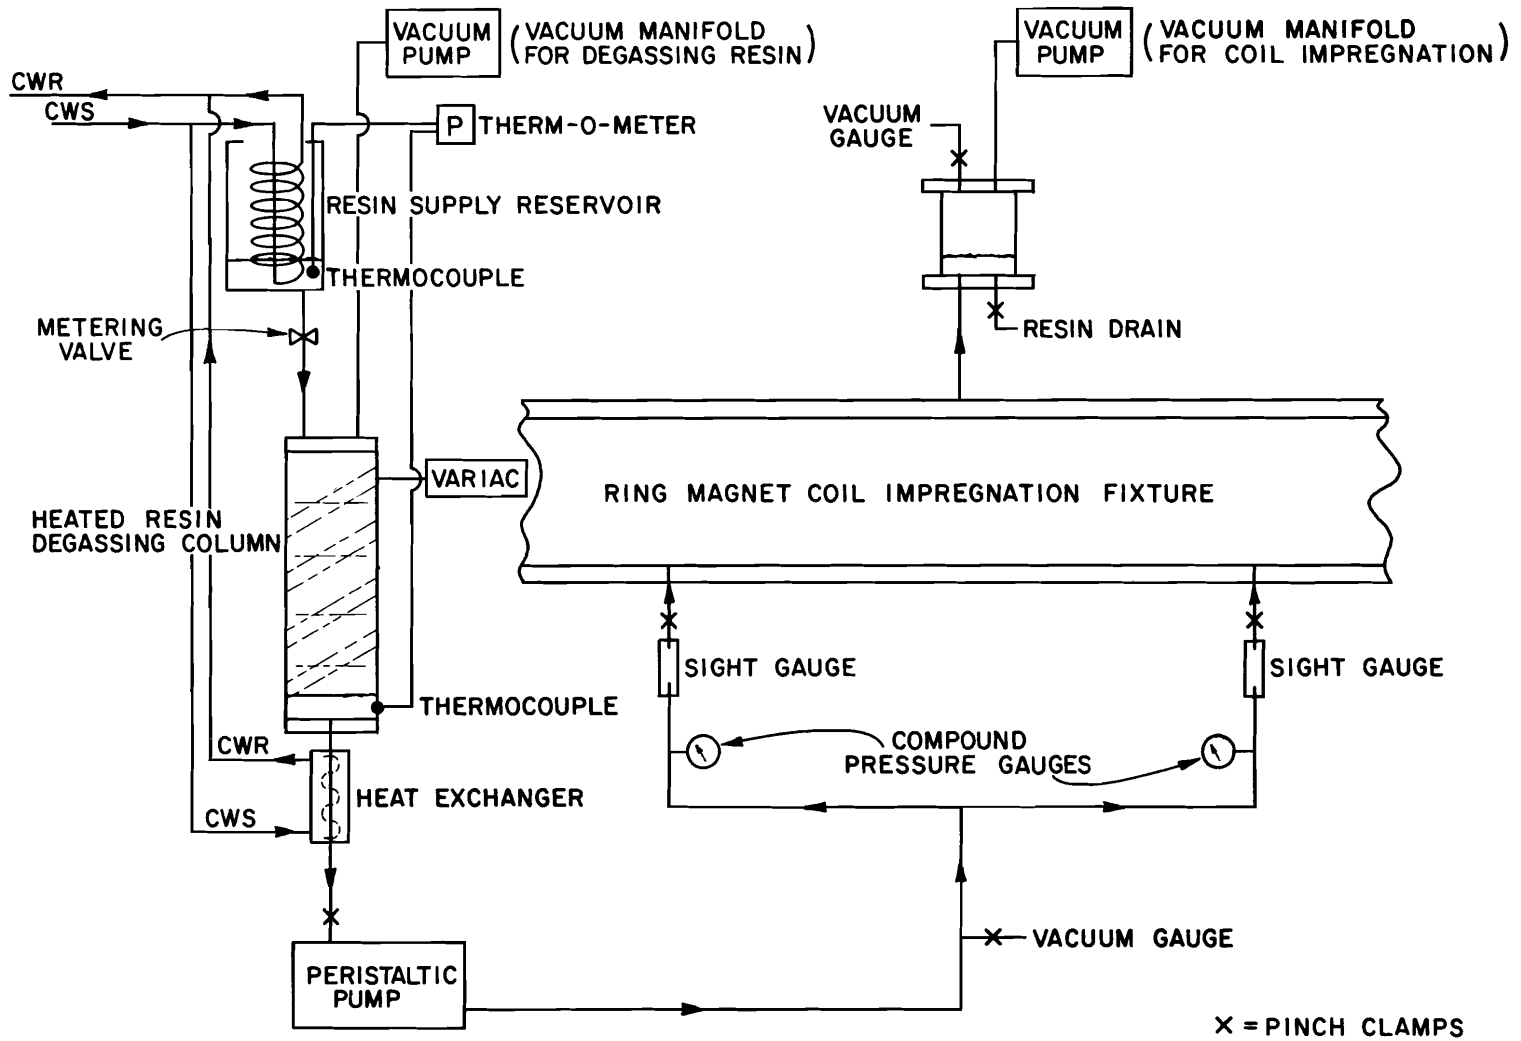
FIGURE 8
SCHEMATIC OF A TYPICAL PUMPING STATION

Impregnation Equipment. Four pumping stations, each supplying epoxy to two fill ports, were used. Figure 8 is a schematic drawing of a typical pumping station that consisted of: 1.) A water-cooled reservoir to increase the usable life of the epoxy supply. 2.) A heated

vacuum-degassing column to facilitate the removal of the dissolved air introduced when the epoxy components are mixed and to keep the air solubility of the epoxy high so that any air bubbles would be dissolved when atmospheric pressure was reapplied to the epoxy. 3.) A heat exchanger to cool the heated degassed epoxy for more usable life. 4.) A hand operated peristaltic tubing pump to supply epoxy to two fill ports and to pump epoxy through the fixture. 5.) An epoxy sight gauge in each fill line to check the epoxy for air bubbles before the epoxy enters the fixture. 6.) A compound pressure gauge in each fill line to monitor the pressure of the epoxy during impregnation and to insure that the pressure of the epoxy never exceeded atmospheric pressure, which would stress the silicone rubber vacuum seals of the fixture in the wrong direction. 7.) A thermocouple vacuum gauge to check fixture vacuum before impregnation. 8.) A dual readout thermometer to monitor the temperature of the epoxy in the reservoir and in the degassing column. 9.) A sight gauge reservoir at the vacuum port to tell when the epoxy had been pumped through the fixture, to prevent epoxy from being pulled into the vacuum pump by any bubbles in the line, to provide a reservoir for the excess epoxy pumped through the coil section to further flush out air, and to provide a reservoir of epoxy for back-filling the coil section after the vacuum was removed.
