DCA312 Yoke Chevroning

TS-SSC 91-177 S. Delchamps October 8, 1991

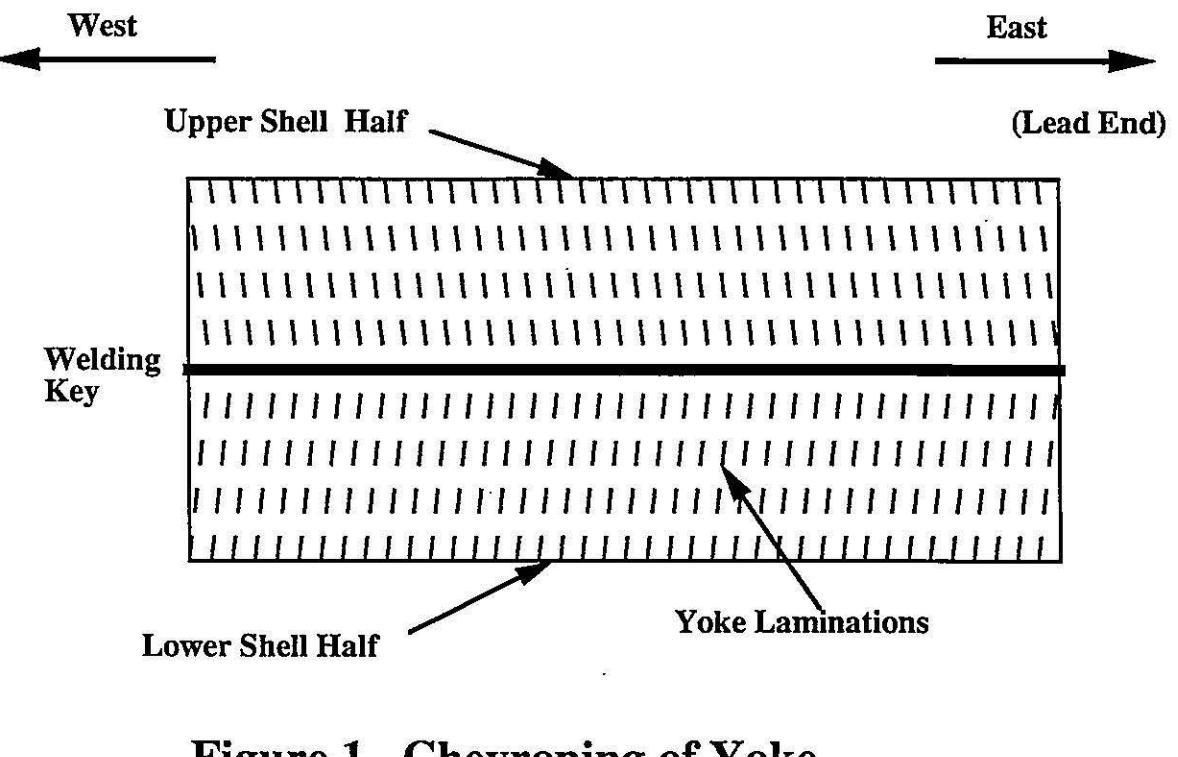
Description of the Incident: "At full pressure [7000 psi] before welding of the cold mass all of the 12 foot yoke packs shifted causing the press pressure to drop from 7000 psi to 6000 psi."¹. (This occurred on August 26, 1991.)

After this incident, the press pressure was dumped and the cold mass was rolled out of the press. When the upper shell half³ was removed, it was found that the upper and lower yoke laminations had "chevroned" as shown in Figure 1. The degree of the chevroning was not recorded quantitatively, but those present recall it as 5 to 7 laminations⁴ as measured from the parting plane to the outer surface of the yoke laminations. The laminations tilted toward the west as shown in the figure.

Figure 1. Chevroning of Yoke Laminations in DCA312

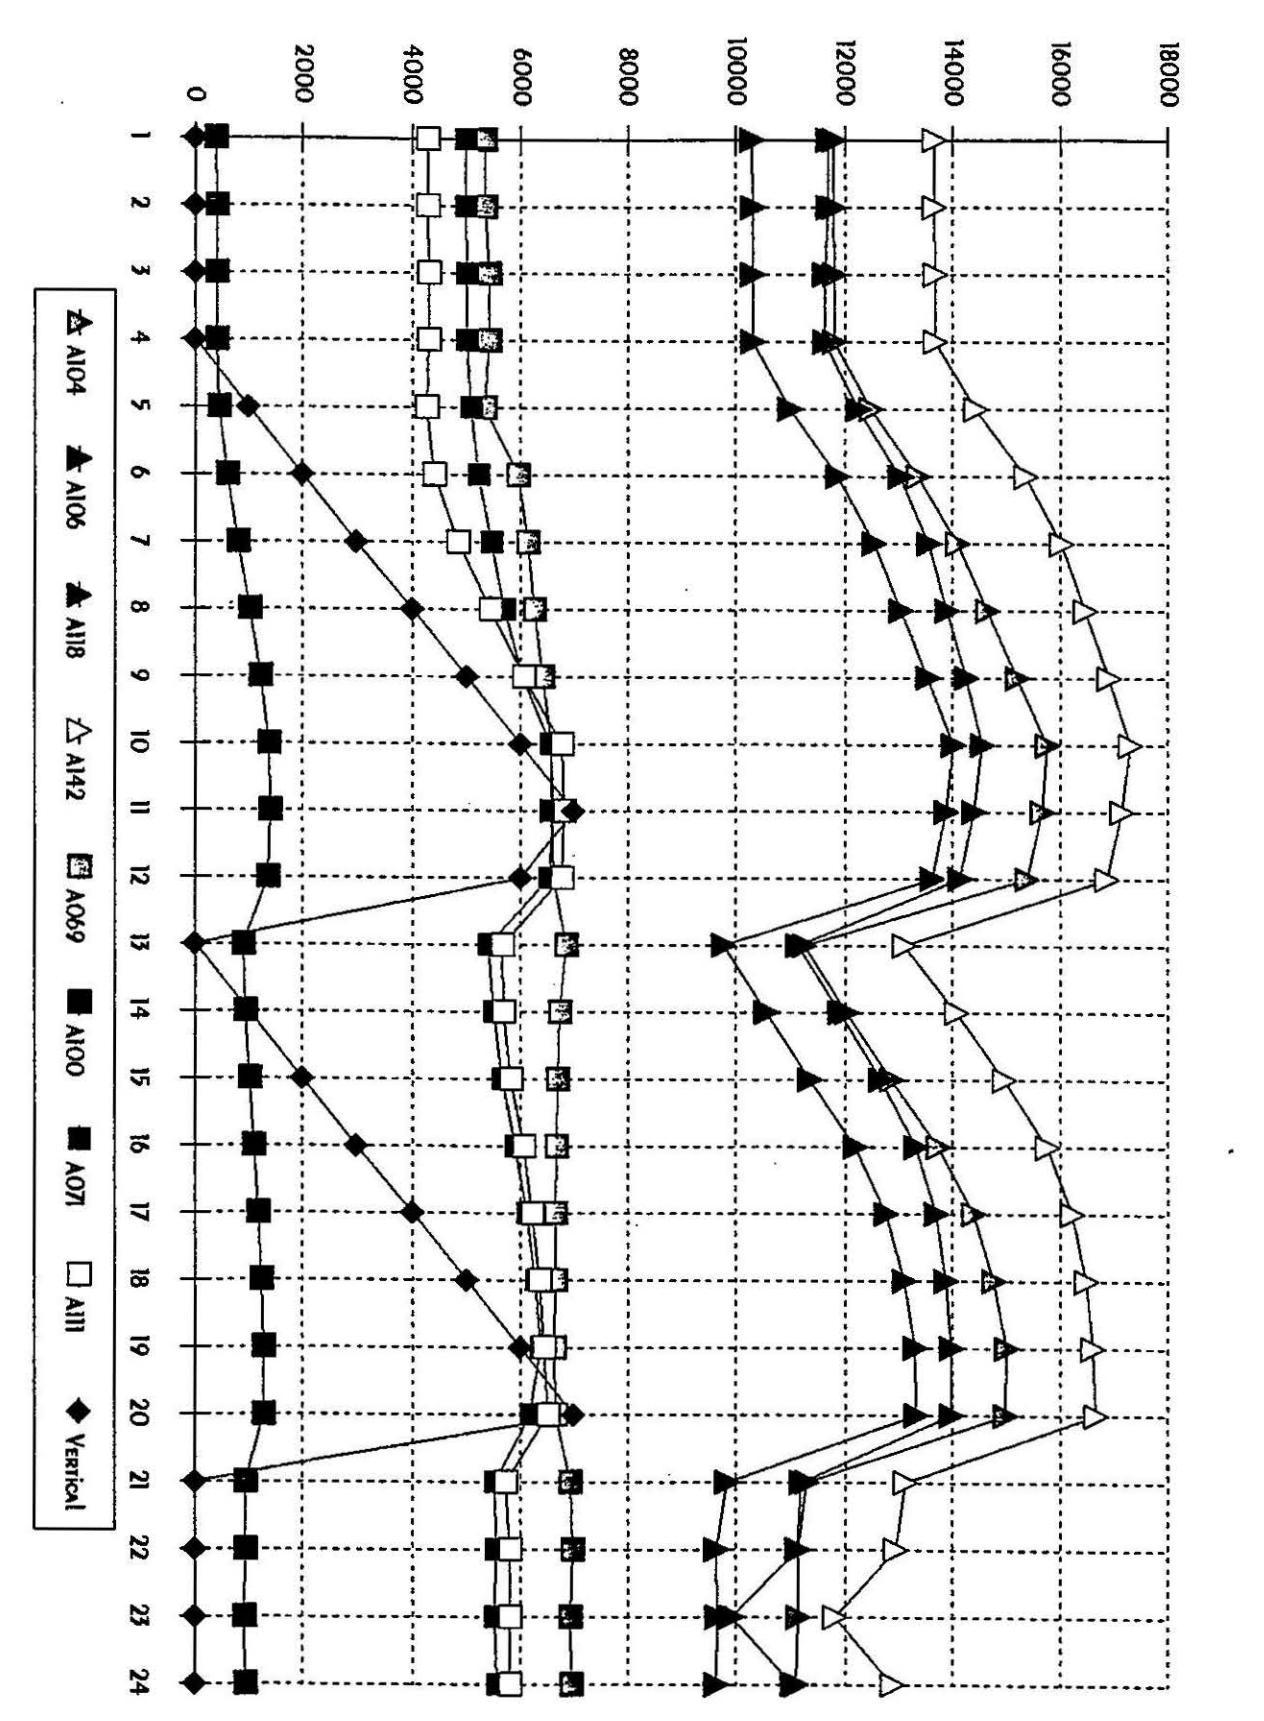
FIGURE 20 DCA 312 LEAD END YOKE READINGS

The triangles in the Figures 2a and 2b denote inner coil gages. It is seen that on the second pressing, where the chevroning took place, the inner coil stresses increase at the same rate as on the first pressing. However, they start and end at a lower pressure on the second pressing.

The outer coil gauges show little change in stress on either the first or the second pressing; one of them (A115 in the lead end pack) shows an odd double-valued behavior.

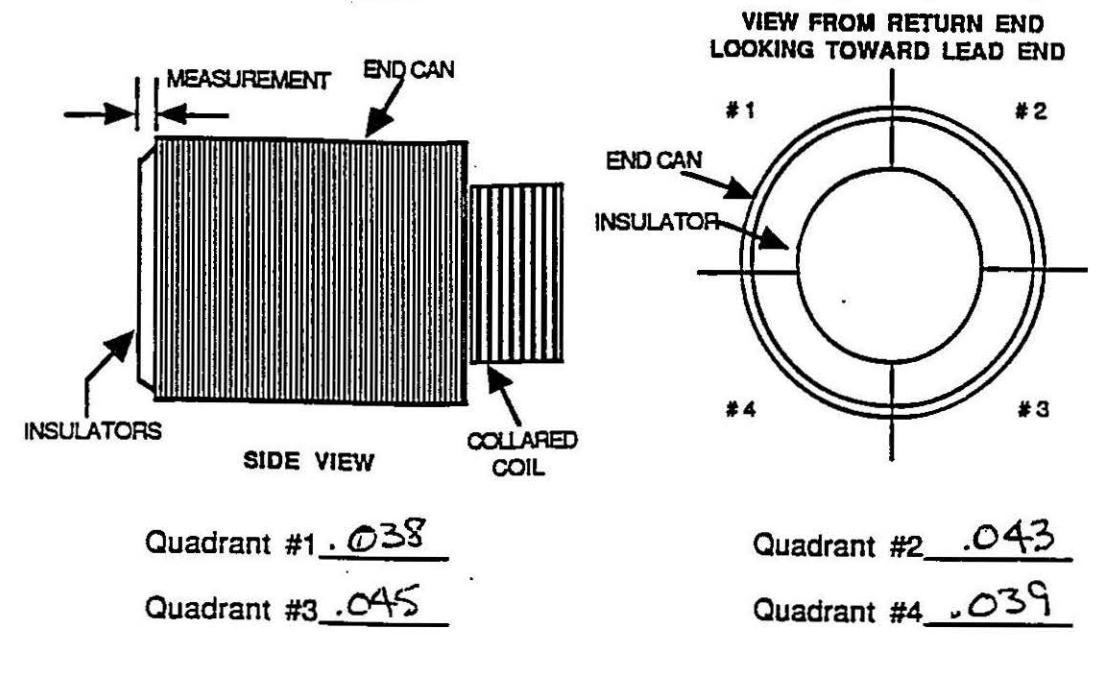
Figure 7. End Clamp "Closure" Measurement

End Clamp Position, Diameter, "Closure": The return end clamp was found to have slid ~.1" toward the return end of the collared coil assembly. Both the lead and return end caps were removed, and the relative positions of the G10 CR insulator surfaces and the ends of the aluminum end clamp cylinders were measured ("closure" measurement, see Figure 4). The diameters of the end clamp cylinders were measured as well. None of these dimensions was found to have changed by more than 2 mils from the pre-incident values. (Unfortunately, the raw post-incident data have been lost.)

The lead end clamp assembly was apparently not damaged. At the return end, the green putty used to make the saddle surfaces flush with the collet insulator surface cracked when the return end clamp slid. This green putty was repaired. Both end caps were re-

welded. No attempt was made to move the return end clamp back to its original clamped position.

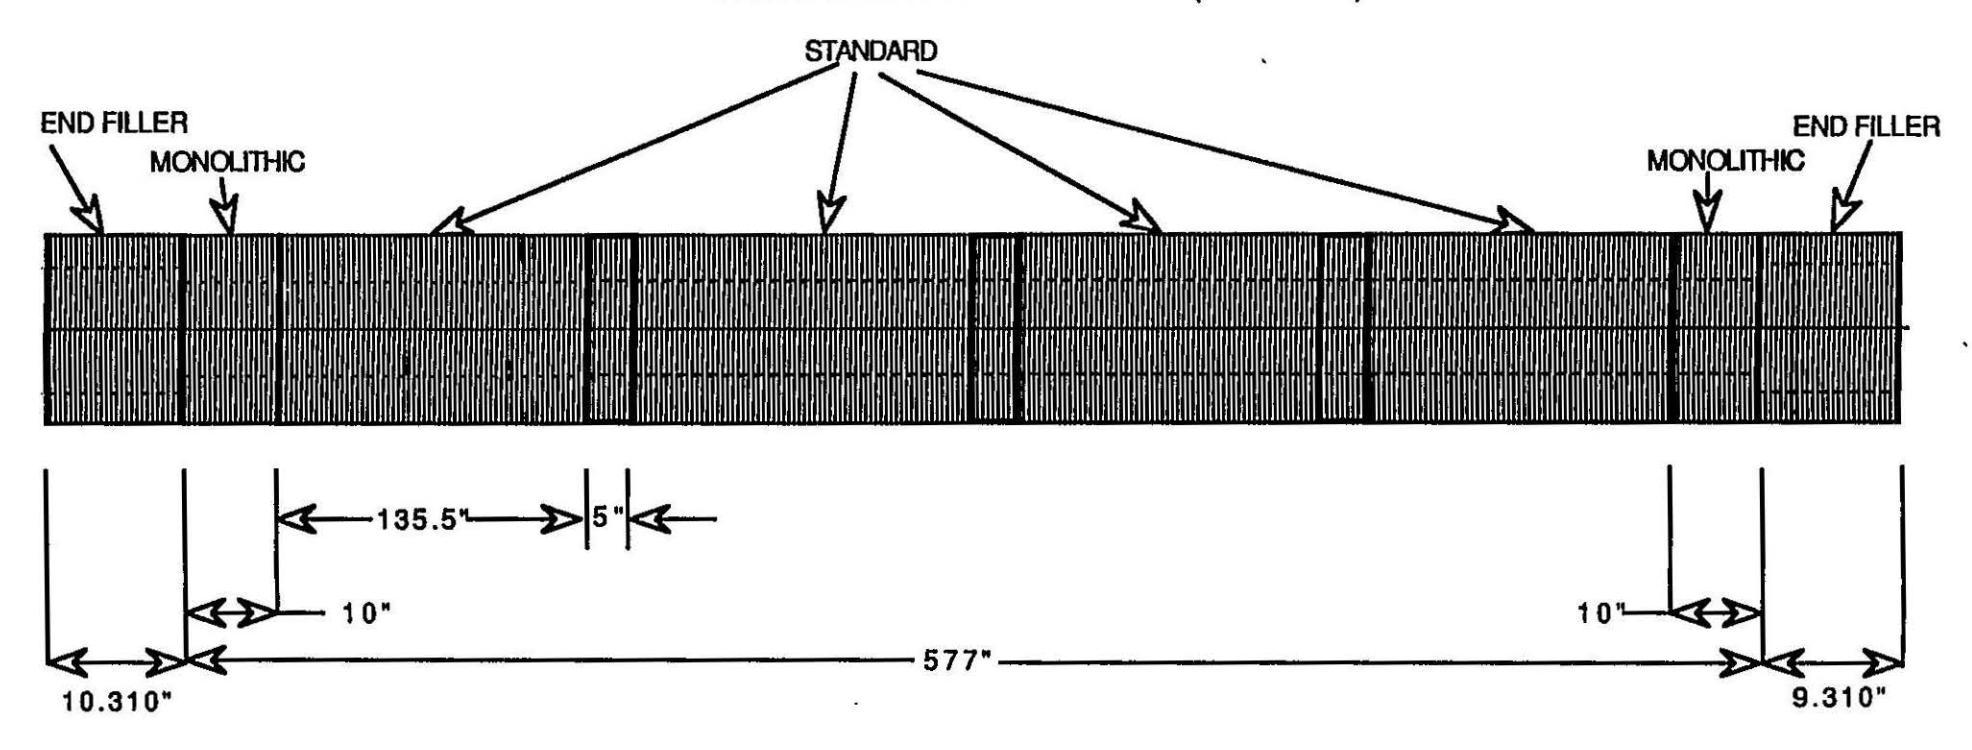
Figure 5. Proposed Solution to Yoke Lamination Chevroning Problem (M. Gordon)

Proposed Solution to the Chevroning Problem: The proposed solution⁷ to the chevroning problem, which is evidently caused by a lack of stability of the yoke assembly under pressure, is shown in Figure 5. First, a higher packing fraction (99%; the original value was $98\%^8$) will be used in the standard packs. Second, epoxy reinforced "monolithic" packs will be placed not only at the ends of the yoke assembly but at three positions along the magnet to give better support.

This approach has already been used in the assembly of the DCA312 and DCA313 cold masses.
