Impact of Forming, Welding, and Electropolishing on Pitting and the Surface Finish of SRF Cavity Niobium

Abstract—A broad range of coupon electropolishing experiments are described to ascertain the mechanism(s) by which large defects are formed near superconducting radio-frequency (SRF) cavity welds. Cold-worked vs. annealed metal, the presence of a weld, and several variations of electropolishing (EP) parameters were considered. Pitting is strongly promoted by cold work and agitation of the EP solution. Welding also promotes pitting, but less so compared with the other factors above. Temperature increase during EP did not strongly affect glossiness or pitting, but the reduced viscosity made the electrolyte more susceptible to agitation. The experiments suggest that several factors that are rather benign alone are combined by the cavity forming, welding, and processing sequence to promote the formation of defects such as pits. Process changes to mitigate these risks are discussed.

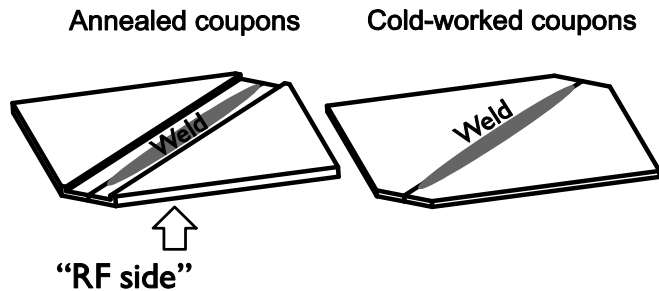
Fig. 1. Sketch of the coupon geometry and weld orientation. The electron beam trajectory was such that full penetration was made toward the side designated as the “RF side”. For the annealed coupons, this side is opposite the machined surface, in analogy with cavities.

Annealed coupons were drawn from Fermilab cavity-grade stock [4], being cut from the same 2.8 mm thick sheets as were used to fabricate recent SRF cavities. Coupons were cut by wire electrical discharge machining (EDM) to 7.5 cm squares (no-weld samples) or into triangular pieces (weld samples) as shown in Fig. 1. The diagonal edge to be joined during welding was machined to 1.7 mm thickness 8.3 mm back from the diagonal, which is characteristic of TESLA cavity equator weld parameters [13].

Cold-worked coupons were made by rolling annealed sheet from 3.3 mm thickness to 1.7 mm thickness using a 2-high rolling mill at the Applied Superconductivity Center, National High Magnetic Field Laboratory, Florida State University. Approximately 10% thickness reduction was applied per pass, with pieces rotated by 90° between passes. Weld samples were cut by EDM first into 6.2 cm squares and then separated along the diagonal as also shown in Fig. 1.

Coupon welding took place at Advanced Energy Systems, Inc. (Medford, NY), Pavac Industries (Richmond, BC), and at Sciaky Inc. (Chicago, IL). A Fermilab operator performed the welding at Sciaky. Vendors will not be identified later in this paper. Clamping and tooling to hold the pieces together and align the diagonals with the weld was left up to the vendor. Fig. 1 shows the coupons and the weld geometry.

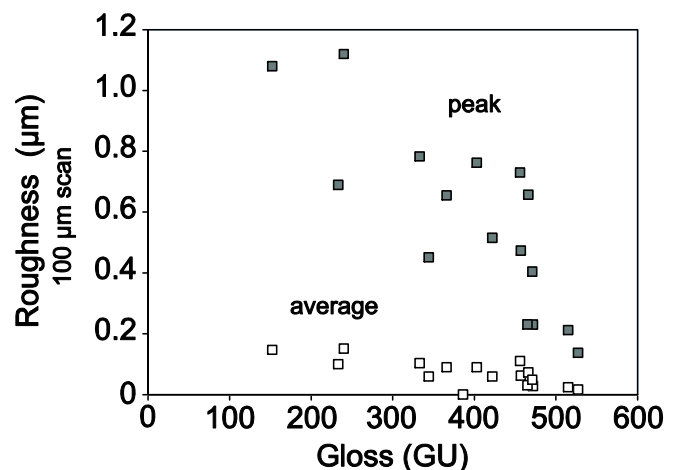
Fig. 2. Comparison of average and peak roughness as a function of gloss. The roughness data were acquired for a 100 μm line scan.

The quality of the electropolishing was determined by measurements of gloss and roughness. A gloss meter, which measures reflected light intensity from a calibrated source, was used to quantify the shininess of the surface in terms of “gloss units” GU. A high-quality electropolished stainless steel block (594 GU) and a black anodized aluminum block (94 GU) were provided as standards. Micro- and macro-roughness were measured with a stylus profilometer using 1 μm and 1 mm scans. Roughness is known to obey fractal behavior for SRF niobium [14], so peak and average roughness are not meaningful without the scan dimension. A clear correlation was found between both parameters and gloss, where the correlation for micro-roughness is shown in Fig. 2. Henceforth, therefore, we report only gloss measurements. Finally, area scans were also used to obtain topographies of defects.

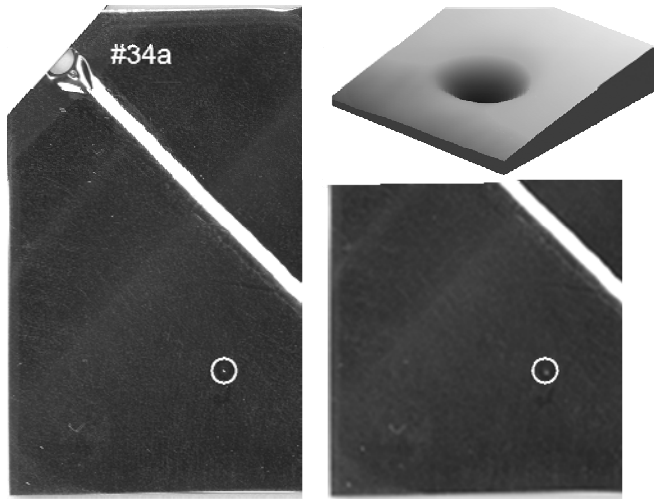
Fig. 3. Benchmark sample used as a reference for identification of pits. At left is shown a cropped image at actual size and 600 dpi as obtained from a flat-bed scanner. Black regions represent high gloss due to lack of diffusive scattering. A large pit is indicated by the circle. At lower right is the same image re-sampled to 72 dpi. Notice that significant contrast change remains inside the indicated area after the re-sampling. Inset at top right is a stylus profilometry scan 1 mm x 1 mm x 50 μm high, showing the dimensions of the pit to be approximately 500 μm across.

A sample with a clearly located 500 μm wide hemispherical defect was used as a reference to guide screening of coupon images. This is also shown in Fig. 3. Areas of high contrast were then analyzed with the profilometer to ensure that the contrast variation was not caused by debris, scratches, or other features. Since light is acquired at an angle offset from the illuminating filament, some diffusive scattering is required to

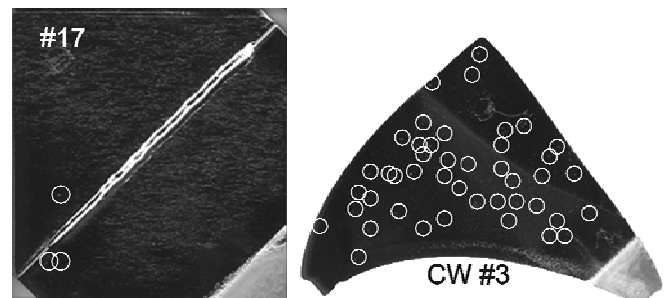
Fig. 4. At left is an annealed welded coupon from welder B. A mirror-like finish comparable to annealed coupons with no weld is seen. However, a few large pits are also located near the weld as indicated by the circles. At right is a cold-worked coupon, with many pits indicated by the circles. The distorted triangular shape is due to the deformation of rolling, where the starting piece was a triangular half-coupon. Images are shown at 220 dpi.

Examples of an annealed weld coupon and a cold worked coupon are shown in Fig. 4. In both cases, gloss like that of the annealed EP coupons is indicated by the generally black appearance of the scans. Some pits were identified in the annealed weld coupons, as indicated in the figure. Cold-worked coupons exhibited a starkly different appearance, as the example in Fig. 4 shows. Within the glossy regions, numerous speckles appear with sufficient contrast to pass the identification criterion discussed earlier. Closer inspection with profilometry of a couple of these regions, shown in Fig. 5, reveals that a mixture of many smaller pits accompanies the large pits. The number of small pits is at least an order of magnitude higher than for the large pits, suggesting that there are hundreds of small pits per square centimeter.

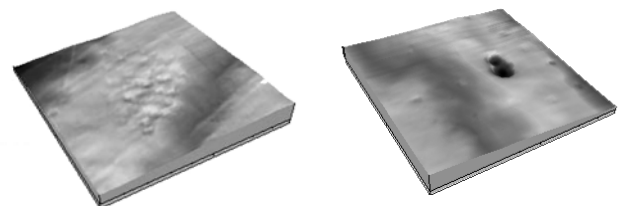
Fig. 5. Profilometer scans of different regions of CW #3. At left is a region 1 mm x 1 mm x 25 μm high, while at right is a region 1 mm x 1 mm x 50 μm high. Notice the mixture of large and small pits in the right profile.

The difference in defect numbers between annealed and cold-worked coupons is rather astonishing. Cold working clearly promotes the formation of defects at many scales, not just the large scales comparable to the 500 μm reference defect. Profilometry scans such as those shown in Fig. 5 clearly detail much greater activity at scales less than 100 μm . Further study by electron microscopy, laser confocal scanning microscopy, and atomic force microscopy is underway to understand the fine detail. In particular, the role of dislocations in assisting etching processes is well known [16], and recent studies [17] have revisited this topic for cavity-grade niobium.

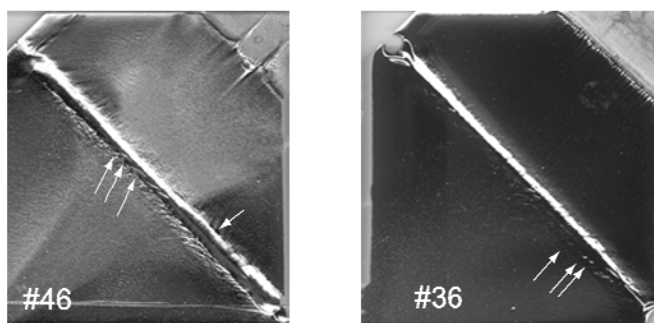
Fig. 6. Cold-worked welded coupons. The arrows indicate new features not seen for either cold-worked coupons or annealed weld coupons.

Examples of cold-worked welded coupons are shown in Fig. 6. In addition to features seen for cold-worked coupons, such as numerous pits across the entire area, and for welded annealed coupons, such as a few large pits located near the weld, new features were seen at the boundary of the weld bead. These features, indicated by the arrows in Fig. 6, appear as dark spots and have a characteristic size of 200 to 500 μm and spacing of ~ 1 mm. Profilometry was difficult to obtain for these regions due to their proximity to the curved bead.

A main observation of this work is that many factors can be relatively benign by themselves, but can lead to significant rates of defect formation when they are combined. Combination of cold work and welding in particular led to the formation of new types of contrast variations near the weld bead, as indicated in Fig. 6. Closer inspection by light microscopy showed that these dark features were bowl-shaped dimples and gaps. As explained earlier, profilometry was not possible due to the strong surface contour of the weld bead.

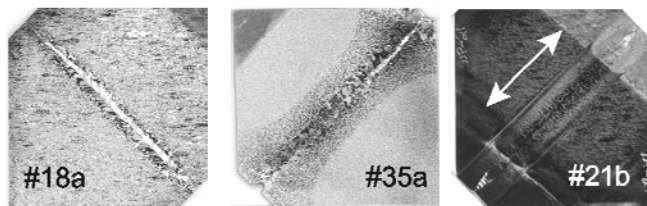
Fig. 7. Weld coupons polished with some form of agitation of the electrolyte. At left, #18a was processed with a higher flow of electrolyte past the sample. In the center, #35a was processed with ultrasonic agitation applied during EP. At right, #21b was processed by cyclically dipping the coupon into the electrolyte, where the arrows indicate the region of the coupon coated by a meniscus. All of these coupons previously were polished to high gloss by standard EP. Notice the grain contrast revealed by these procedures, which is akin to grain contrast revealed by BCP and other etching techniques.

Finally, a set of coupons processed with various forms of agitation given to the electrolyte is shown in Fig. 7. The implications of various agitation techniques will be discussed shortly. It is important to note that, in all of these examples, high temperature was important for exacerbating the effects of the agitation; experiments at 30 °C yielded inconsistent results. Annealed weld coupon #18a was processed with a small cathode, 1/20 the area of the niobium, which allowed much higher flow of electrolyte past the coupon surface. Grain contrast in this image is suggestive of typical etching processes used in metallography. The HAZ is difficult to determine due to the large grain size of this annealed metal. Ultrasonic agitation was applied during the electropolishing of cold-worked weld coupon #35a, which produced a similar effect as for coupon #18a but over much shorter time. The HAZ is clearly visible due to the fine grain structure of the cold-worked metal. Annealed coupon #21b was cyclically dipped into the electrolyte with a period of ~10 s. Again, grain contrast is seen in the central region where a meniscus coated the sample. The region at bottom left remained in the EP solution and took on a much better gloss, free from visible grain boundaries. Many (> 10) large pits were identified in the central meniscus region of #21b and located in the HAZ.

The agitation was effective for revealing the HAZ for cold-worked specimens. This is due to the substantial difference in grain size between the recrystallized portion of the HAZ and the unaffected metal. Agitation apparently exacerbates pitting, as suggested by the large pits seen on samples #21b and #35a. This might be expected when local chemical attack can be accelerated by supplying fluorine to the coupon surface.
