SSC Technical Note No. 80

SSC-N-590

CONSTRUCTION, TEST AND DISASSEMBLY OF 17 m SSC DIPOLE DD0012

February 18, 1989

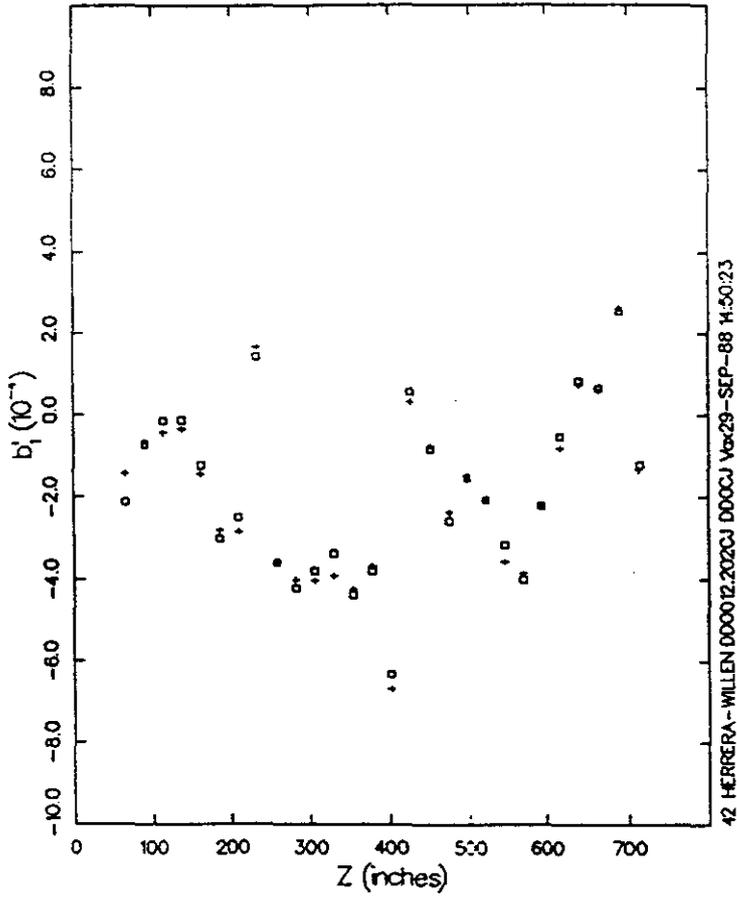
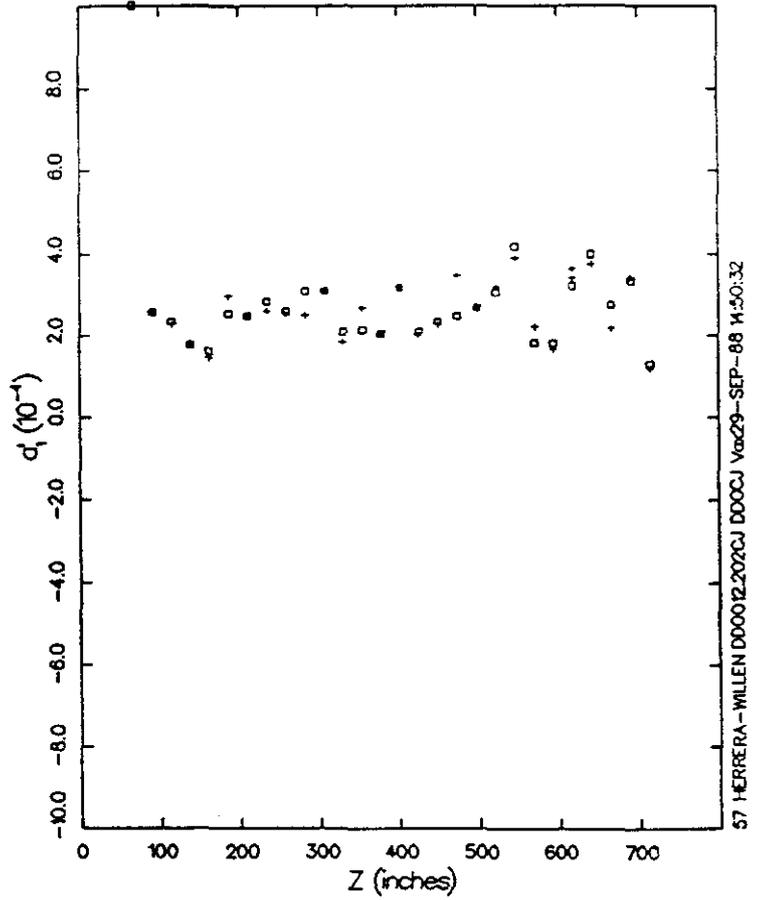
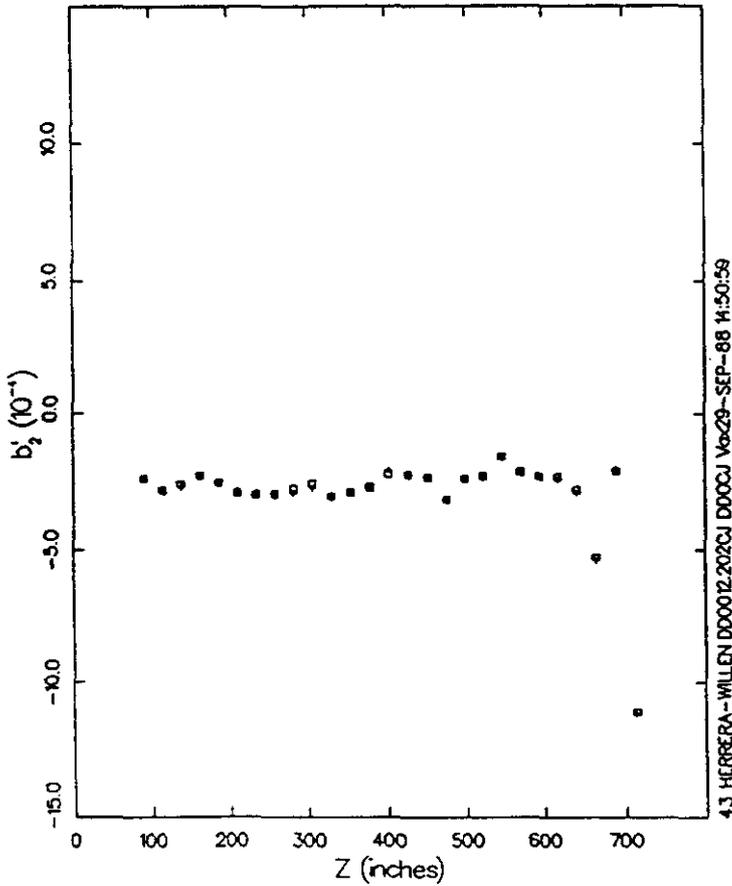
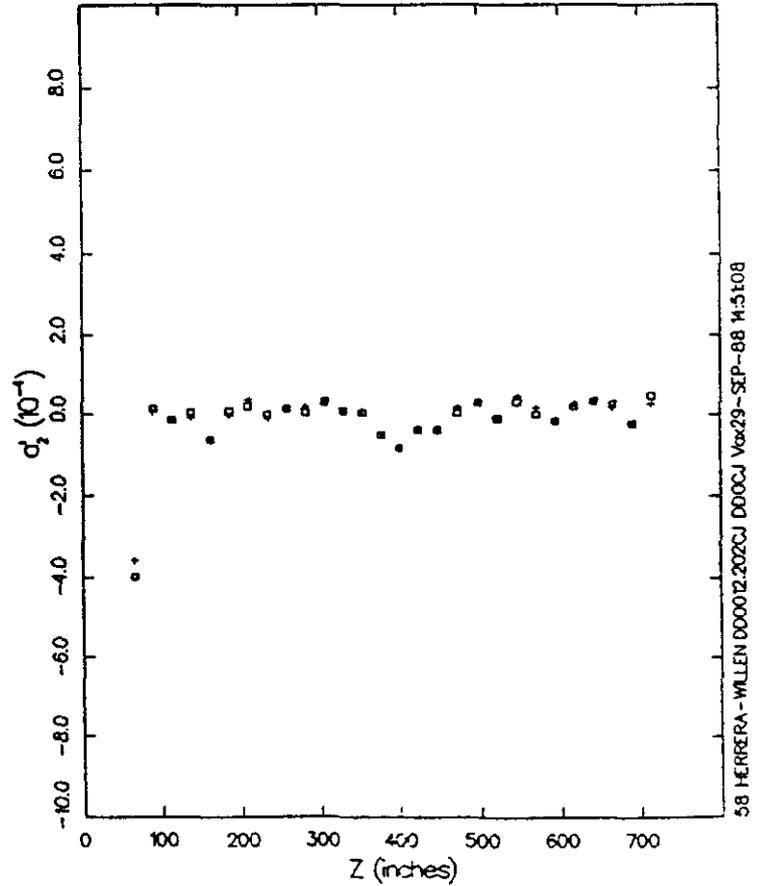
Fig. 1. III.A.1

11 DD0012 Normal quadrupole fractional coefficient at  $r,cm=1.00$

12 DD0012 Skew quadrupole fractional coefficient at  $r,cm=1.00$

15 DD0012 Normal sextupole fractional coefficient at  $r,cm=1.00$

16 DD0012 Skew sextupole fractional coefficient at  $r,cm=1.00$

After testing at Fermilab the cold mass was returned to BNL and mounted on an assembly fixture at room temperature. The magnetic field was then measured using the BNL mole. A number of caveats apply to these measurements, the most important being that no correction has been made for feeddown. The measured multipole field strength and dipole field angle, averaged over the magnet length, are given in Table 1.III.A.1. The Table contains z-averages for +10A, -10A, and the average of these two currents for one of the two runs. (Averages from the other run agree within a few hundredths of a unit.) For the +10A data only, the lowest order multipoles and the dipole angle are plotted against z in Figs. 1.III.A.1 and 1.III.A.2 (bottom half) respectively. A full report of the data is given in a separate report (BNL Magnet Test Group report TMG-390).

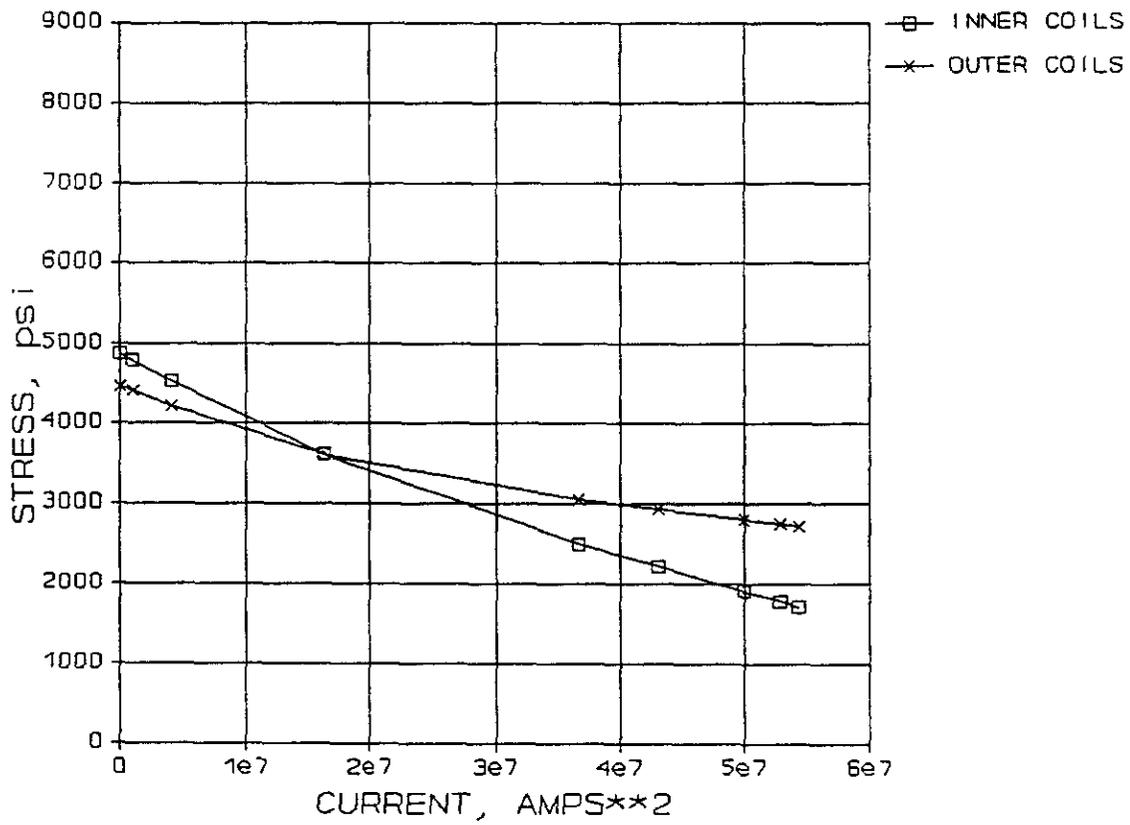
Fig. 2.II.A.2

The average stress for the inner and outer coils is plotted against the square of the current in Fig. 2.II.A.2. The deviation from a straight line suggests elastic moduli which increase with current.

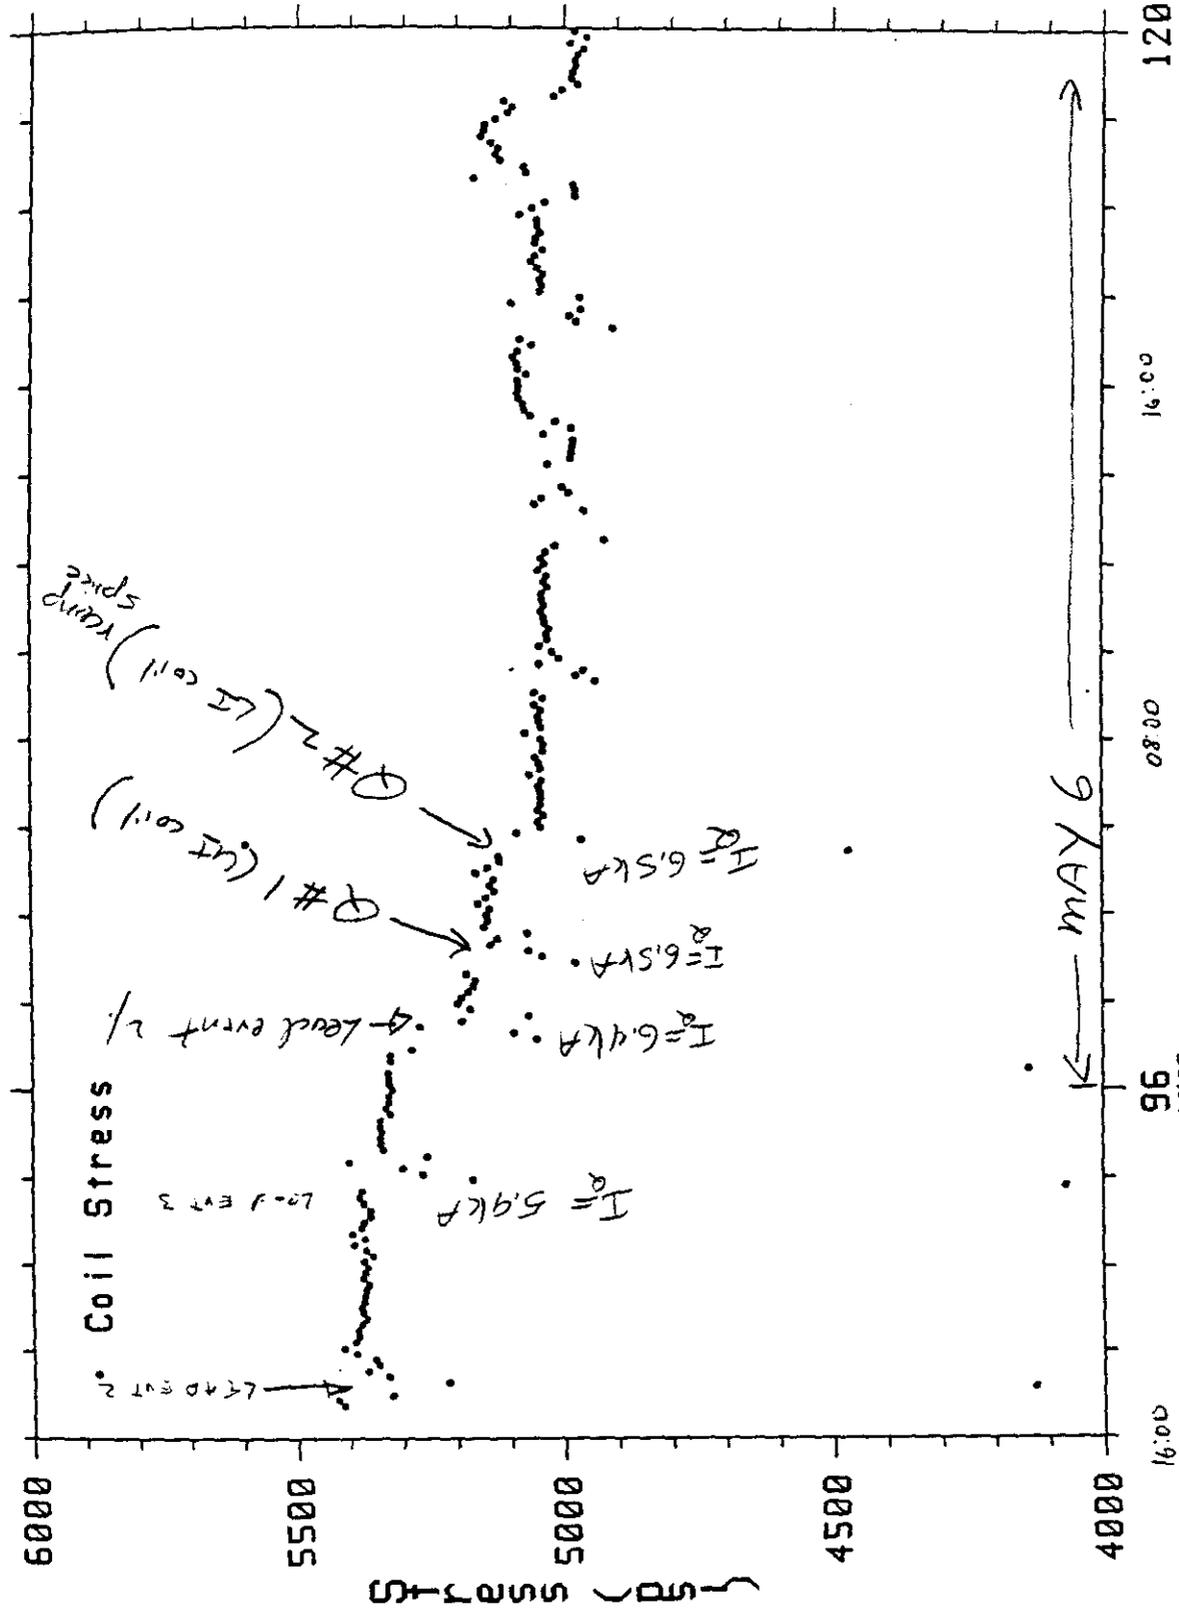
Fig. 2.II.A.3

# Average Inner Coil Stress

The complete history of the magnet is summarized in Table 2.II.A.2. Broadly speaking, the 0.8 kpsi drop of prestress in the inner coil from the time of assembly until disassembly at BNL may be due to creep. (Interestingly, the outer coil prestress increases 0.4 kpsi during the same period.) The inner coil cold prestress values show no significant change during either of the two periods of cold testing. (The same can be said for the outer coil values.) This is interesting because the inner coil prestress values dropped about 0.5 kpsi during the initial testing of the magnet (Fig. 2.II.A.3, which does not use the post-test 4.2K constants).

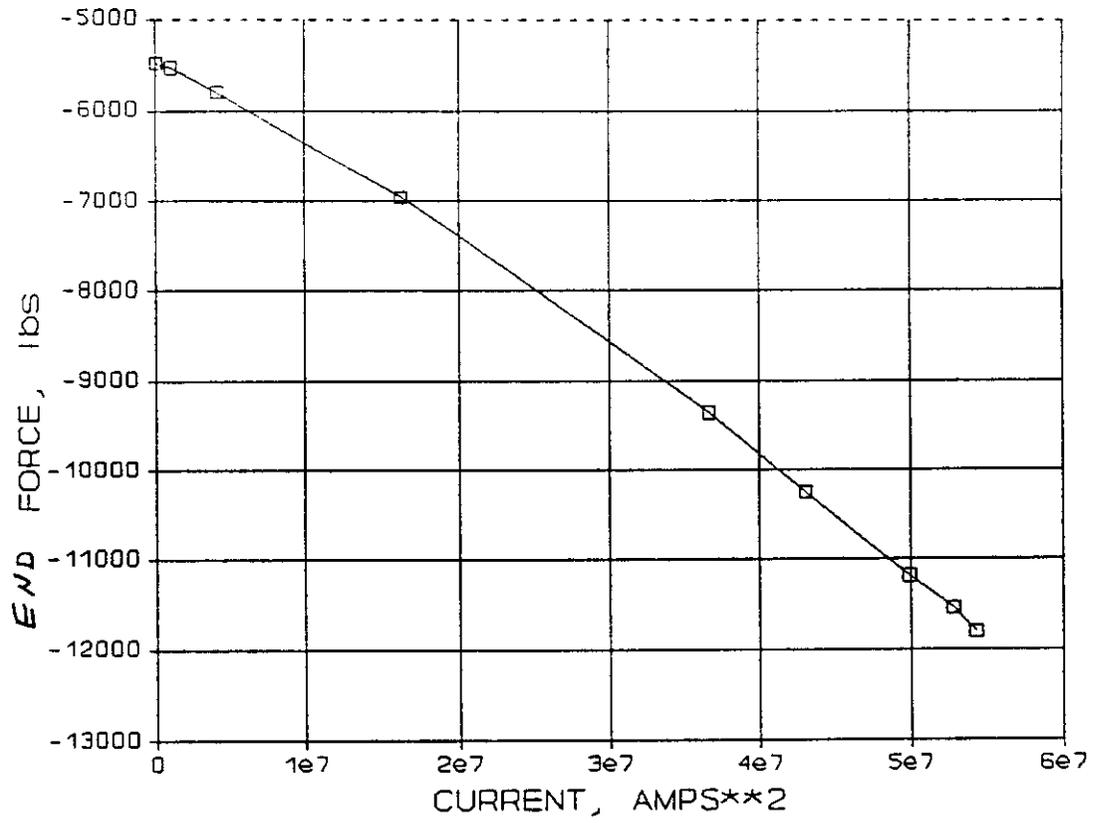
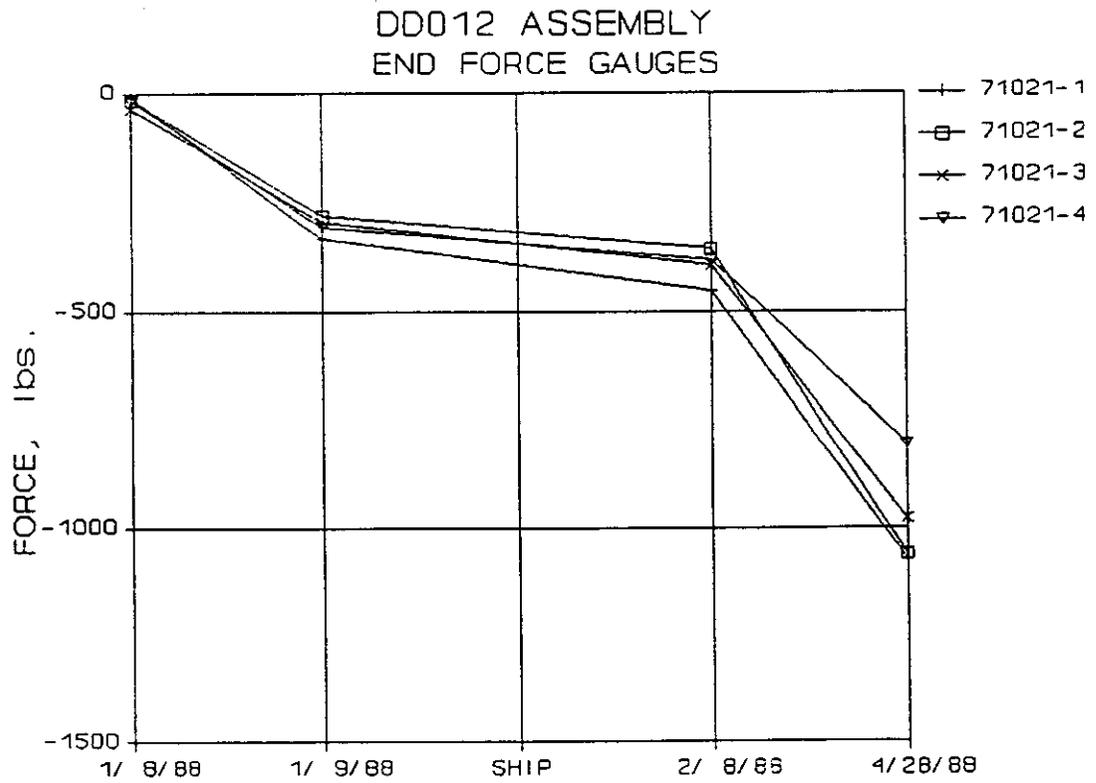
Up to the highest current for which data are available, 7.4kA, the end force increases linearly with the square of the current (Fig. 2.II.B.1). From 0A to 6.6kA the end force increase is about 4.8 klbs, much less than the calculated value of 15 klbs. Presumably friction from the coil through the collars, shims and yoke to the skin accounts for the difference. This was advantageous in magnet operation, since experiments at BNL indicated that this class of coil end (alumina and epoxy) could fail if the end force exceeded 20 klb.

The non-lead end of the magnet was instrumented with four bullet gauges, each adjusted at the time of assembly to apply 300 lbs force axially on the ends of the coils. At some stage during the work done at Fermilab, the force reading increased from 1200 lbs total to 3900 lbs total, with the four bullets continuing to track one another well. It is not known which step caused the increase. The warm history of the bullets prior to testing is shown in Fig. 2.II.B.1 (bottom).

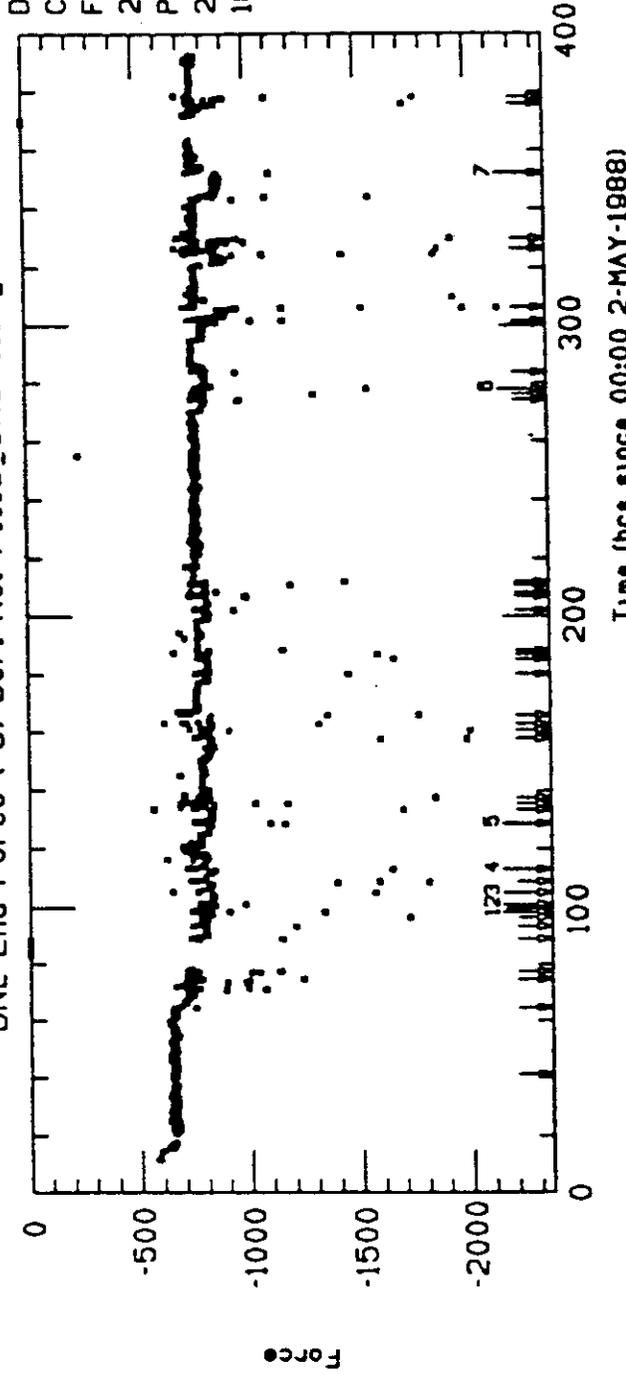
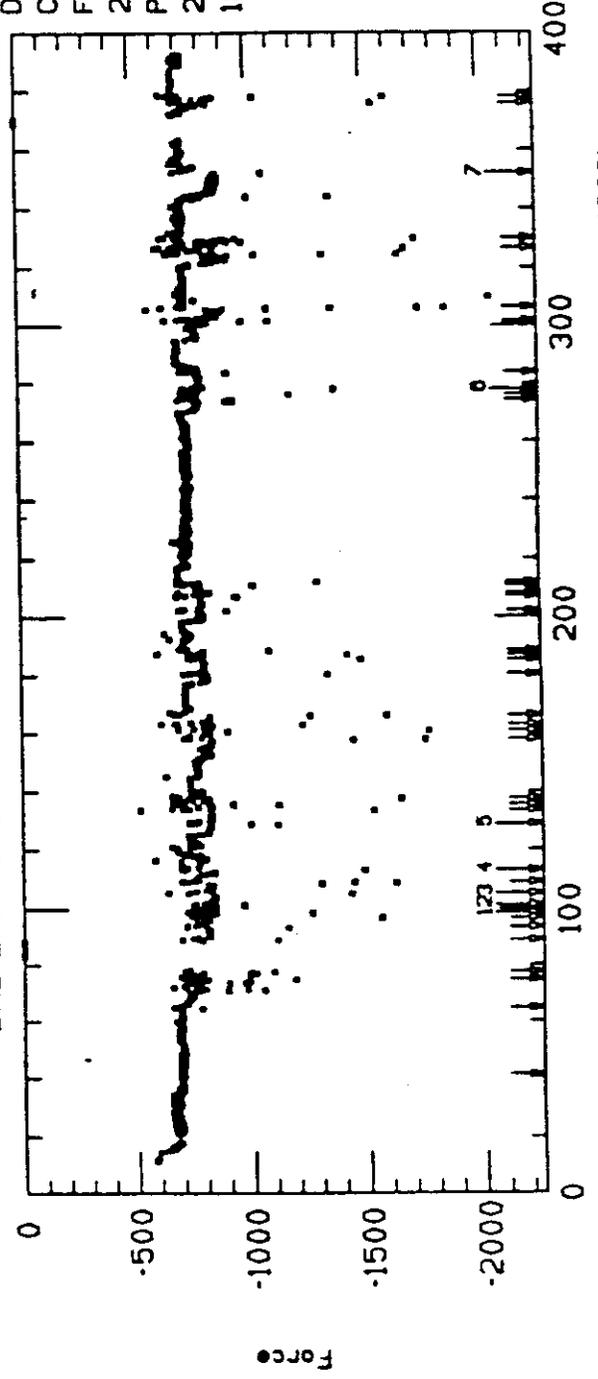
Fig. 2.II.B.2

BNL End Force ( 3) Ser. No. 71116\_3A&71116\_3B

BNL End Force ( 4) Ser. No. 71116\_4A&71116\_4B

The complete history (at zero current) is given in tabular form along with the azimuthal data in Table 2.II.A.1 (bottom). The end force increased somewhat with cooldown and during testing. The increase attributed to testing went away when the magnet was thermally cycled. There was a small increase in end force (about 100 lbs) during the initial training (time = 100 hours), as shown in Fig. 2.II.B.2.

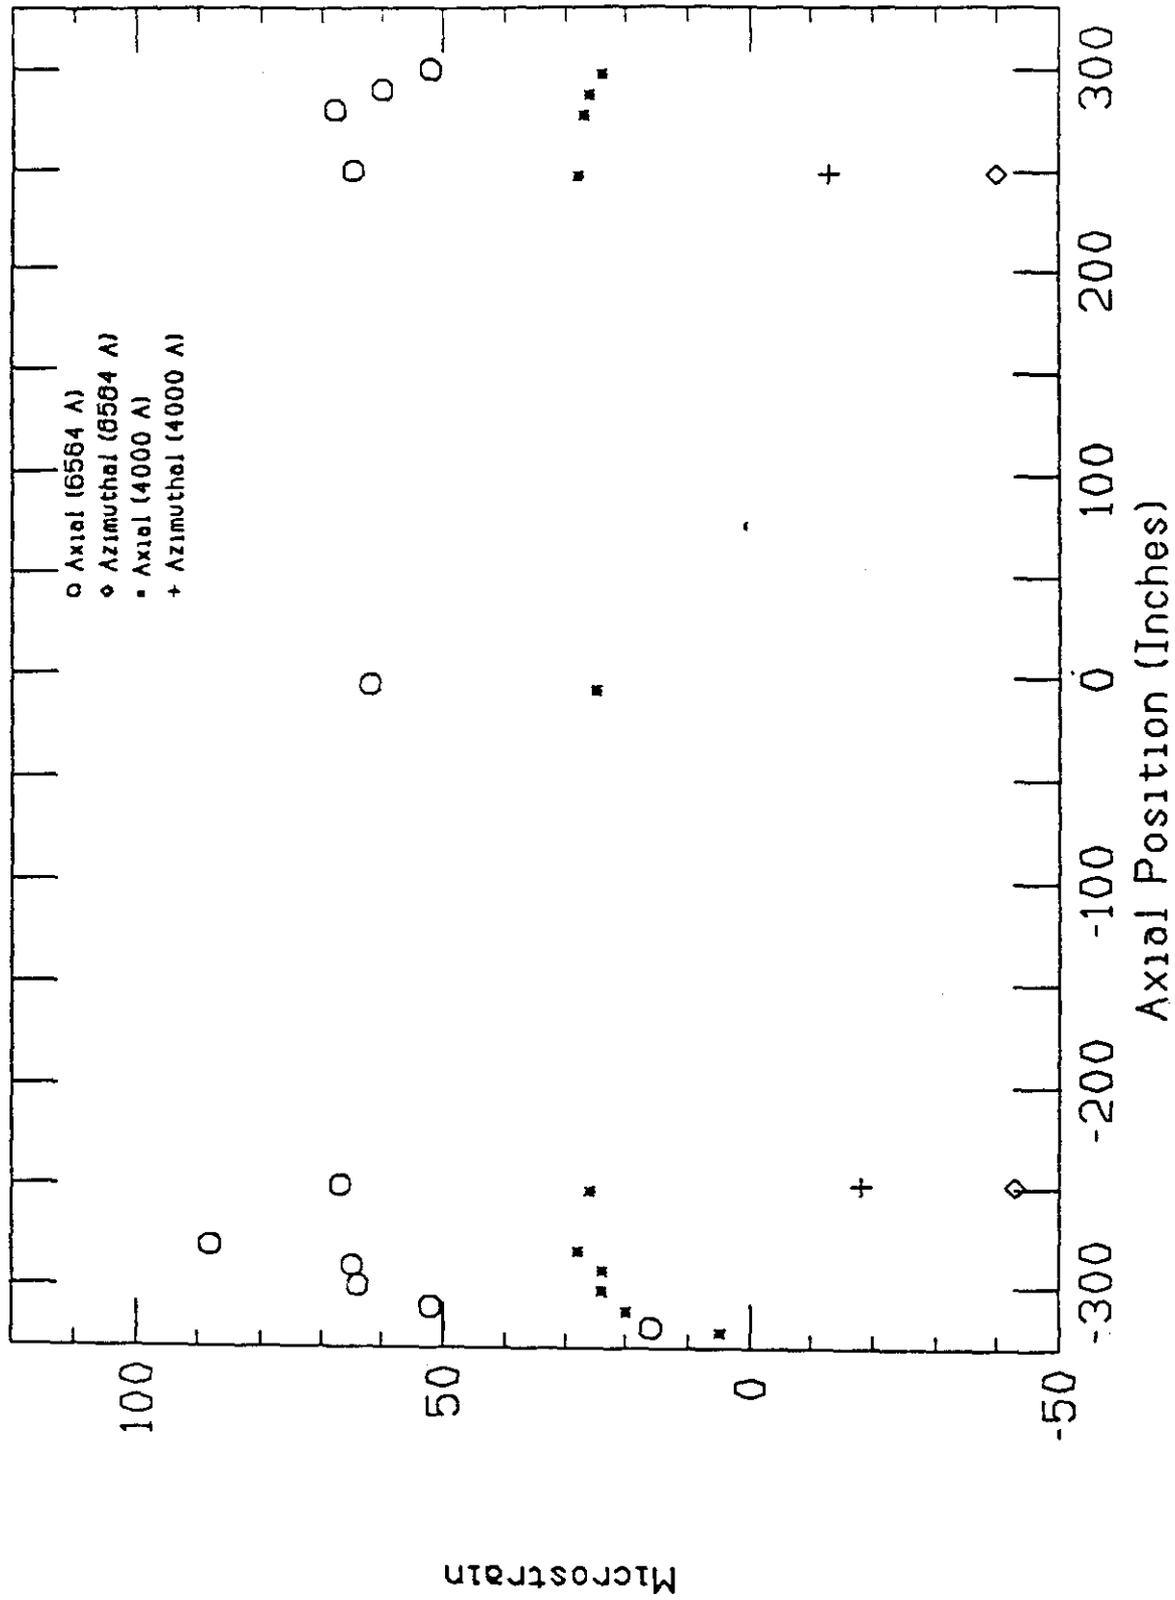
Fig. 2.II.C.1

# DD00012 Shell Strain Gages

Qualitatively the data agree well with the model that the axial Lorentz force is transmitted primarily through the yoke (rather than the end plate) and is taken up by the skin within 30" of the end (Fig. 2.II.C.1). All but two of the eleven axial gauges describe a smooth variation of strain along the axis, indicating good gauge-to-gauge consistency. The response of the two azimuthal gauges was qualitatively what was expected (opposite in sign to the axial gauges; increasing response as current increased).

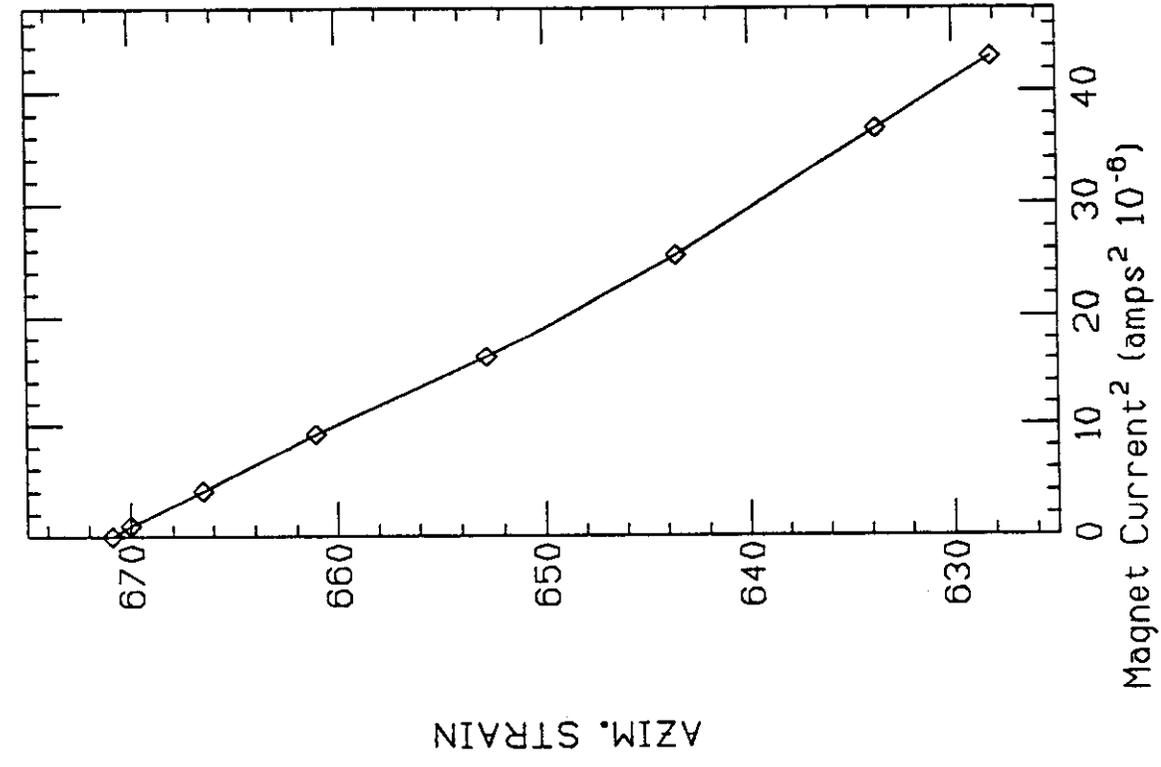
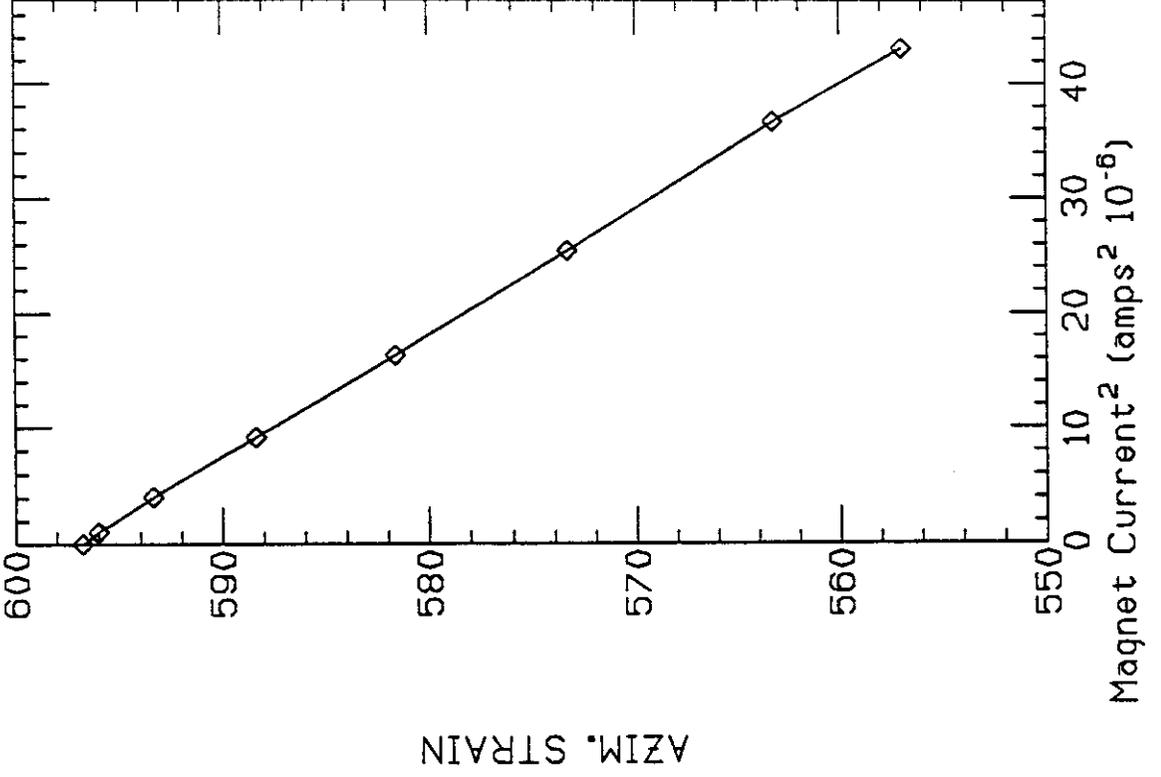
Fig. 2.II.C.2

SHELL 81" FROM FEED STRAINGAGE SG0114

SHELL 81" FROM RET STRAINGAGE SG0115

The gauge variation with  $I^2$  is close to linear, as expected (Fig. 2.II.C.2). However, the strain was found to vary in a stepwise fashion over many hours, for an unknown reason, making the extraction of long-term and cooldown data unreliable (Fig. 2.II.C.3). (It is thought that the problem arose because the compensating gauges were in vacuum and only weakly coupled thermally to the cold mass.) All 15 gauges had the same problem with baseline shift. Within this (large) 100 microstrain uncertainty, the shell gauges showed no dramatic changes during the course of the test.

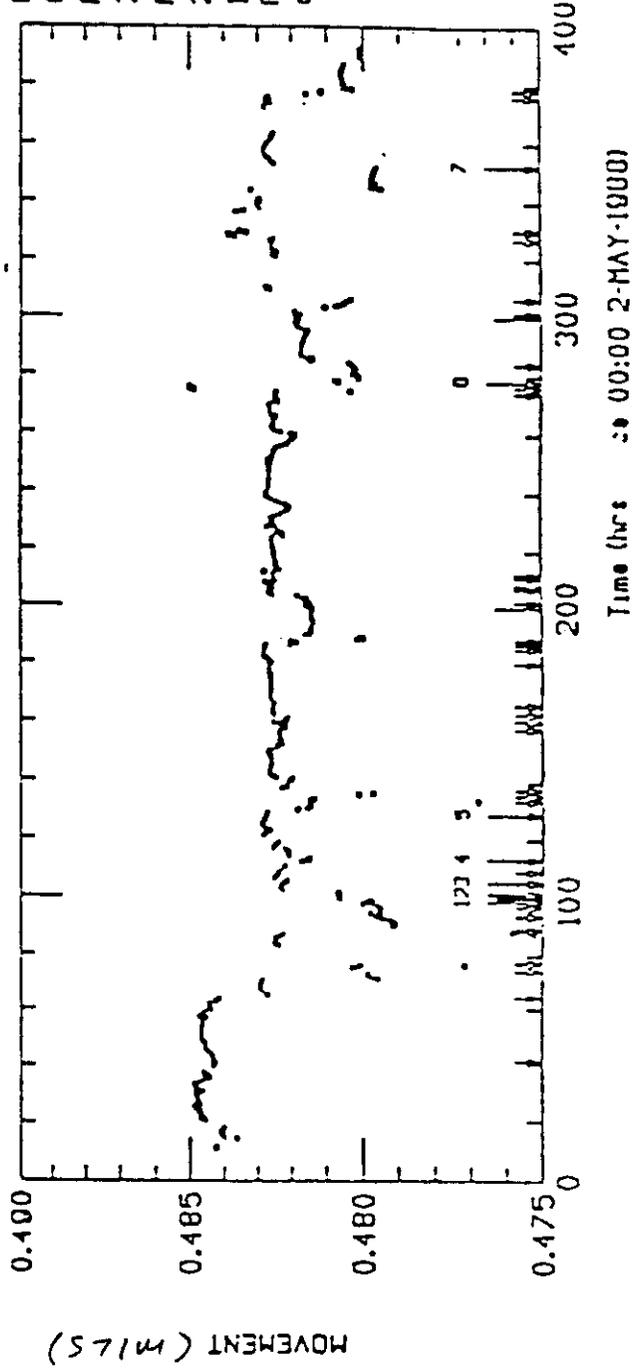
Fig. 2.II.D.1

Ktlh(76): COLD MASS SHELL EXTENSIOINT EXT-01  
CALIBRATION ADJUSTED FOR 2 INCH SENSOR

The plot of extensometer with time shows that the (cold) magnet became longer by 2 mils at the time of the second lead event (Fig. 2.II.D.1). After correction for backlash, the extensometer also shows that the magnet lengthens linearly with  $I^2$  to a total of 44 mils at 6.56 kA (Fig. 2.II.D.2).

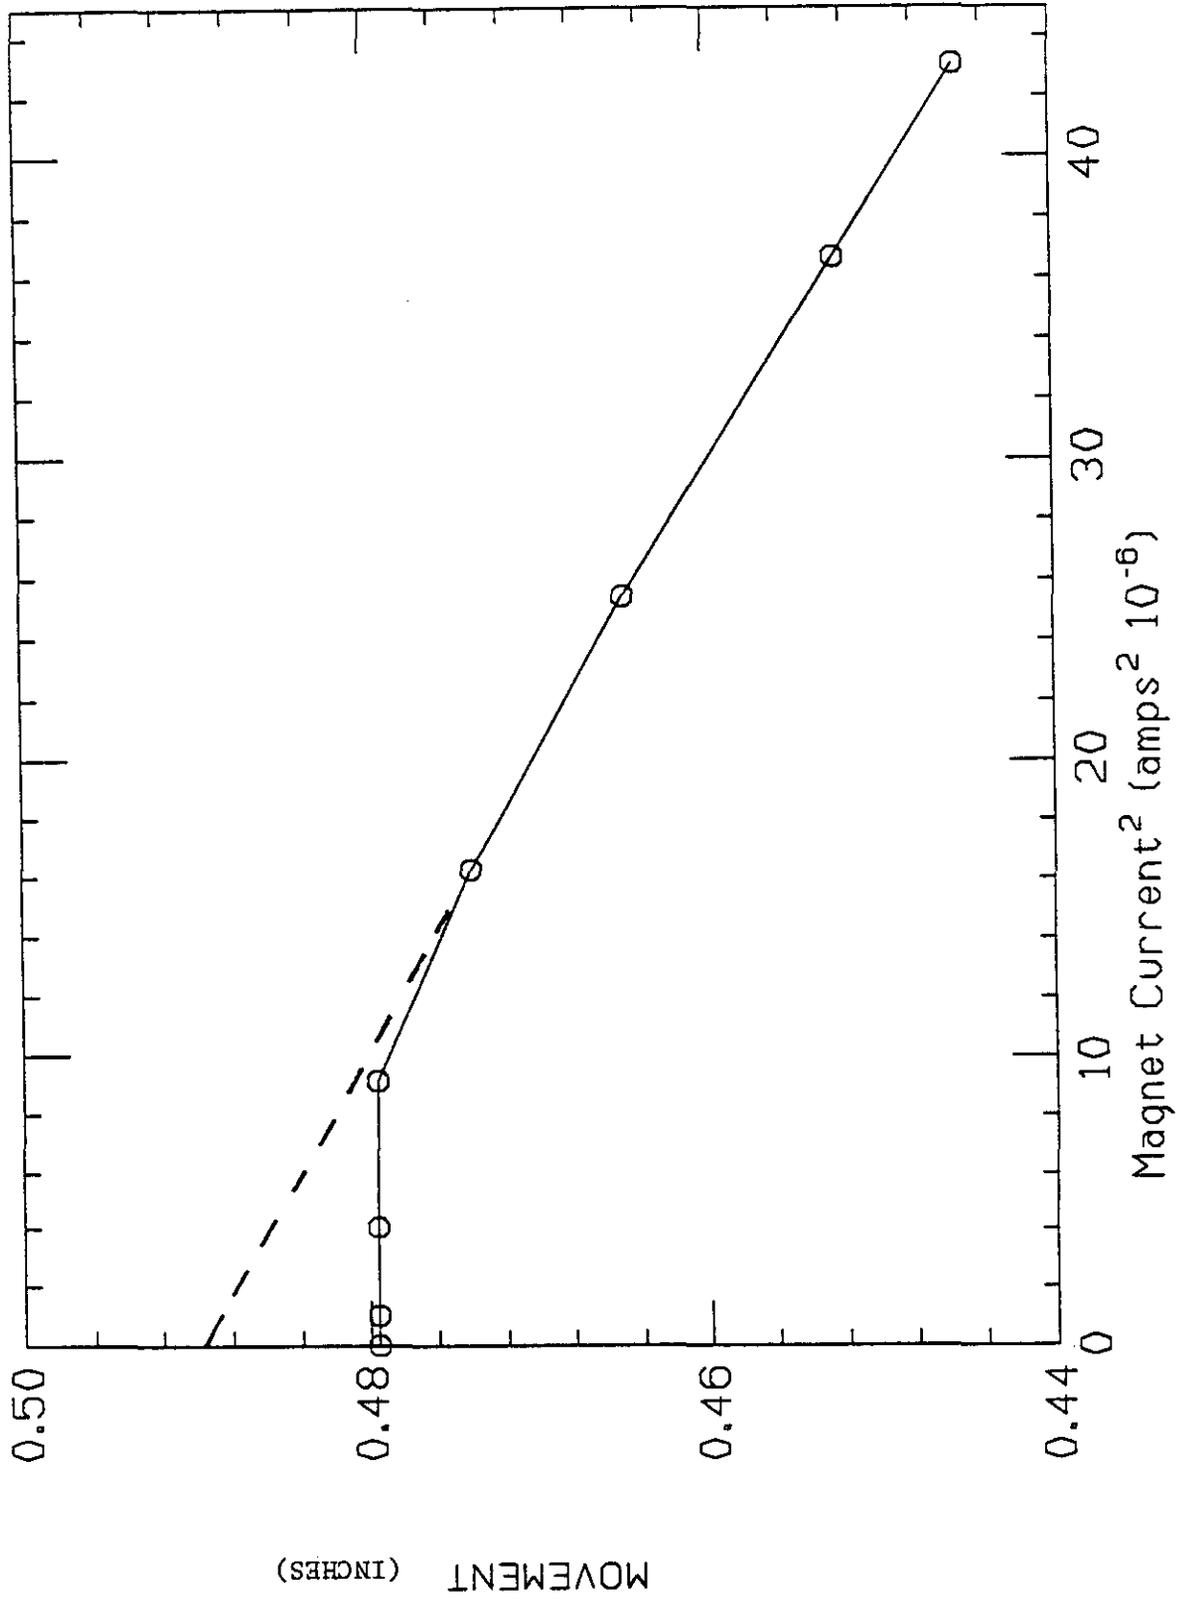
Fig. 2.II.D.2

DD0012: COLD MASS SHELL EXTENSION EXT-01  
CALIBRATION ADJUSTED FOR 2 INCH SENSOR

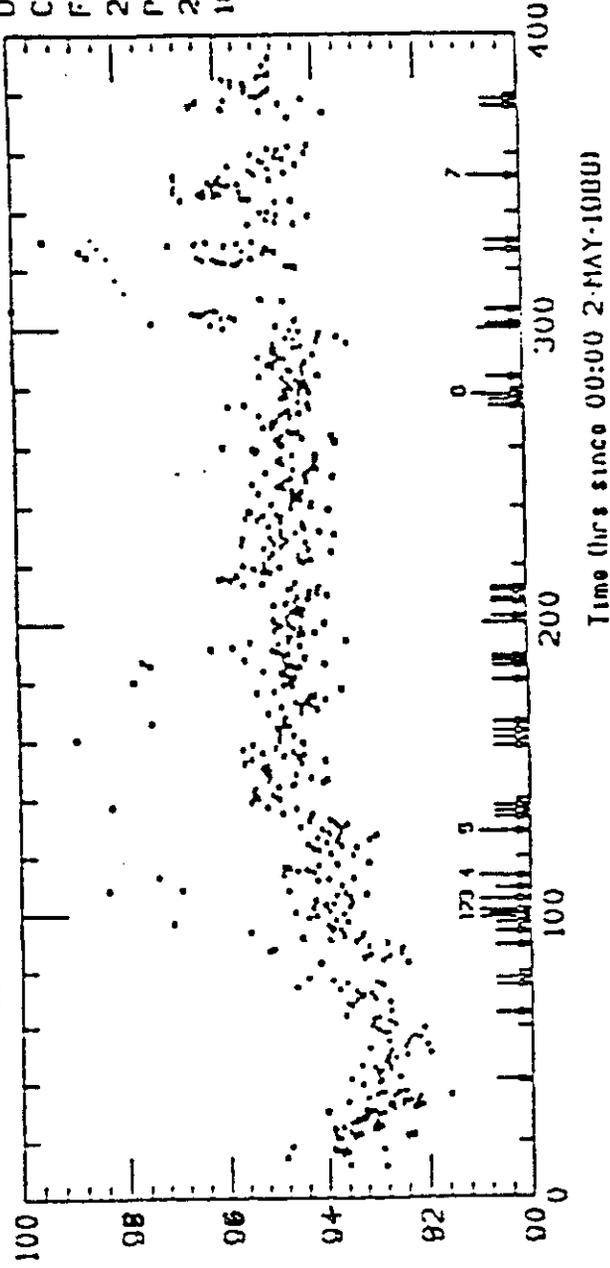
Fig. 2.II.E.1

KUNIGI: END PLATE (FEED) STRAINGAGE SG0110 /D025

Schermer concluded that these gauges are not useful for magnets with thick end plates, because the end plate motion is so small. The early time history (Fig. 2.II.E.1) shows a change of 1 microstrain during the initial few quenches. A signal of about 3 microstrain can be seen during the excitation to 5.5kA (Fig. 2.II.E.2).

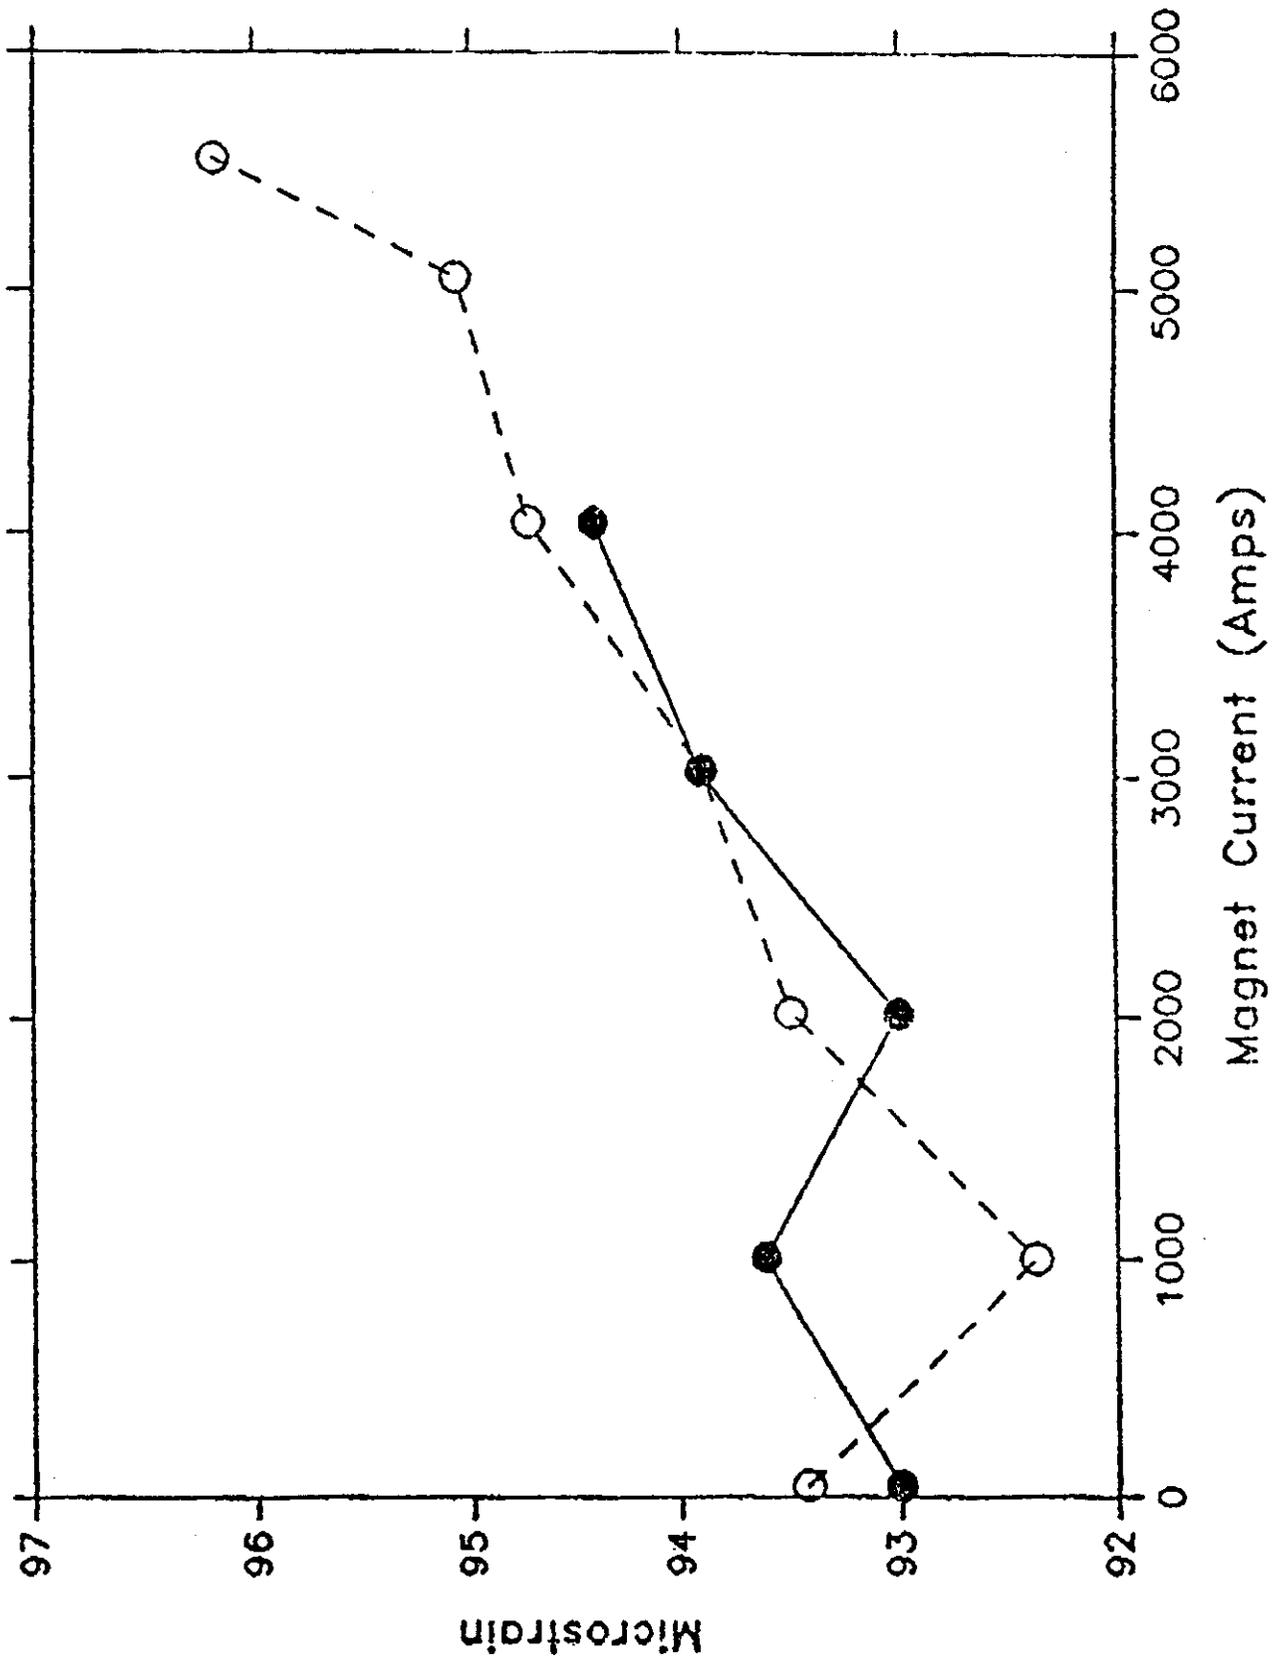
Fig. 2.II.E.2

# Lead End Motion

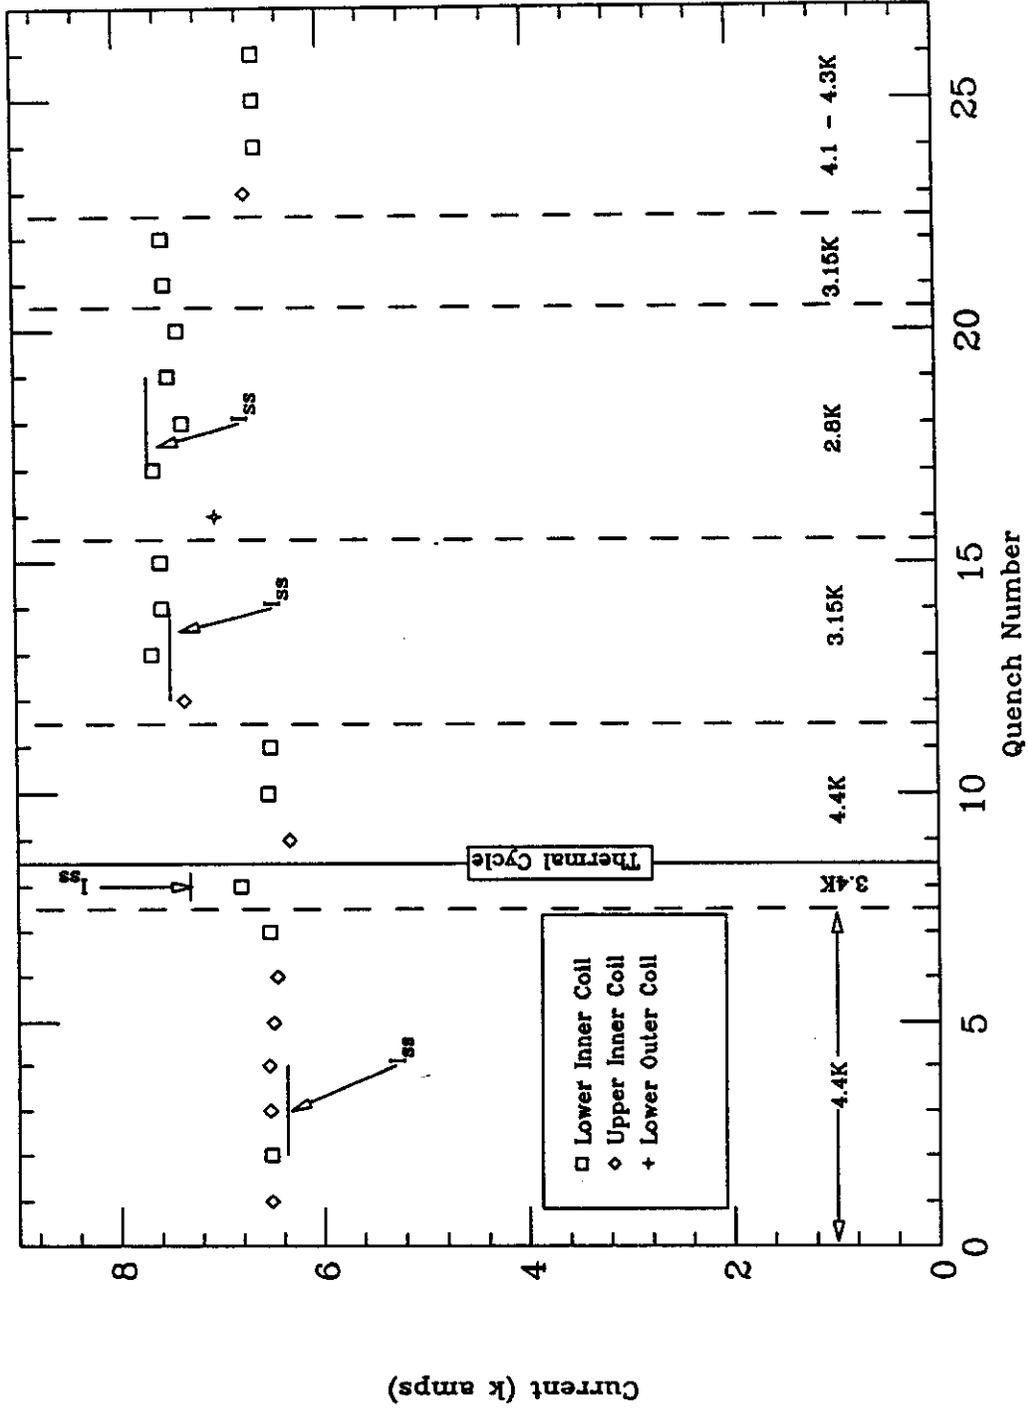
Fig. 2.III.A.1

DD12 Current at Quench

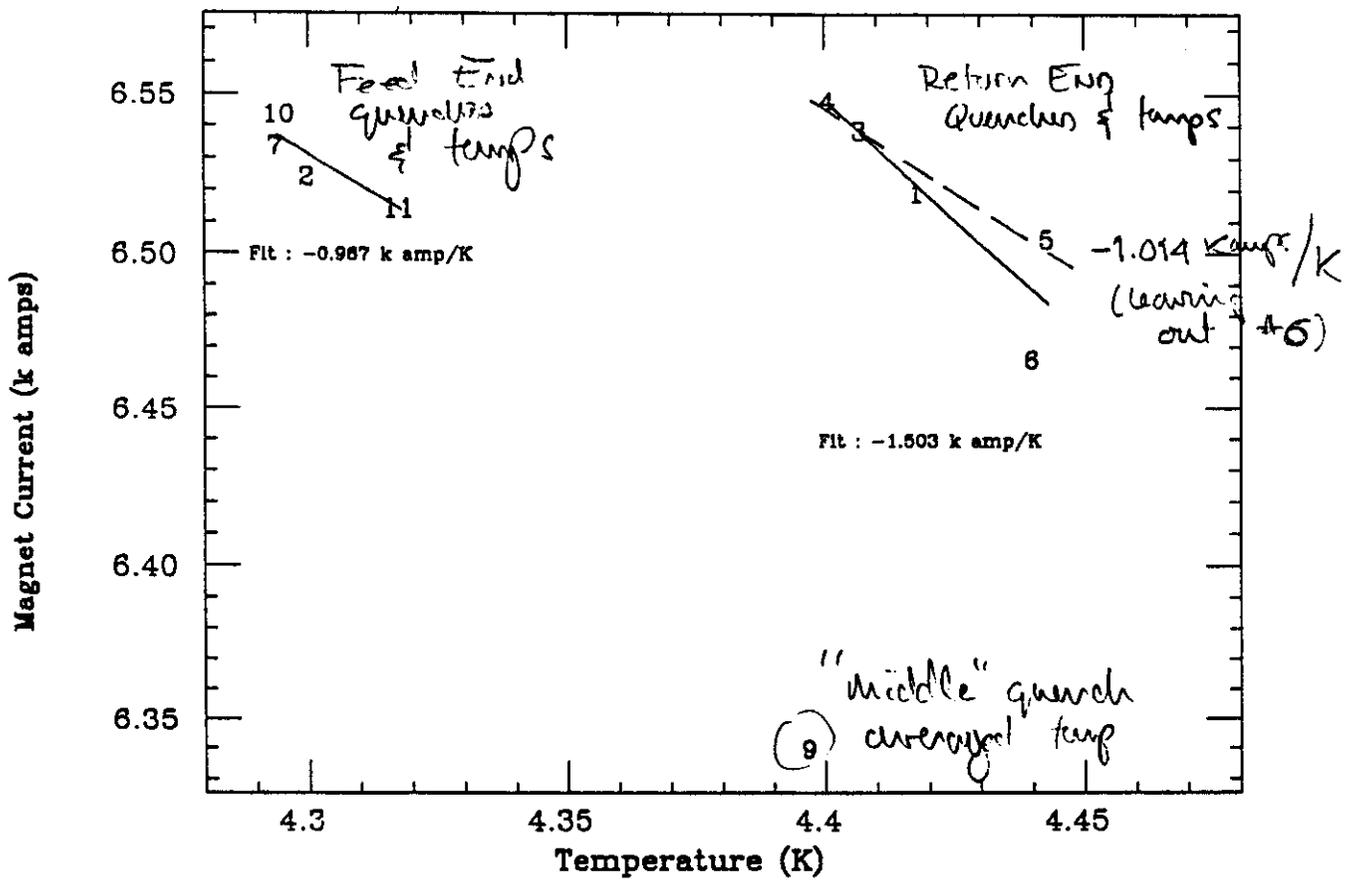
Fig. 2.III.A.2

### DD0012: Quench Current vs. Temperature

thermometers yields the expected linear relations between temperature and quench current, with scatter at the 10A level. The fits to the data are close to the value calculated with Morgan's parameterization, which lies in the range 1.06 - 1.09 kA/K at this temperature. (Two quenches do not fit this pattern. Quench 9 is a retraining quench after the thermal cycle. Quench 6 occurred after the magnet had been held at a fixed current for 15 sec prior to a spot heater quench, rather than during the usual 16A/sec ramp.) The highest quench current was 7675A (quench 13). The magnet was thermally cycled between quenches 8 and 9 in coincidence with a warmup for cleaning out the refrigerator purifiers.
