SSC Technical Note No. 80

SSC-N-590

CONSTRUCTION, TEST AND DISASSEMBLY OF 17 m SSC DIPOLE DD0012

February 18, 1989

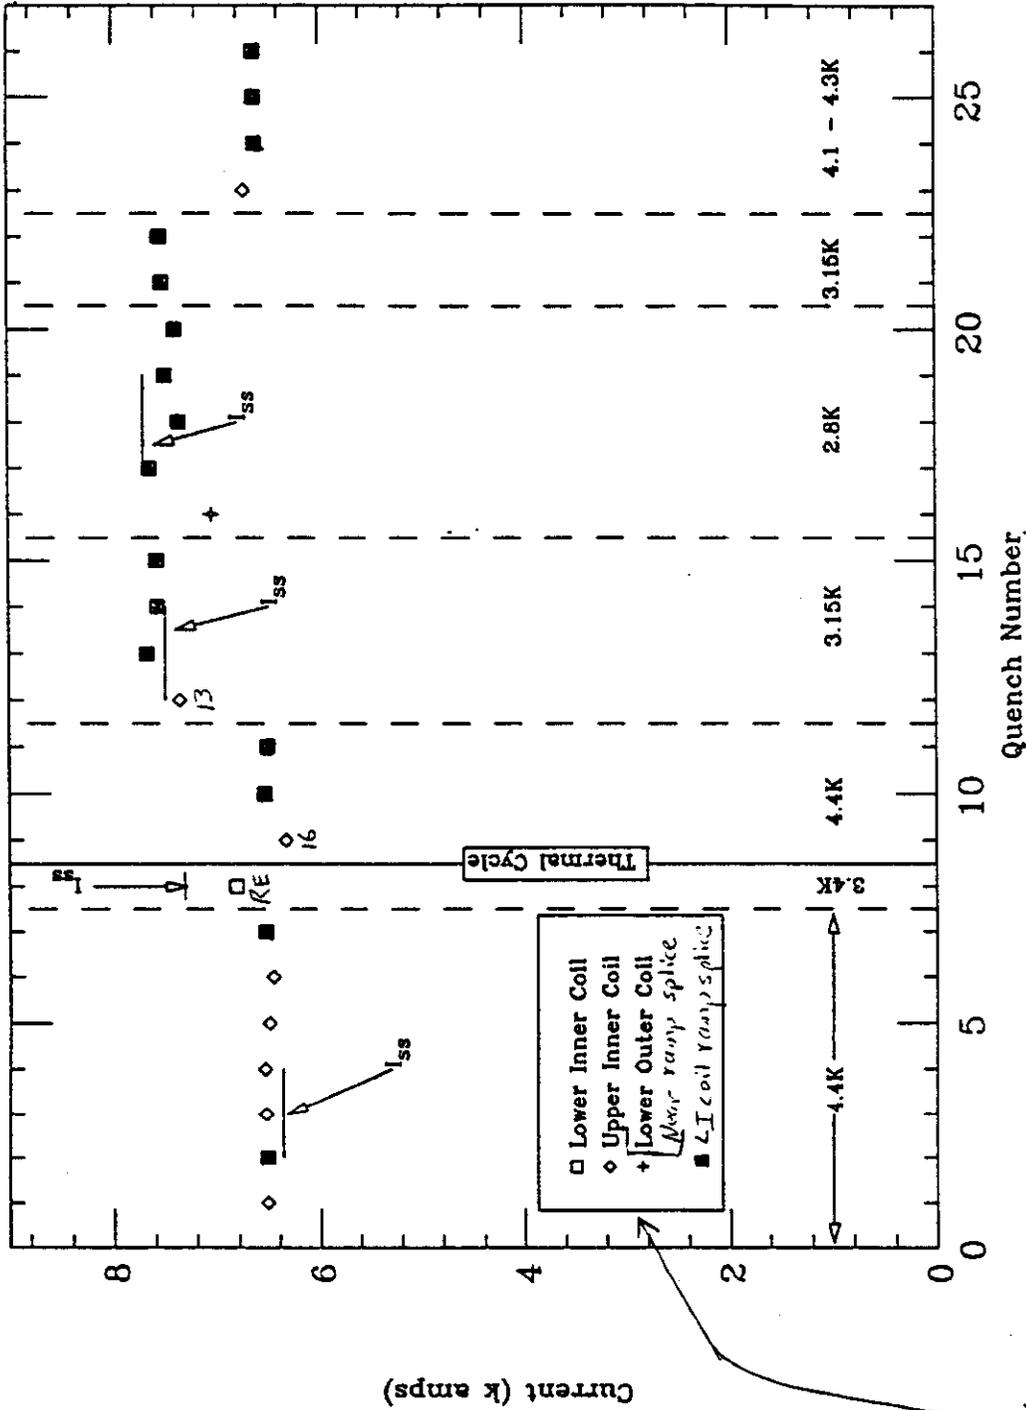
Fig. 2.III.B.1

DD12 Current at Quench and Quench Origin Summary

◇ Plateau quenches (UI coil, Return End, at voltage top)  $I_{ss}$  from SSC-N-519  
 ◇<sub>n</sub> - straight section quenches; n = turn number  
 RE - return end

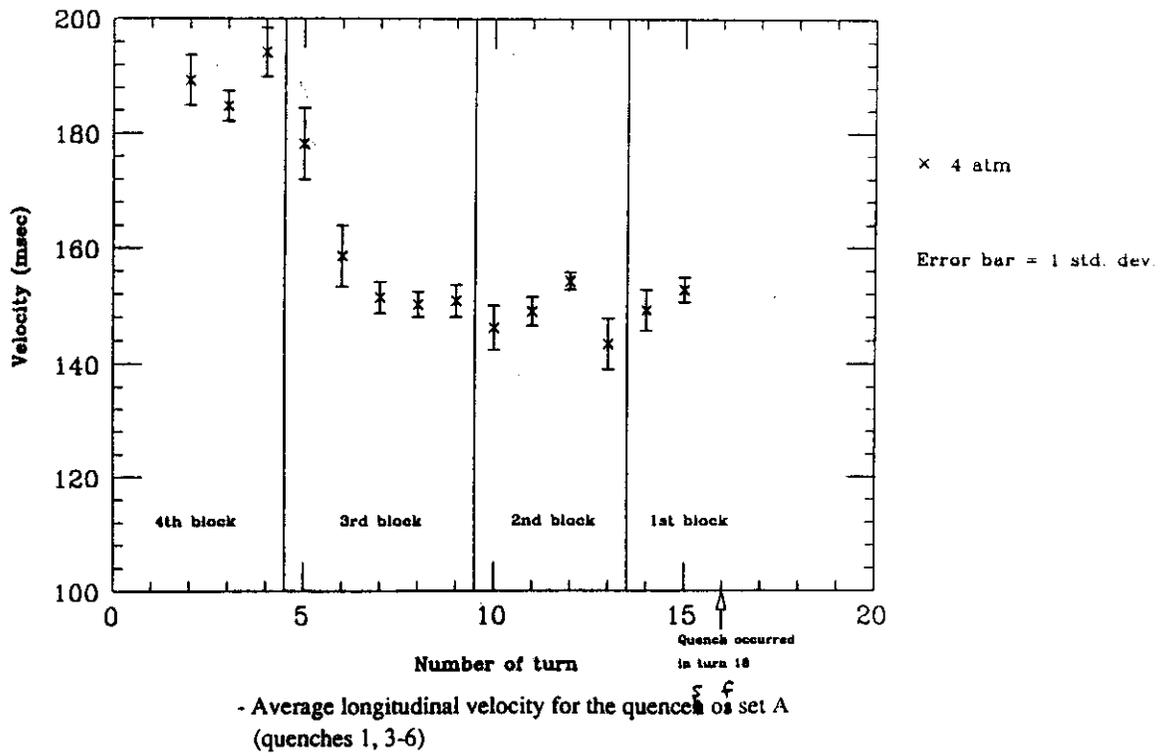
Fig. 2.III.C.1

### Longitudinal velocity vs. Number of turn

(DD0012 - Avg. velocity for quenches 1,3-6)

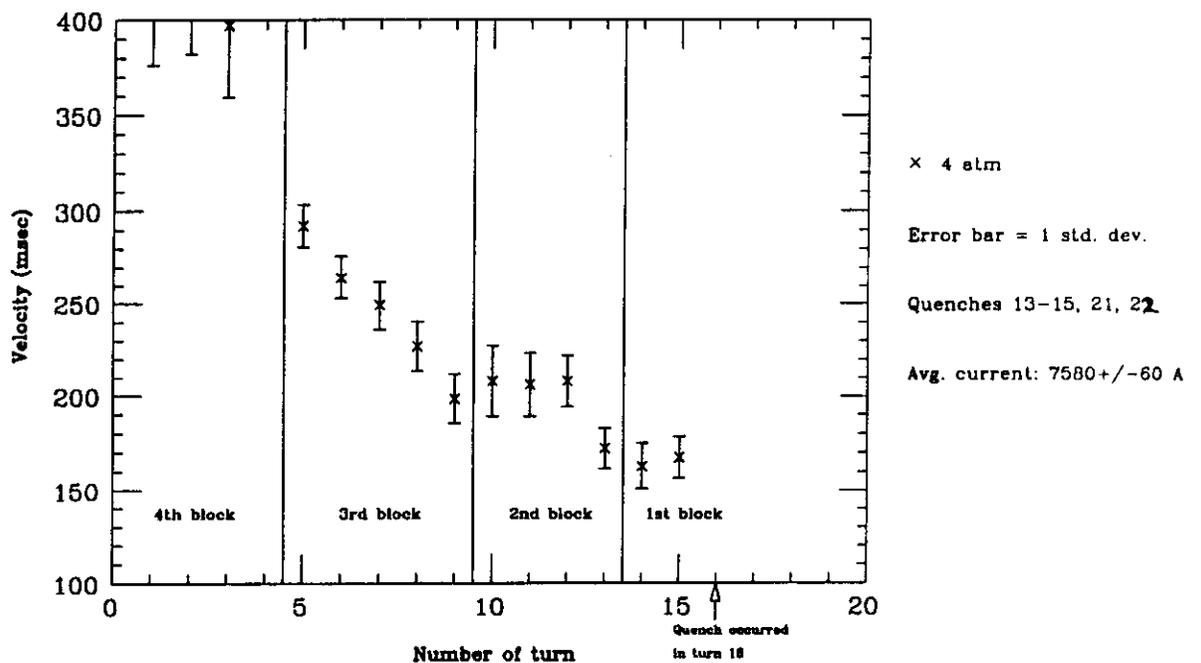
Fig. 2.III.C.2  
Average longitudinal quench propagation velocity for the five ramp splice quenches at 3 K.

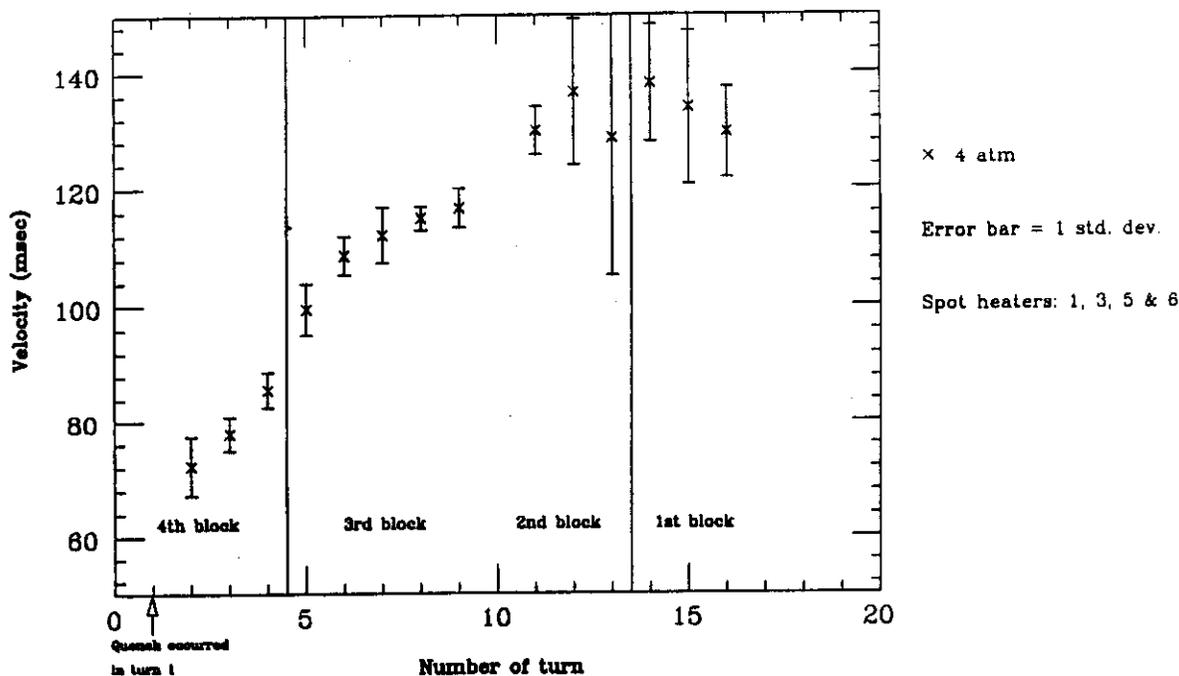
Fig. 2.III.C.3

Average longitudinal velocity plot for each quench at 5753 A.

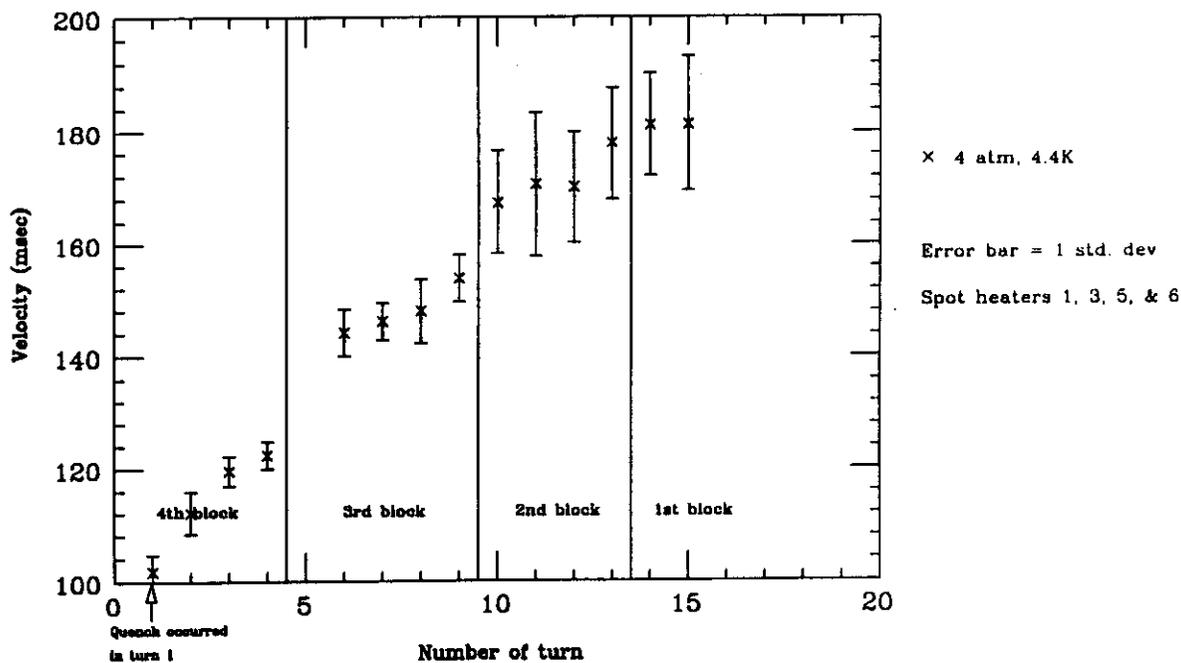
Fig. 2.III.C.4

Average longitudinal velocity plot for each quench at 6466 A.

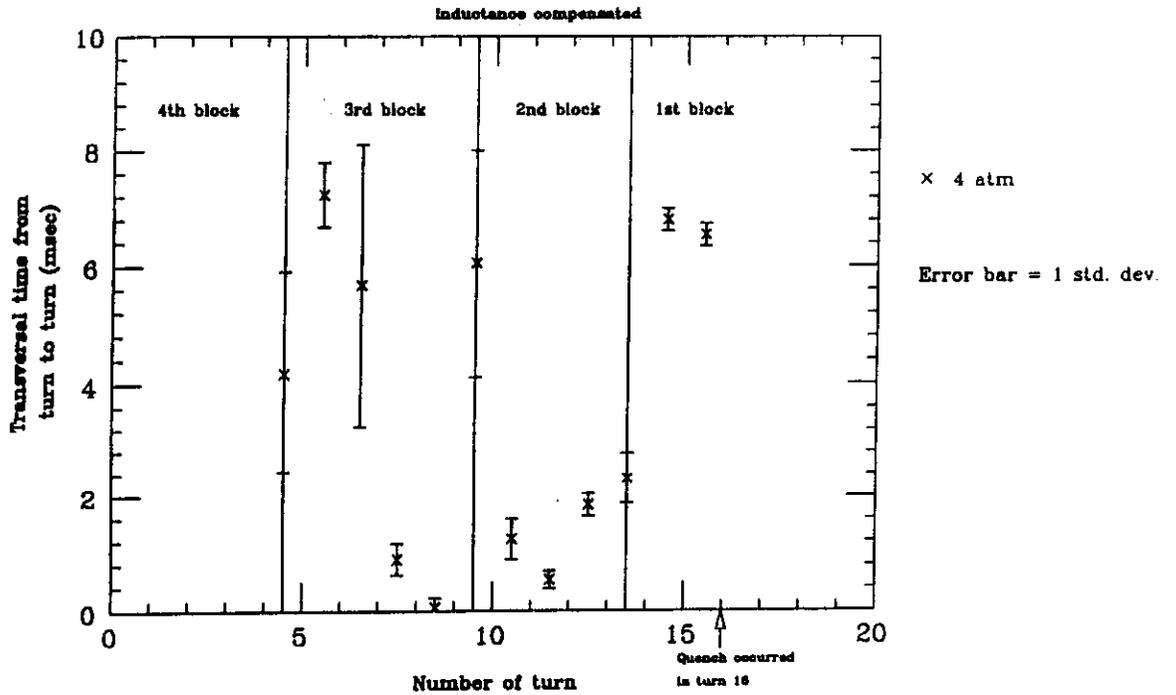
Fig. 2.III.C.5

Average transversal propagation time for all the quenches of Set A

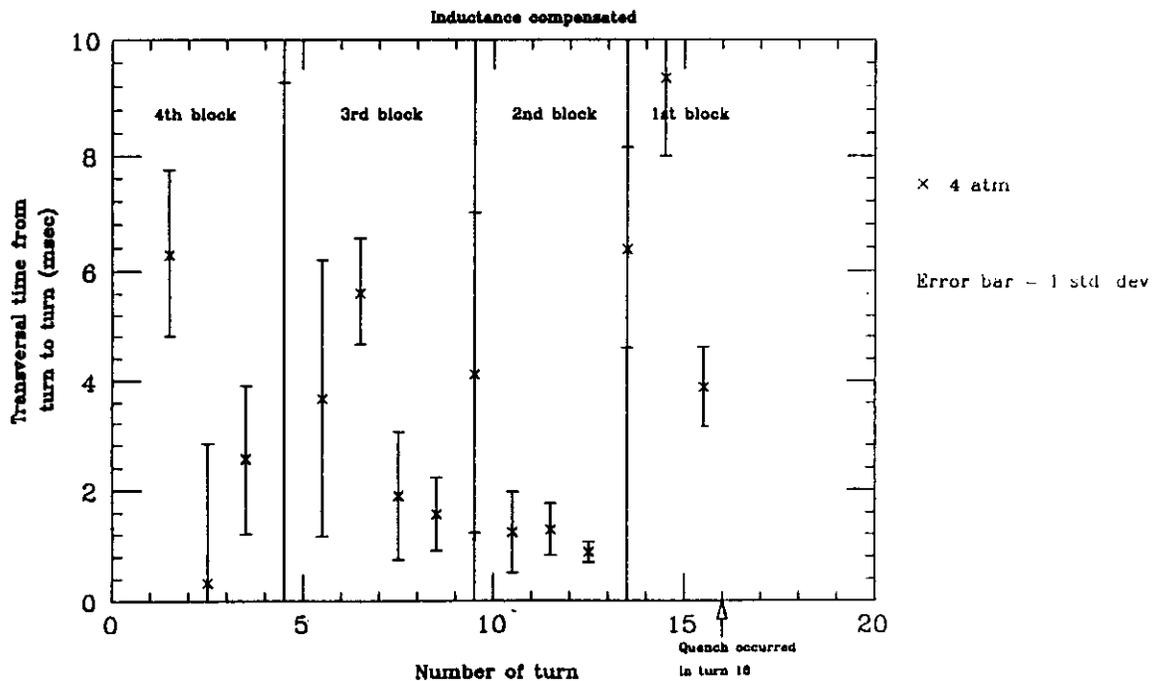
Fig. 2. III.C.6

Average transversal propagation time for all the quenches of Set B

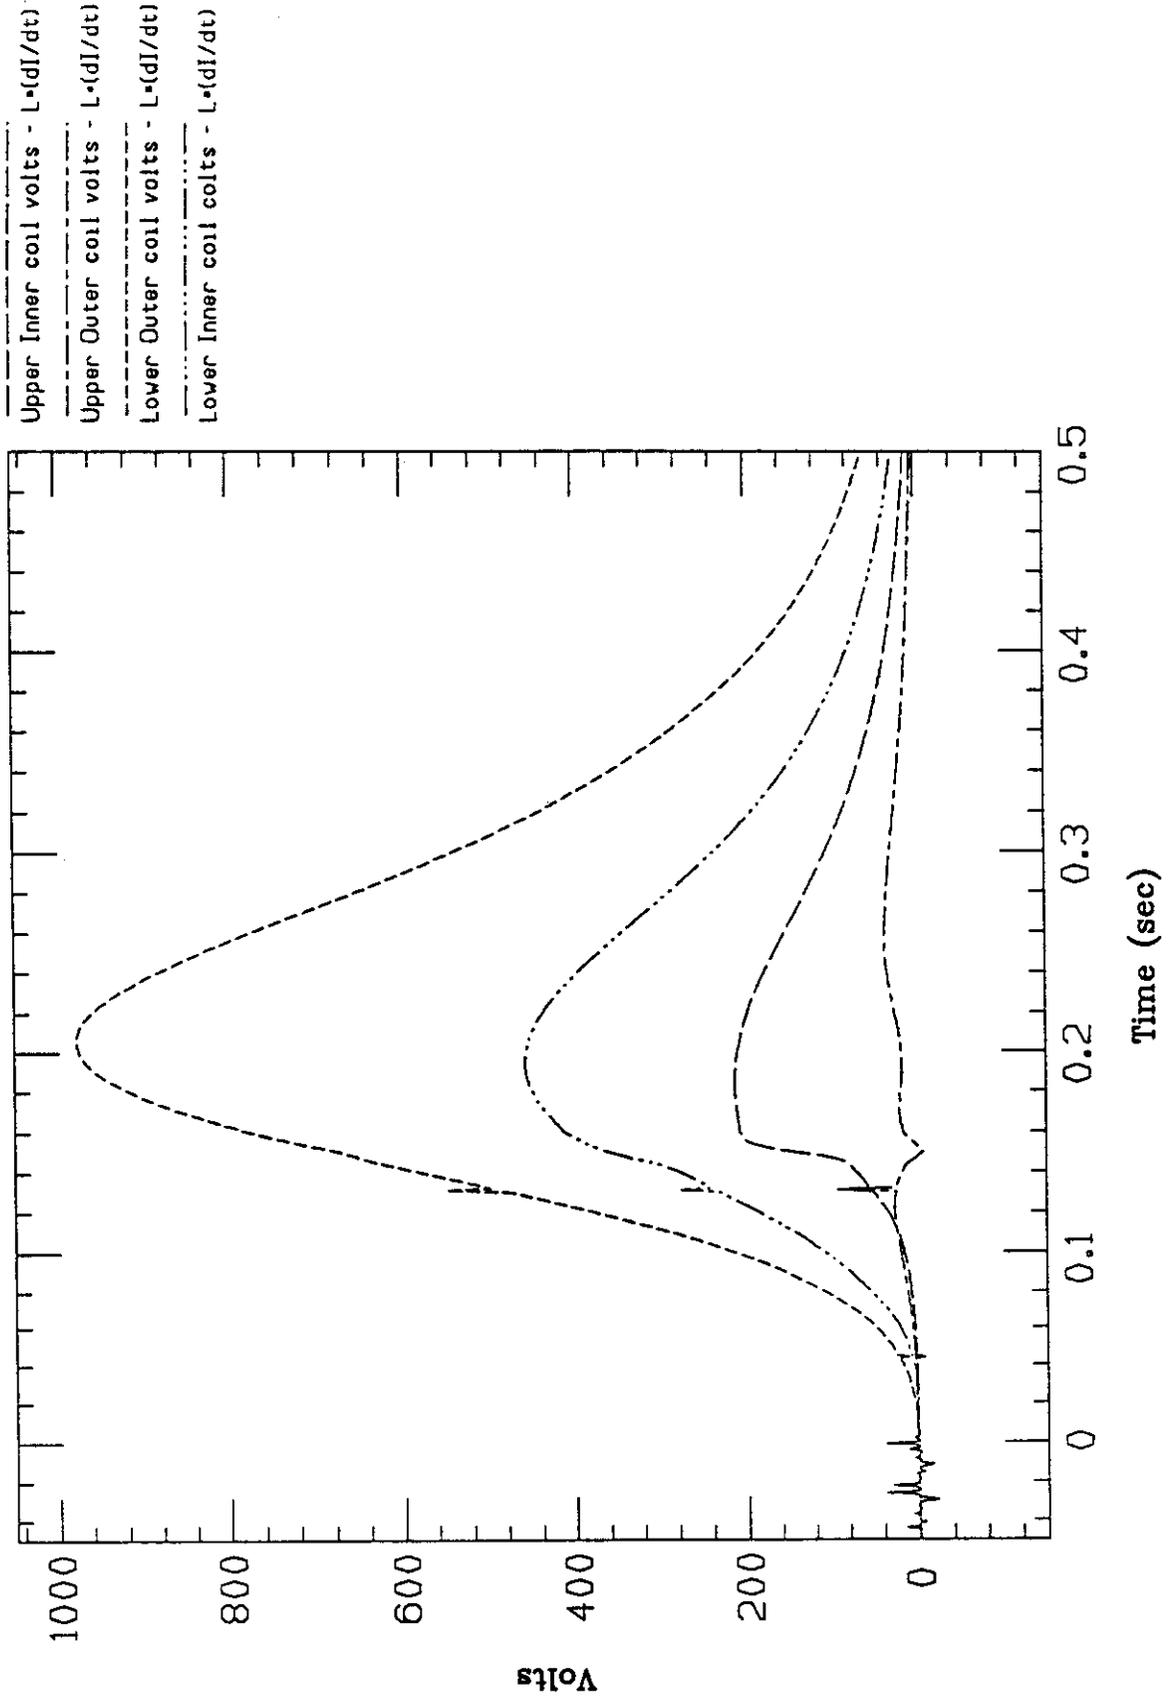
Fig. 2.V.A.1

### DD0012: Resistive Voltage - Quarter Coils

File : DD0012.QB082 Magnet : DD0012 - Quench Date : 24-JUN-88 - 06:02:14 Quench # 16  
S.C.# 1 I(quench) = 7050.6 (amps) MIITs = 10.055 TO = -0.014

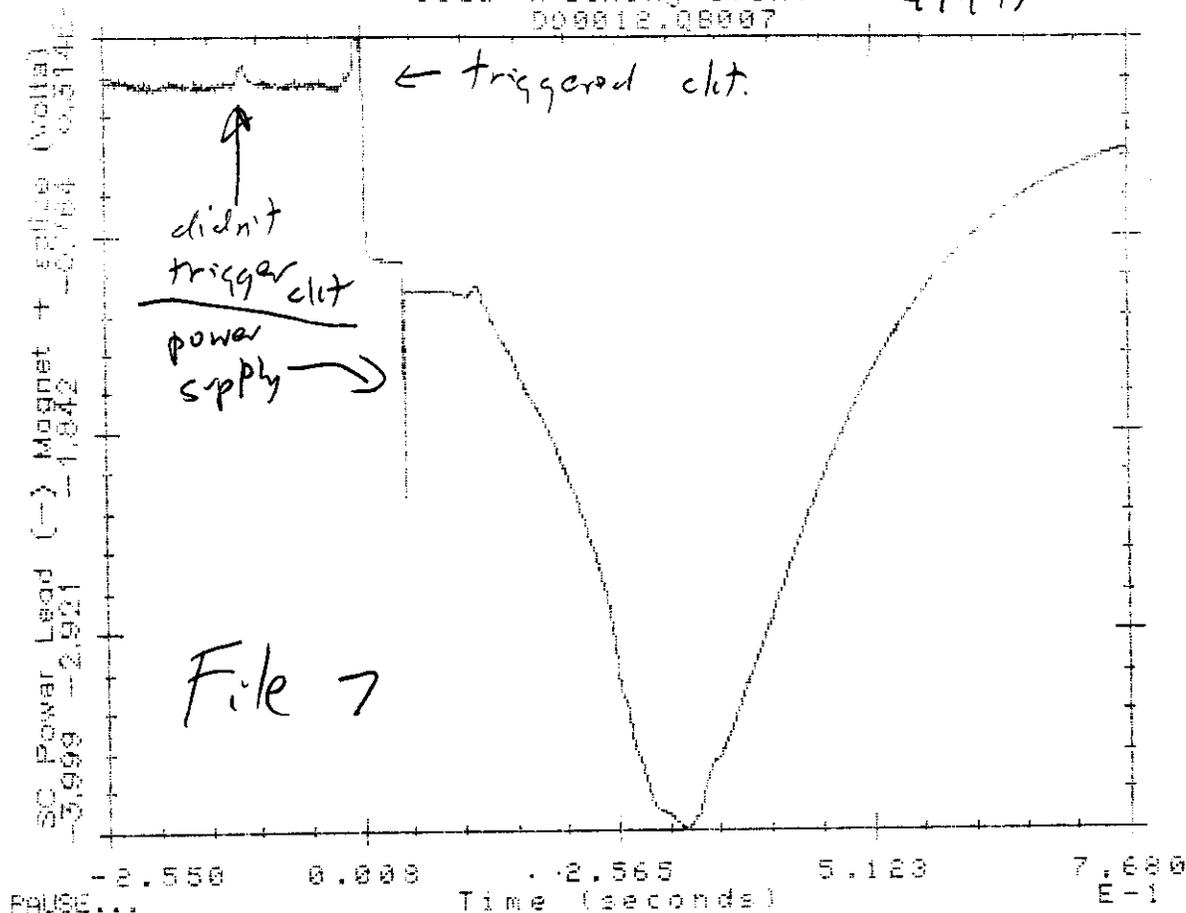
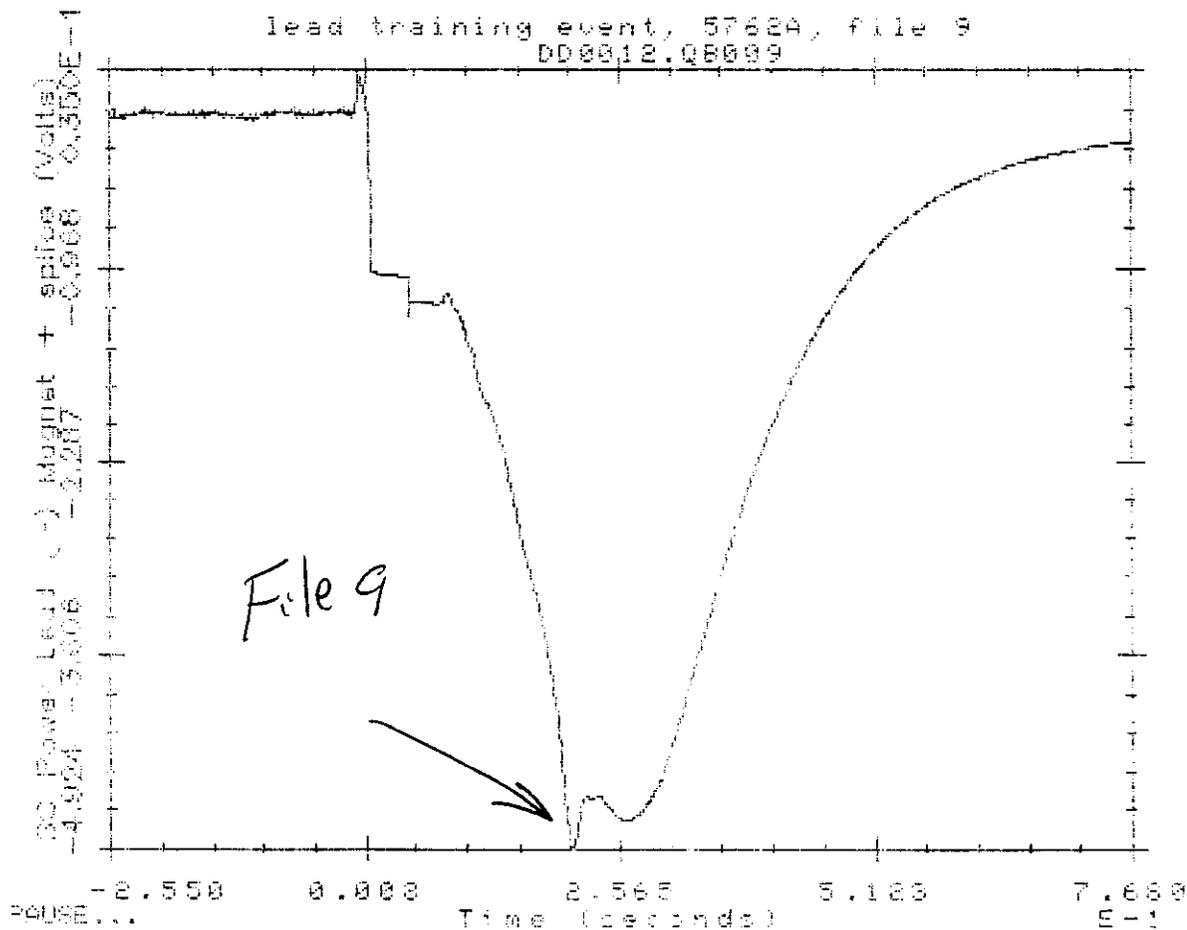
Voltage pulses which exceeded the lead quench detection threshold and which originated in the buss occurred four times before the first spontaneous quench of the magnet and twice after that. Two examples are given in Fig. 2.V.C.1. The

example from file 7 also contains a smaller pulse about 100 ms before the trigger. Since the pulse occurs before the event, it was concluded that the voltage was due to conductor motion in the field (or something similar) and not to a quench (which would produce a monotonically increasing voltage on the scale displayed here).

The plot for file 9 shows another pulse about 200 ms after the trigger. These pulses could be generated if the lead relaxed all or part of the way as the field decreased.
