Eddy Current Inspection of Superconducting Cable During Manufacturing

D. A. Bein, J. Zbasnik,
S. Graham, and R. Scanlan

March 1992

*Presented at the International Industrial Symposium on the Super Collider, New Orleans,
March 4-6, 1992.

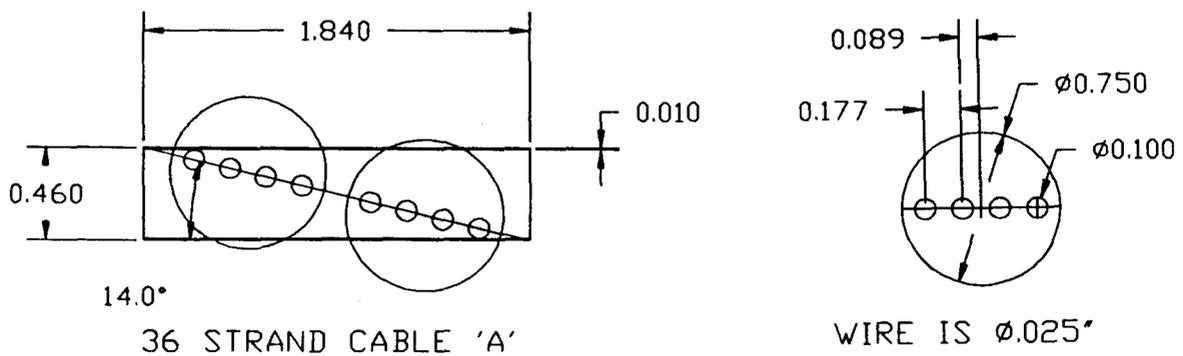
Figure 1. Eddy current probe diagram.

We modified the probes used in the previous LBL experiment to allow complete coverage of a single strand. Referring to Figure 1, each probe element was 2.5 mm in diameter, and there were four elements in each probe. We aligned the probe elements parallel with the pitch of the strand, to improve signal to noise ratio, within each of the probe holders.

The probe elements were wired in series and then the probes were wired in a differential fashion.

This bridge configuration allowed us to inspect an entire strand, and if there was some difference in the signal seen by either of the probes an output occurred across the bridge indicating some type of defect. This configuration was used for both the top and the bottom set of probes. The probe holders were made out of Delrin with a shallow recess made for the cable to run through. In addition there were thru holes for the probes to be mounted in, with a pair of tapped holes drilled perpendicular to these thru holes for screws to hold the probes at a fixed stand off. We used a probe stand off distance of 0.1 mm which gave us an adequate signal to noise ratio, but left us with acceptable sensitivity.

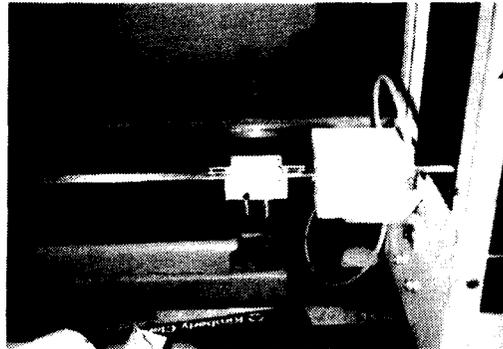
Figure 4. Probe arrangement between turk's head and caterpillar.

We then moved the transducer banks between the turks head and the caterpillar. The tension in this region was very constant, of the order of 200 pounds, which resulted in a very steady Eddy current background signal. The set-up, with staggered probe position, is shown in Figure 4.

The probes were initially arranged this way without the proper mechanical fixturing, but with the transducer holders "riding" on the oscillating cable they performed surprisingly well. The holders were not held by any rigid fixture, but only supported by the cable itself, and constrained to move with any oscillation of the cable. In this orientation we began to obtain a low - noise signal output, and it became evident that cold welds also could be detected.

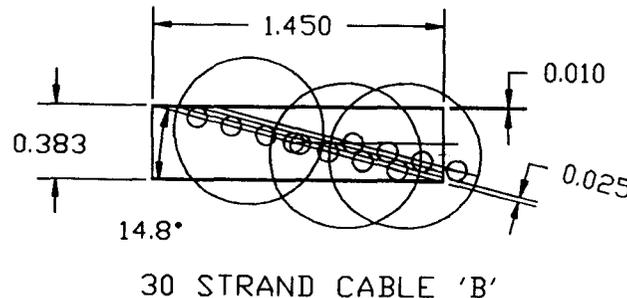
Figure 5. Orientation of Eddy current probes for inspection of 40mm cable

40mm Outer Cable Experiments. This cable run was for LBL quads, and it had no cold welds. The geometry of the orientation of the transducers is shown in Figure 5.

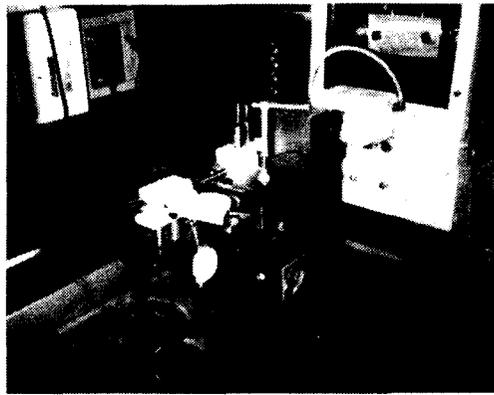
Figure 6. New probe locating fixture.

Our earlier run showed that the optimum position to locate the transducers was upstream of the caterpillar, and we built a simple rigid fixture to accomplish this. The arrangement is shown in the following photograph, Figure 6.

Again the probes were mounted in the carriers that were free to “ride” on the cable. The same stand off distance was used , 0.1 mm. And the probes were wired in the same fashion as in the first run.

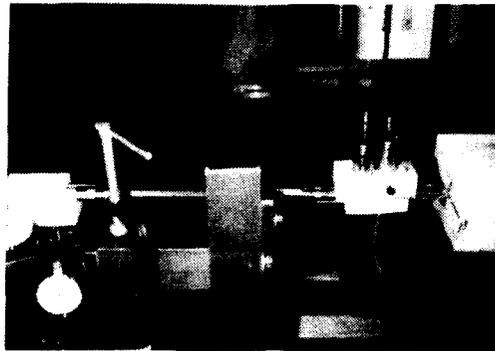
Figure 7. Final probe location.

The original positioning of the transducers again had to be modified as shown in the Figure 7.

As is shown the bottom transducer was situated in front of the mounting bar and the top transducer was situated riding against the back of the mounting bar. This seemed to give us an acceptable signal to noise ratio, and a uniform background signal. The mechanical fixturing still seems to be lacking, in that occasionally the cable seems to stick in the transducer holders causing an anomalous signal. In this run we were able to detect very small surface defects, such as scratches, and small galls in the strand of the cable of the order of the diameter of the individual probes themselves, which are 2.5mm in diameter, which the cognisant LBL personnel present asserted that these were insignificant flaws. This clearly demonstrated the sensitivity of the probes to even small defects. Further tests are needed to set the detection threshold levels to prevent false alarms from being generated by these small, allowable defects. After the cable run was complete there was a sufficient amount of strand left over to make some intentionally defective cable.

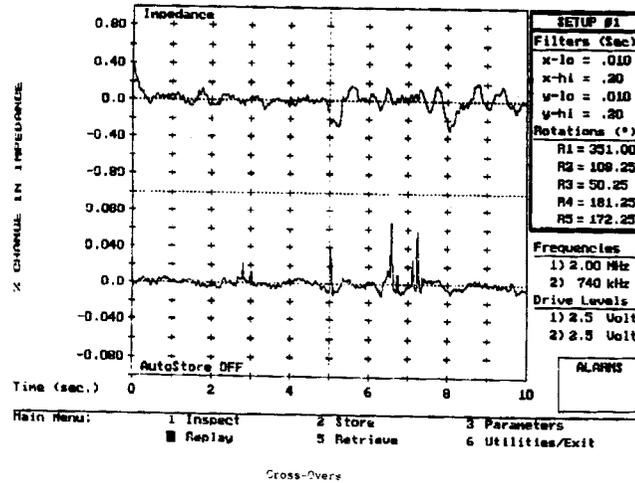
Figure 10. Trace indicating cross-over.

These were then inspected and clear indications were detected using the smart EDDY 3.0 system, and our specialized probes. The output signal traces associated with the cross-overs, and cold welds, shown in Figures 10, and 11, respectively.

The Eddy current system, and probes proved useful for inspection of the superconducting cable during manufacturing. The instrument, and probes clearly showed that the detection of cross-overs could be made with a signal to noise ratio of 4:1. While the cold weld indications occurred with a signal to noise ratio of the order of 2:1, we need to improve this signal to noise ratio for reproducibility, and reliability of cold weld detection. The results suggest that we can implement the cross-over detection because of both: the satisfactory signal to noise ratio for these defects, as well as, their cause of degradation of the mechanical integrity of the cable. Our future work will entail first optimization of the mechanical fixturing. Then working on better cold weld detection. And finally work on edge detection should be soon to follow.
