Addendum I

**Experiment Utilizing AC Magnetic  
Field Pick-up Coil to Probe  
Short Faulted DCO302**

TS-SSC90-100  
December 5, 1990  
Richard E. Sims

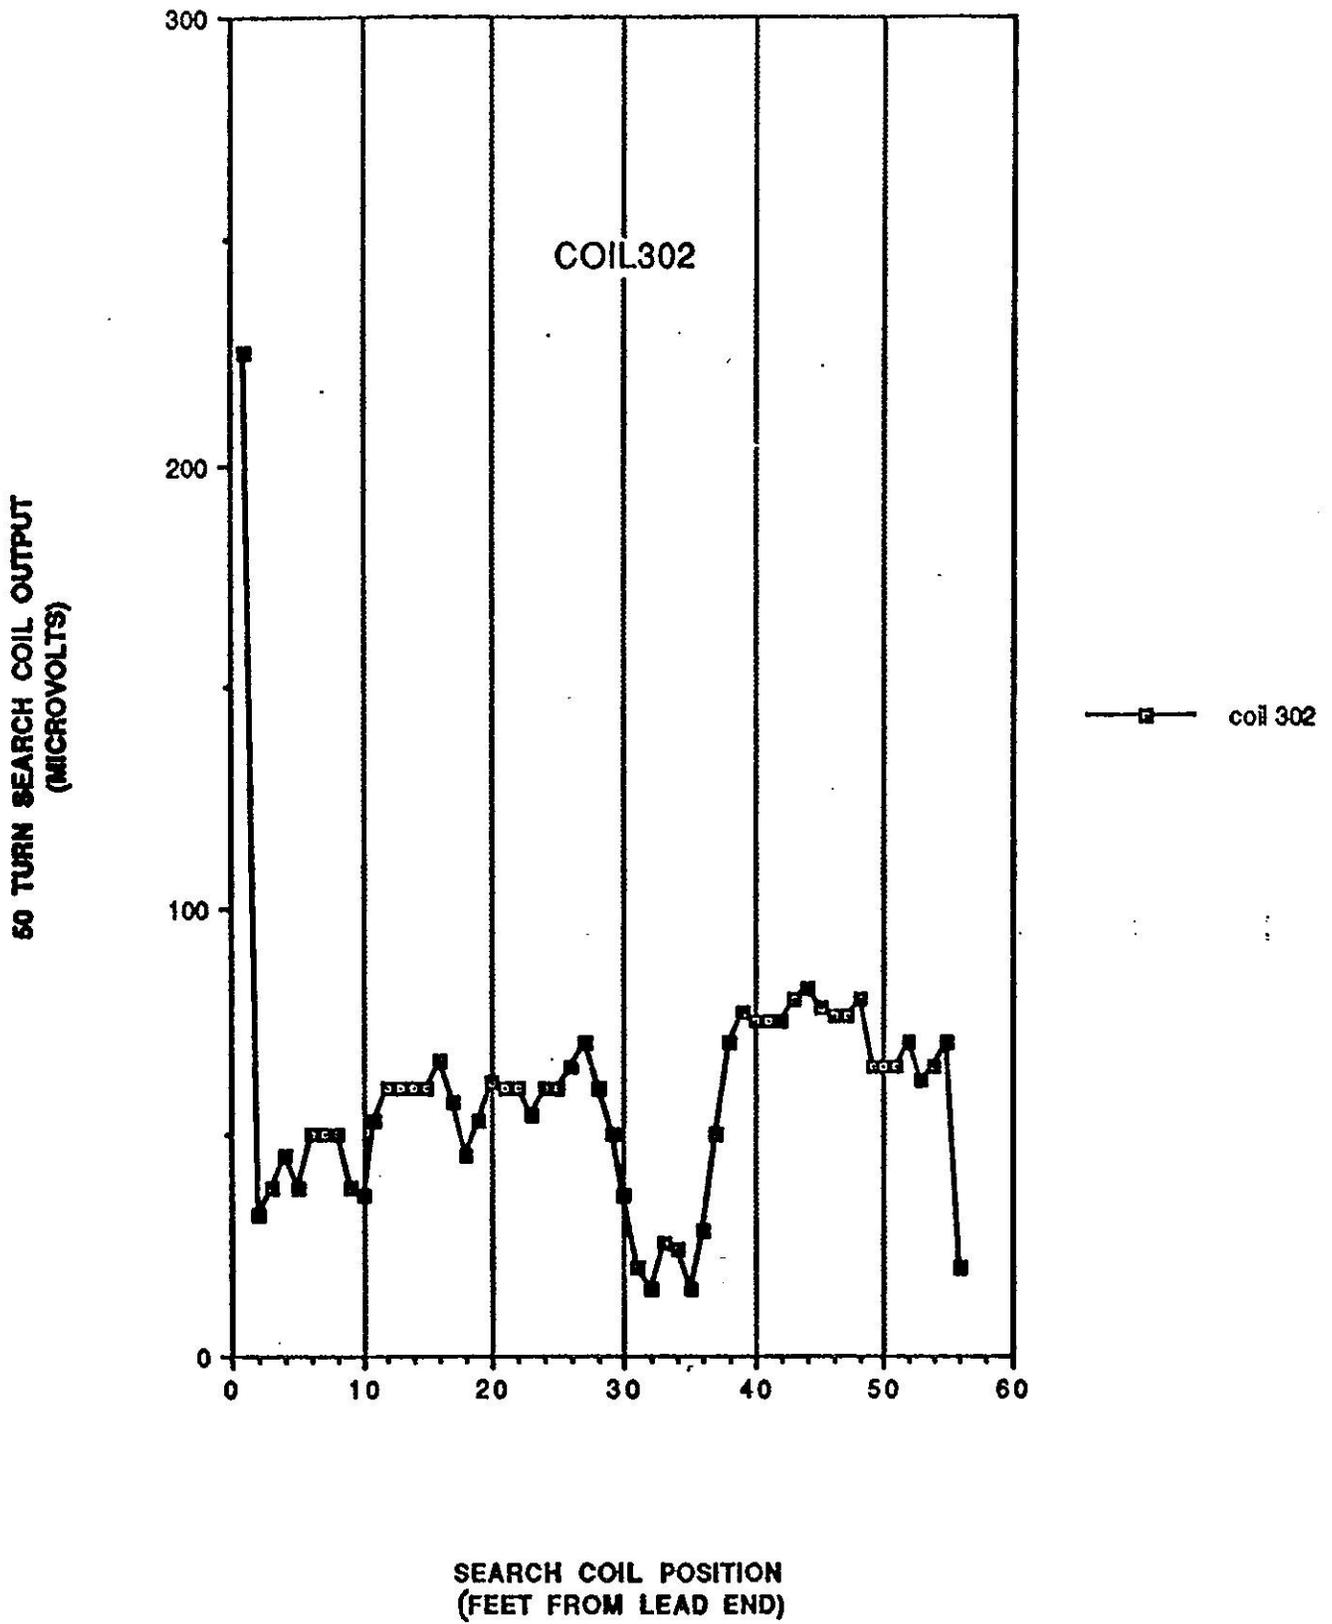
FIGURE 1

This 50 turn coil was again pulled through DCO302 while attached to the same oscilloscope set-up. Although the effect was reduced, the probe was still very sensitive to rotation inside the coil. The scan of the coil was performed despite the rotational sensitivity but every effort was made to pull the probe through without twisting or rotating the probe cable. The results are shown in Figure 1. Note the "W" shaped dip between 27 feet and 39 feet as measured from the mouth of the lead-end beam tube.

HORIZONTAL MAGNETIC FIELD INSIDE BEAM  
TUBE OF LONG COIL WITH 1KHZ APPLIED  
TO TOTAL COIL

It was later found that coil 302 was heavily shorted at a single small spot between upper and lower inner coils and upper and lower outer coils at a location very close to the lead end (approximately 18" from turn-around). The difference between the 302 scan and the 303 scan shows 302 decreasing rapidly in the first foot of measurement and 303 increasing rapidly in the same area. Because there were only two sample coils and 303 was not yoked at the time, no conclusions are drawn. A future scan of 303 is planned after it is yoked to better compare a known shorted coil to a known good coil (303), while both are in the yoked stage.

The "W" pattern in 302 may be from the slightly magnetic stainless steel shim material that was used in the strain gauge pack at 36 feet. The same is probably true of the smaller dip at 18 feet.

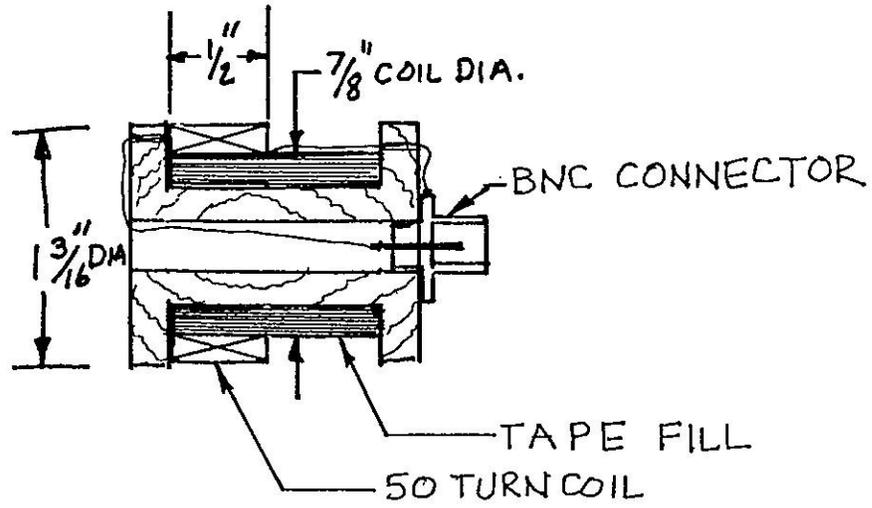
The first attempt was made with a 50 turn coil wound on a 1 3/16" diameter wooden bobbin. The coil was approximately 7/8 inch in diameter and approximately 1/2 inch wide. The ends of the coil were attached to a standard BNC female connector which was screwed into the center hole of the wooden bobbin. A 50 ohm cable which was marked every foot was used to pull the bobbin from the "return end" of the coil toward the lead end. A signal generator set to 1 kHz was connected to DSC302 with the coil connected in the normal manner to produce a vertical field. Approximately 13 volts rms thru 50 ohms was applied to the leads.

FIRST COIL CROSS SECTION

The output of the probe coil was connected to a Tektronix 7603 oscilloscope with a 7A22 vertical amplifier section. As the probe coil was pulled through the DCO302 coil, several peaks and valleys were noted on the oscilloscope; however, it was also noted that rotating the probe by twisting the cable also produced large variations in pick-up voltage. This was thought to be caused by the loop formed by the start and finish leads of the probe coil as they were routed to the BNC connector.

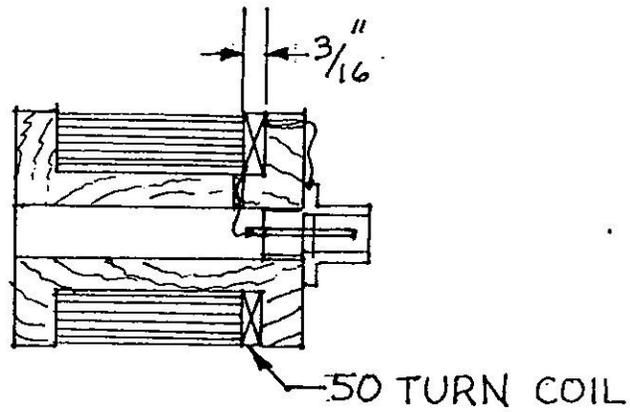
A new probe was built which was only 3/16 inch wide and the start and finish leads were routed with very short leads to the BNC connector.

SECOND COIL CROSS SECTION
