#### Location of turn-to-turn short in DCA318

#### SUMMARY

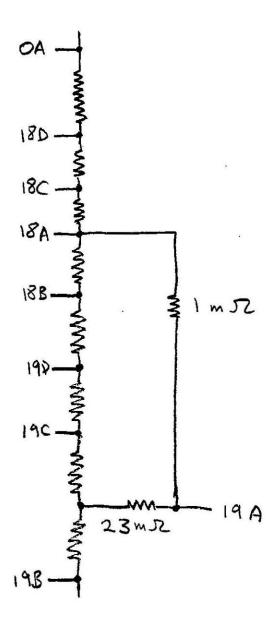
Figure 1

A turn-to-turn short has developed in the upper inner coil of DCA318 (coil 15M-50-1017) during installation of the lead end clamp. Voltage tap measurements were taken to try to locate the short. A voltage of 1.002 V was placed across the offending coil and the voltages relative to tap 19B (at the inner-outer splice) were measured at taps 19A through 17D. The data are displayed in Table I in the column labeled "V (mV)." The voltage at tap 19A is expected to be about 0.5 mV, yet it is measured to be 17 mV, almost equal to the voltage one turn away. This leads us to suspect that the short may be related to damage to tap 19A or an incorrect installation of it. A possible circuit that would explain the observed pattern of voltages is shown in Figure 1. In the analysis below the voltage at this tap is ignored, however.

Unfortunately this contradicts the picture in Figure 1, which was based on the fact that tap 19A shows a voltage close to that at 18A. Tap 19A is 0.75 inches from 18A in the opposite direction from 18B. That is, the resistance measurements, ignoring 19A, indicate that the short is 3.3+/-1.0 inches from tap 19A, while the value of the voltage at 19A can "only" be explained if the short is at 19A. The location determined ignoring 19A is the more likely, however, because the short appeared when the end clamp was being installed. The collared portion of the coil ends 1.8 inches from 18A towards the coil end. The short location from the resistance measurements is therefore 0.7+/-1.0 inches into the end clamp, but 19A is 2.5 inches into the collared portion.

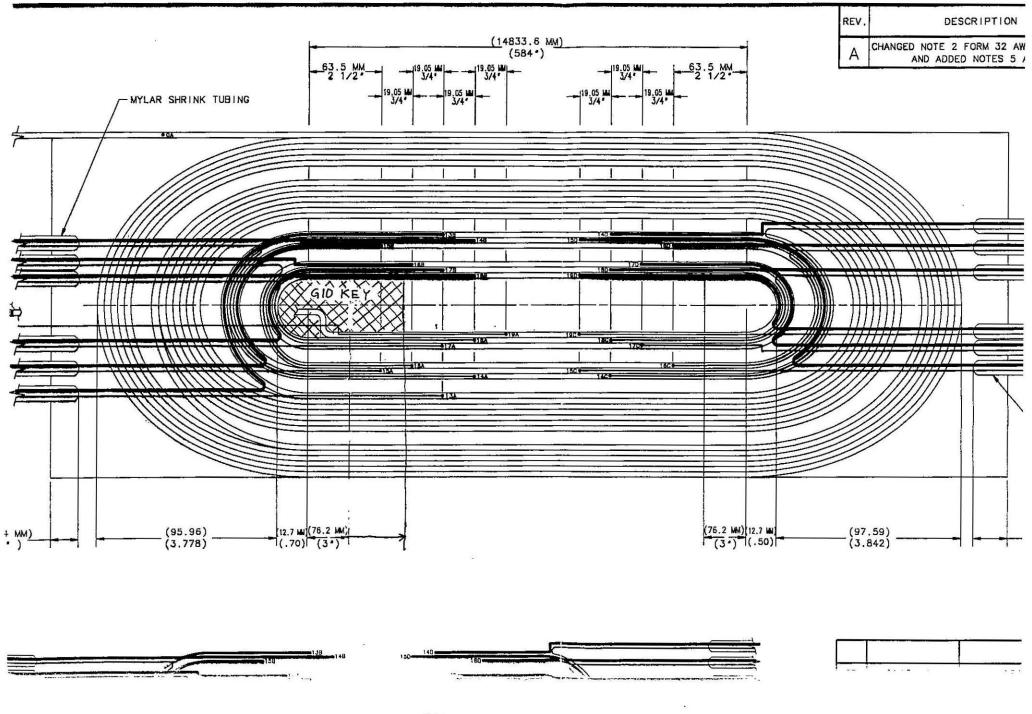
Figure 2

The length of cable corresponding to each voltage tap segment was determined from the voltage tap installation drawing, a portion of which is attaced as Figure 2. The length of the end segment, from the end of the straight section on one side to the beginning of the straight section on the other side was measured to be about 1.8 inches for turn 18. This value was applied to all three turns in Table I, although there is an estimated 0.2 inch difference from one turn to the next. The distance from tab 19A to 19B was set to 10 inches in the Table as a pure guess. (This length does not enter into the determination of the short location.)

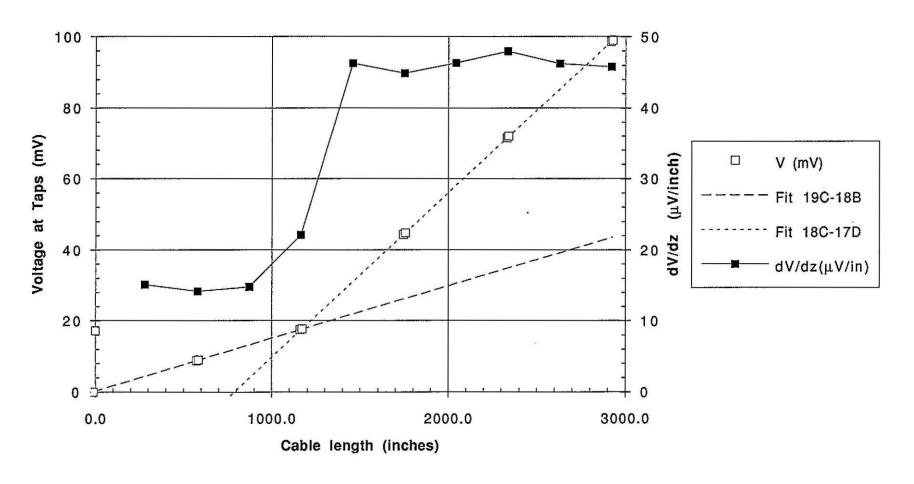
to adjacent pairs. Between taps 18A and 18B the derivative changes by about a factor of three. The lower derivative between 18A and 19B results from the fact that about 2/3 of the current is flowing through the short and only 1/3 through the coil. Because the derivative in the 18A-18B segment is intermediate between that in the segments on either side, the short must be within that segment. Figure 3 is a plot of the voltage and derivative data versus length along the cable. Shown also are two linear least squares fits done to the data on either side of the short. In order not to bias the determination as to which side of tap 18A the short is located, the data from tap 18A has not been used in either fit. The voltages at each tap predicted by the two fits are shown in Table I. In the region of each fit, the measured values deviate from the fit by at most 0.02 mV. Although 18A was not included in the fit, it lies "perfectly" on the fit done to 18C-17D.

### DCA318 Voltage Tap Data (after turn-to-turn short appeared)

At the location of the short the slope dV/dz changes; therefore the location can be determined from the intersection of the two fit lines. The data and the fits in Figure 3 are plotted on an expanded scale around the intersection point in Figure 4. Note again that tap 18A is NOT included in the fit. The lines intersect at z = 1168.3 inches, which is 2.5 inches from tap 18A towards tap 18B. Two main factors enter into the uncertainty in this estimate: the knowledge of the cable length between the end taps and noise in the voltage readings. The uncertainty in the cable length at the ends is on the order of +/-0.25 inch, which gives rise to an uncertainty in the short location relative to tap 18A of about +/-0.1 inch. Both from the deviations of the measured voltages from the fits and from observed fluctuations in the voltmeter readings, the estimated uncertainty in the voltages is around +/-0.02 mV. The location of the intersection point is most sensitive to the data Varying the voltages at 18B, 18C and 18D by +/-0.02 mV points nearest to it. gives rise an uncertainty in the location of the short of +/-1.5 inches, where the contributions from the three taps have been added linearly. Since the short is clearly between taps 18A and 18B, the data from 18A can be included in the fit with those from 18C-17D. This does not change the estimate of the short location, but it does reduce the uncertainty to +/-1.0 inch. Thus the location of the short is determined to be 2.5+/-1.0 inches from tap 18A towards 18B.

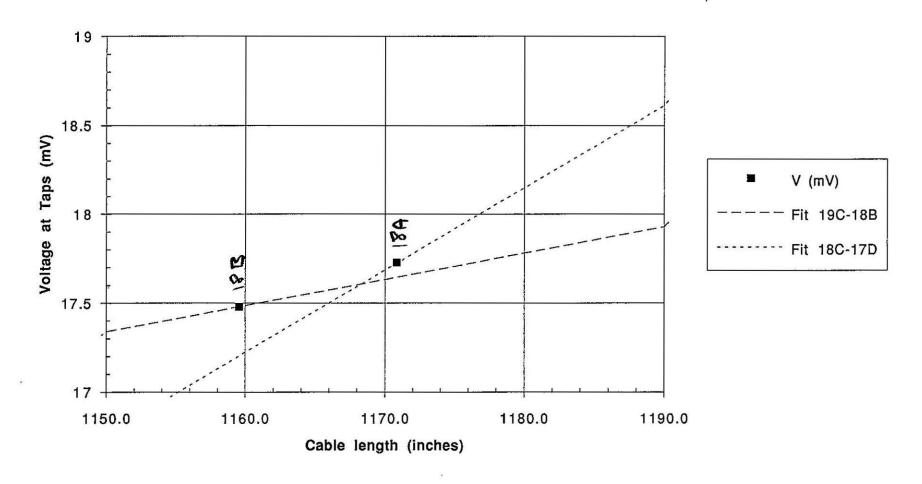
Figure 4

## DCA318 Voltage Tap Data (after turn-to-turn short appeared)

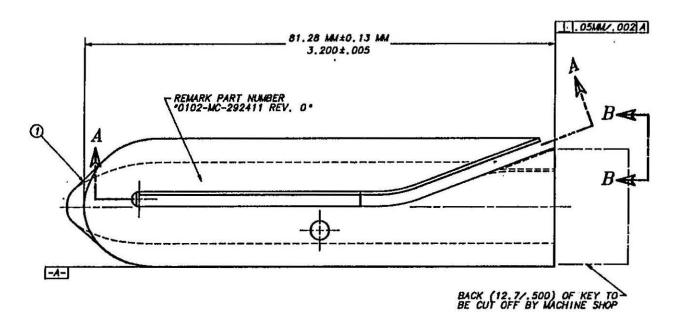
# Figure 5

The short location is near the point where turn 19 moves away from turn 18 and into the inner-outer splice preform. This takes place 0.5 inches into the lead end key (Figure 5) or 2.25 inches from tap 18A. This limits the possible short location to between 1.5 and 2.3 inches from 18A towards 18B.

SSC 50mm DIPOLE COLD MASS INNER COIL ASSEMBLY MODIFIED LEAD END KEY- G-10
