FERMILAB-TM-1885

Detecting Thrust Bearing Failure within a Screw Compressor

Carl Pallaver

May 1994

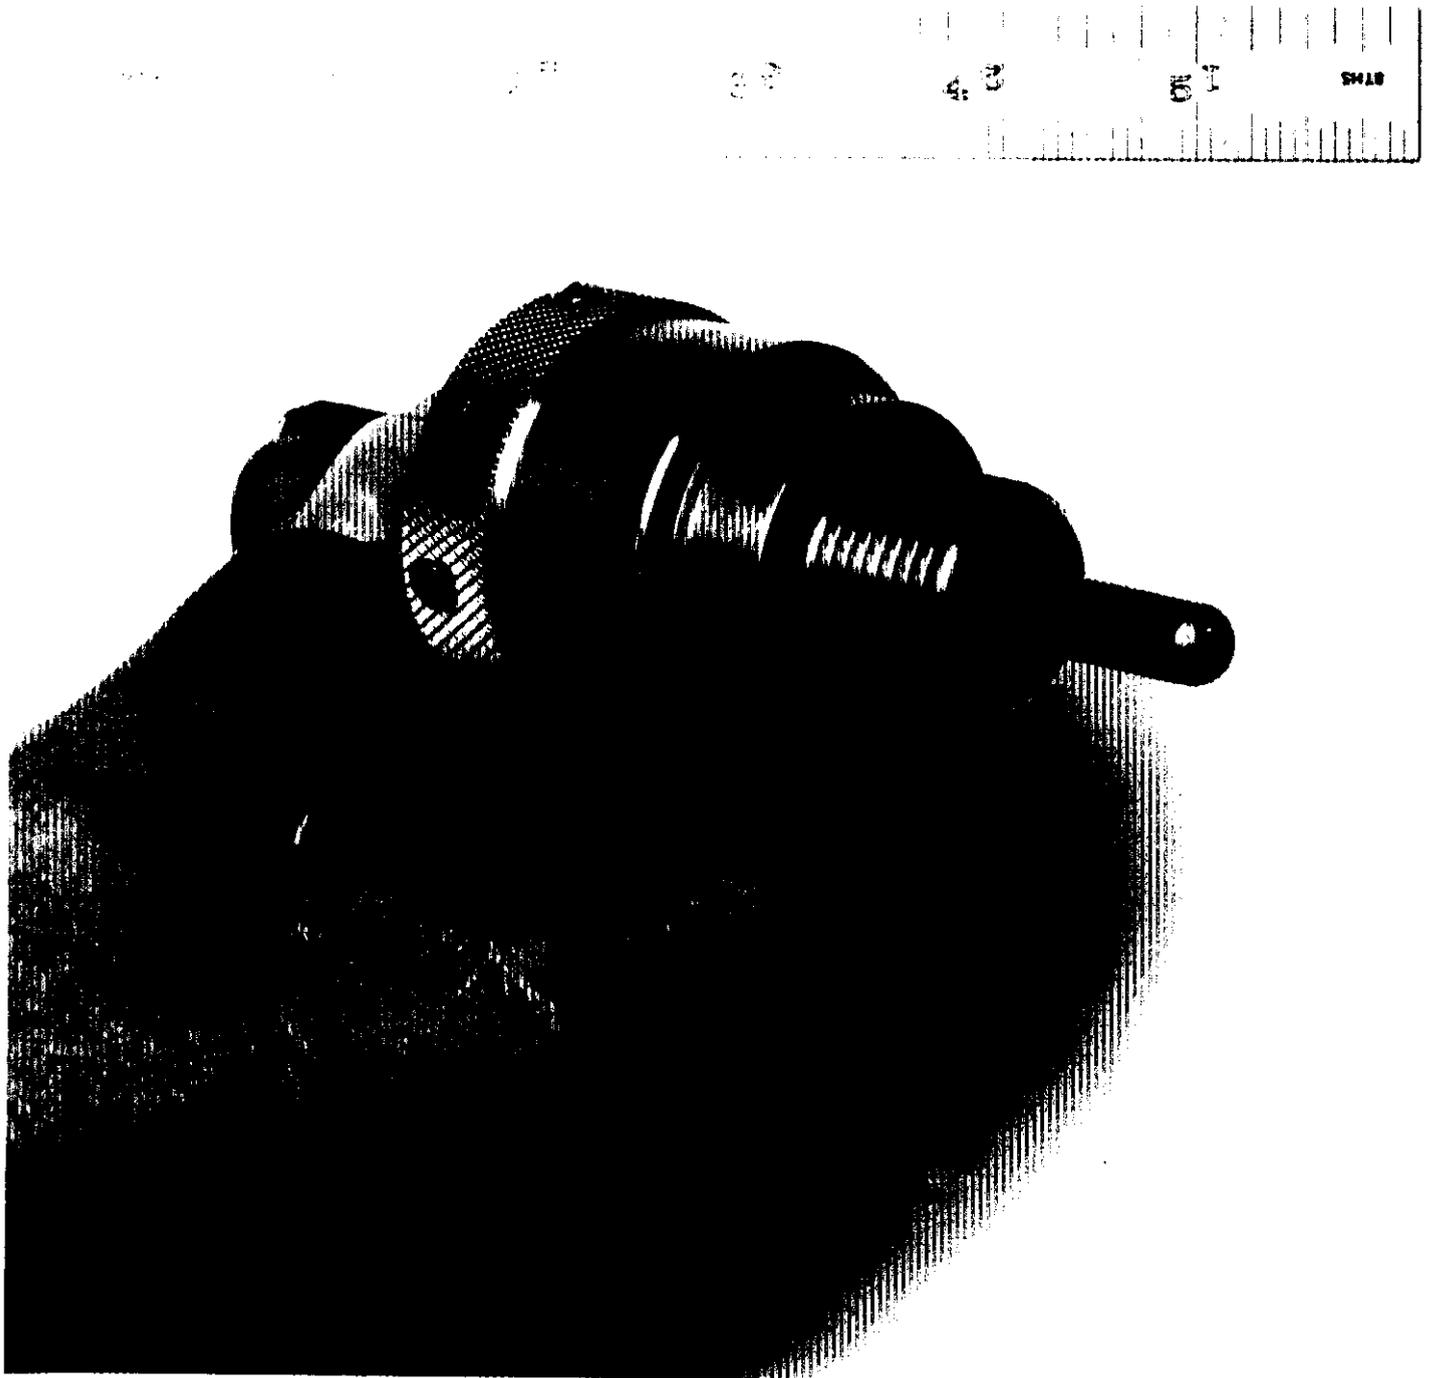
FIGURE 2: SHAFT END PROBE SHUTDOWN DEVICE

1. A simple shaft probe set at .006 inches shuts down the machine when the shaft moves axially. This works well but only protects the main drive rotor.
2. Thermocouples touching each thrust bearing outer race. Four machines are currently in a test program anticipating higher temperature during bearing failure.
3. Vibration readings taken with an economical hand held meter which measures velocity in inches per second peak to peak. These readings are recorded once a month.

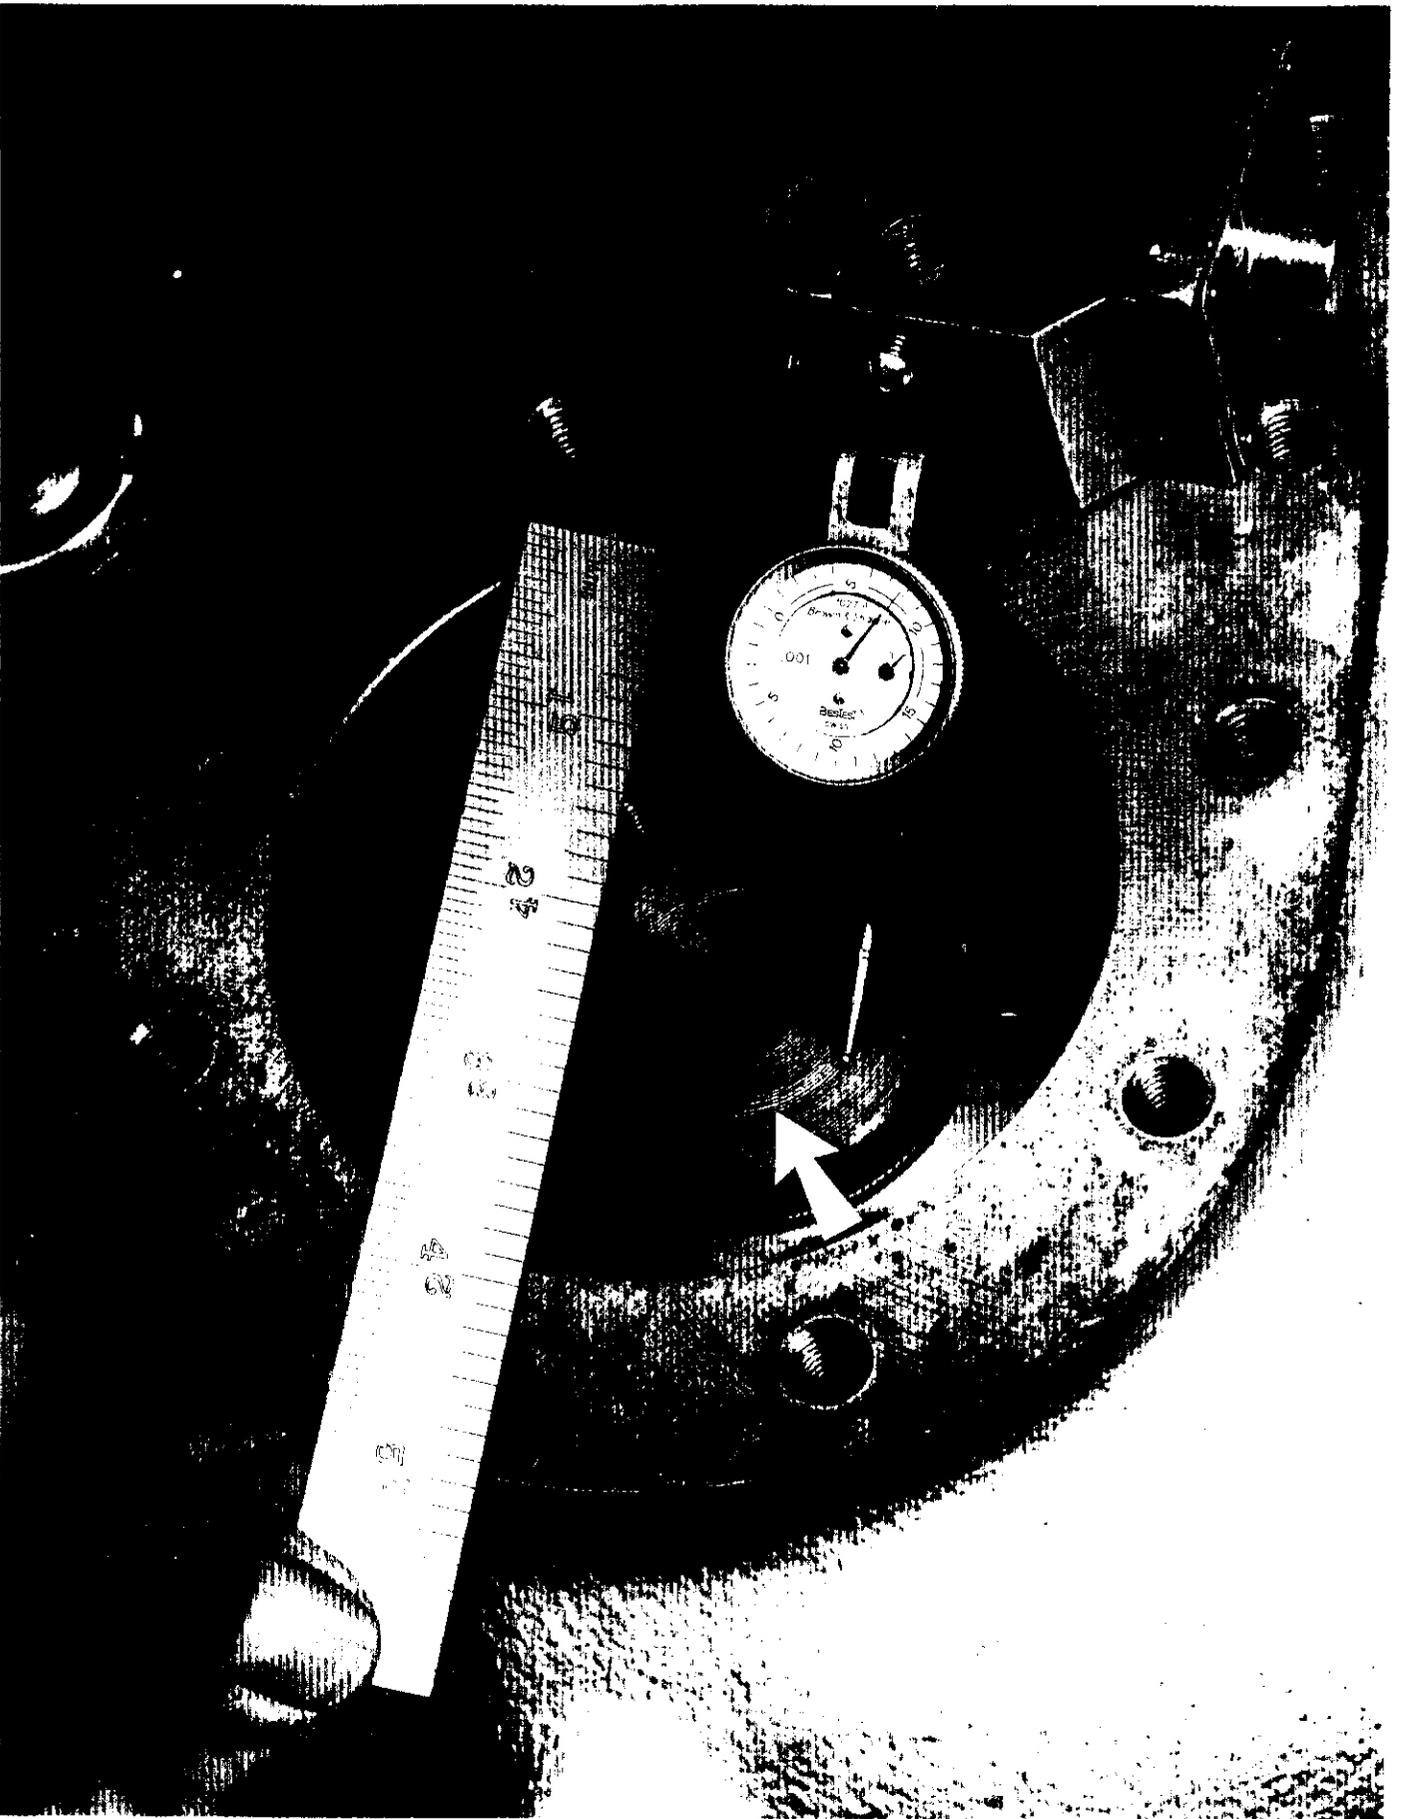
FIGURE 3: MEASURING SHAFT END PLAY

NOTE COPPER WEAR RING MARK CAUSED BY SHAFT PROBE

50,000 hours is a safe limit for the bearings. With a limited, shrinking budget, a sure, economical method is needed to protect our compressors. Recent vibration analysis results have helped determine our needs. Over a five year period vibration readings averaged .05 inches per second peak to peak. Recently, during our monthly readings, vibrations of .28, .28, .18, and .29 were measured on a machine that had 43,000 hours of operation. This was the first time in over 8,000 readings that we observed a significant change. Approximately 20 hours later our shaft probe shut down the machine. The machine was restarted and vibration readings at the same locations oscillated from .28 to .75; 4 hours later the shaft probe shut the machine off again. We replaced the compressor with our spare. Upon disassembly we found .009 inches end play on the drive rotor shaft and burnished balls on the thrust bearings.

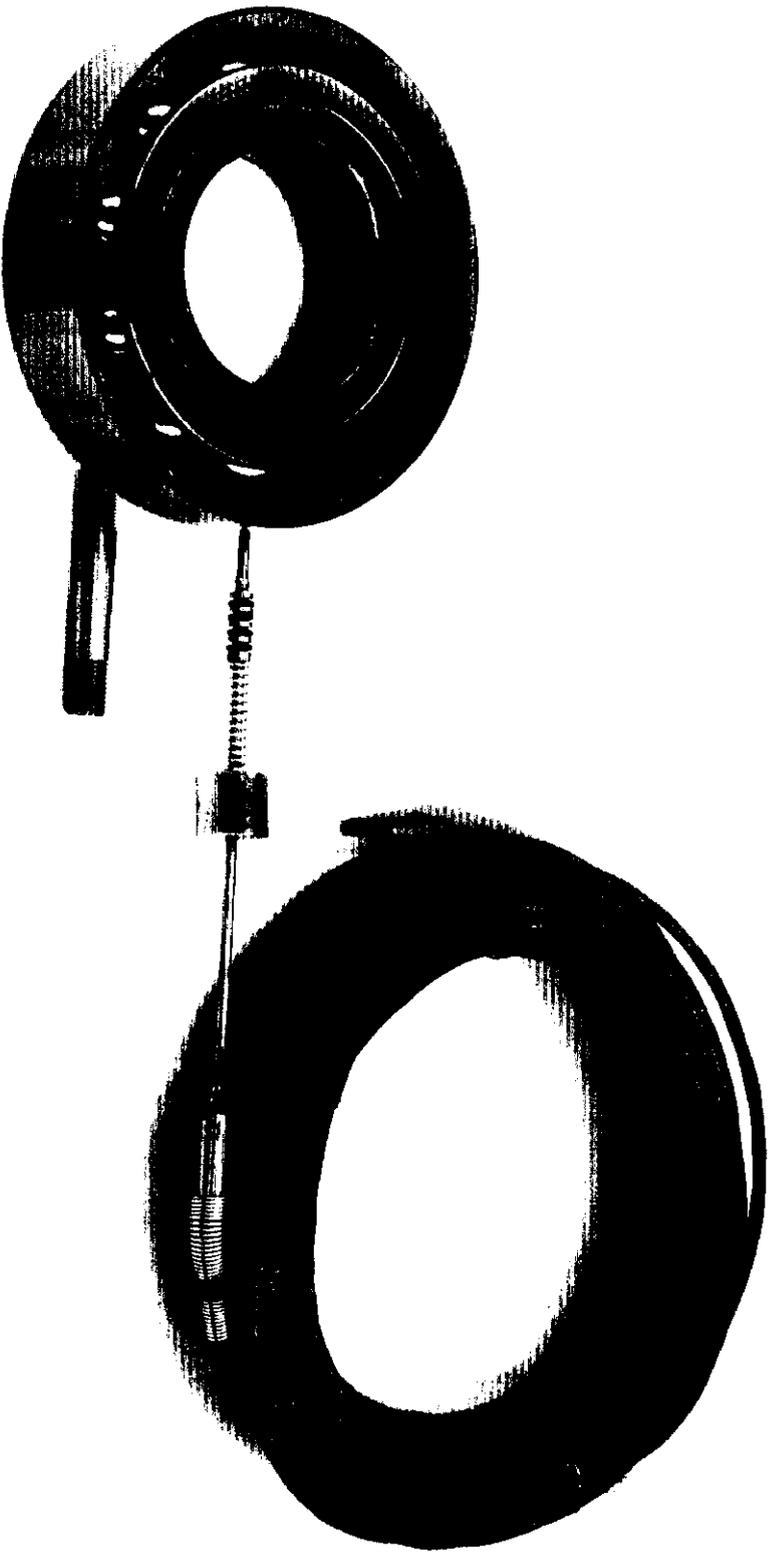
**FIGURE 5: THRUST BEARING OUTER RACE
TEMPERATURE DEVICE (THERMOCOUPLE)**

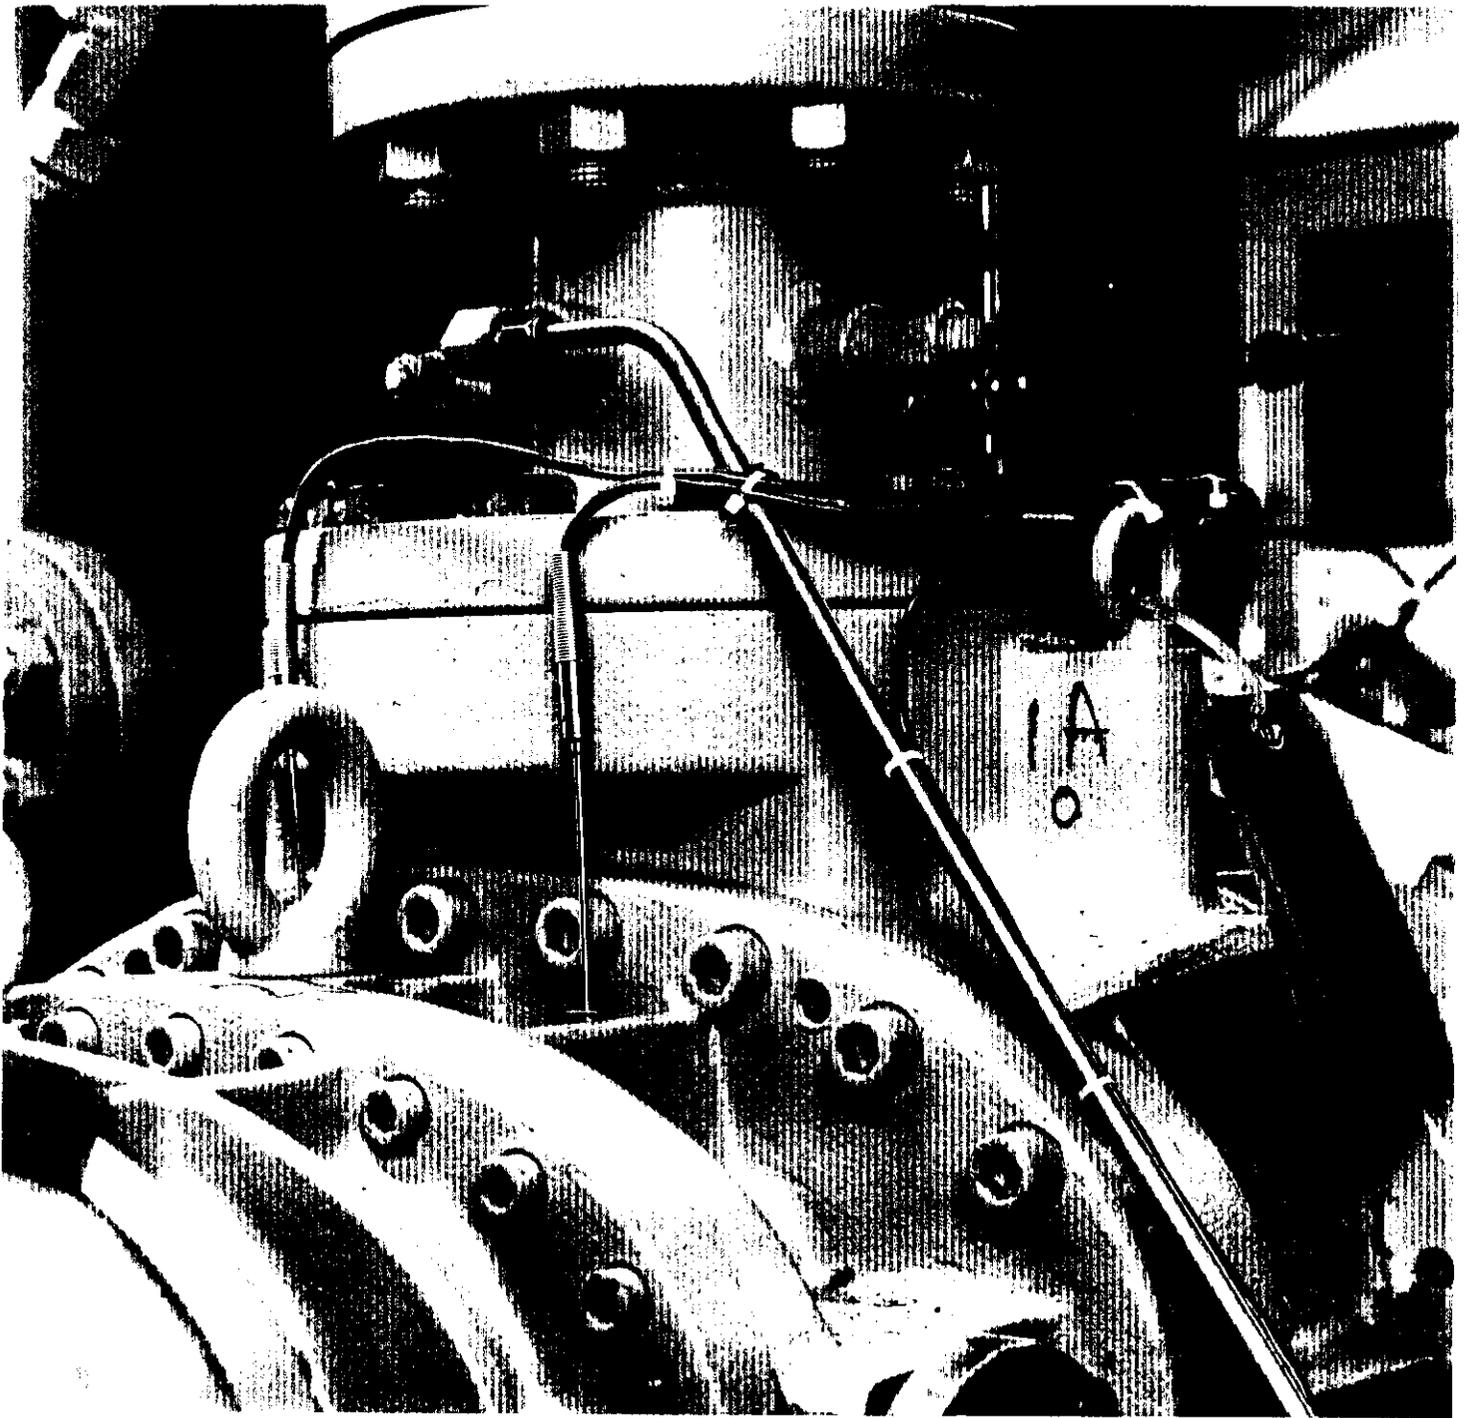
FIGURE 6: POSITION OF THERMOCOUPLE ON HIGH STAGE

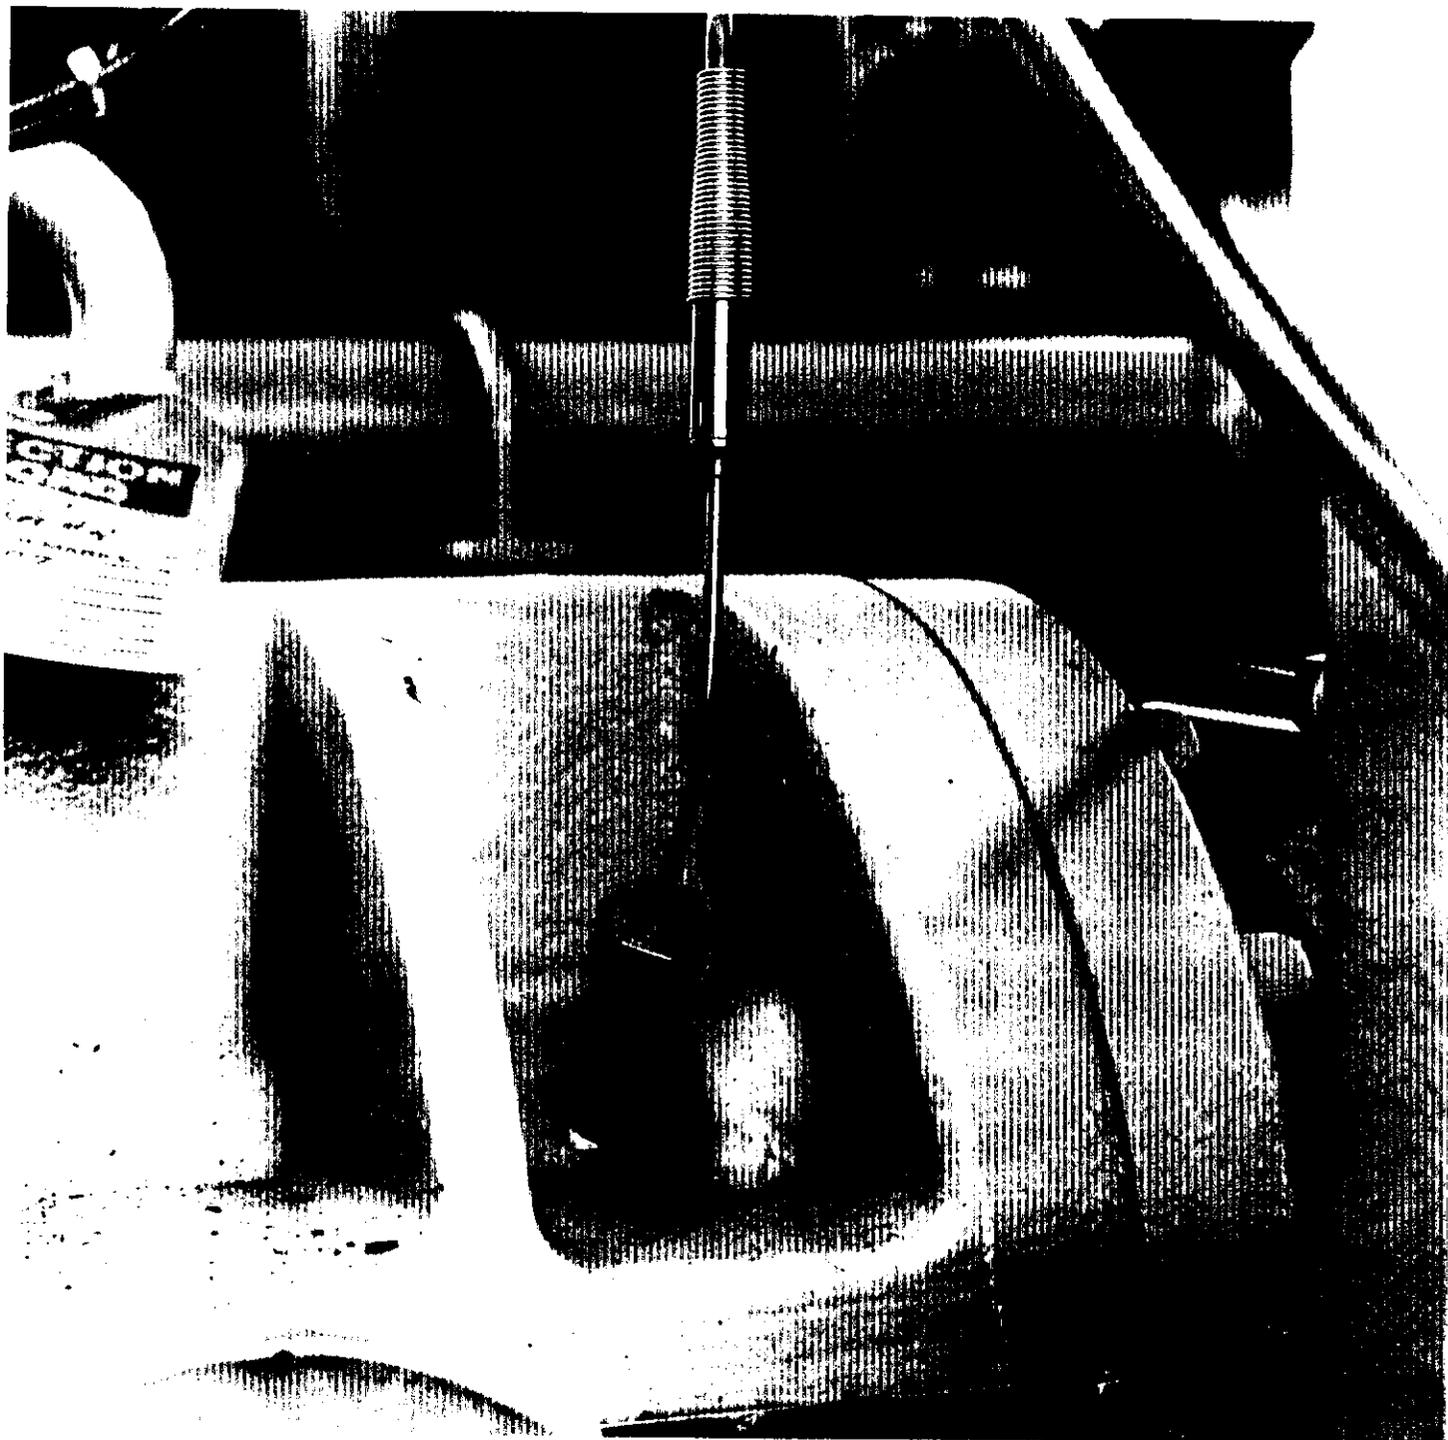
FIGURE 7: CLOSE-UP OF THERMOCOUPLE ASSEMBLY
