**PARTICLE MANAGEMENT STRATEGIES FOR
ULTRA-HIGH VACUUM ASSEMBLIES**

A Co-op Thesis written for

FERMI NATIONAL ACCELERATOR LABORATORY

JOSEPH ANGELO

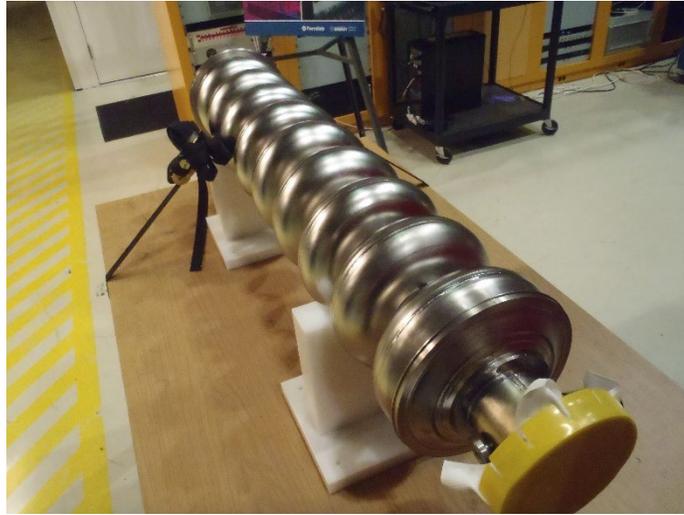
Figure 1. Superconducting niobium radio frequency cavity.

SRFCs, such as the the one in Figure 1, require extreme cleanliness to run effectively, especially at high gradients. Superconducting materials exhibit negligible electrical resistance and significantly reduced impedance when cooled to cryogenic temperatures, below their “critical temperature”, using liquid helium in a Cryostat, pictured in Figure 2. [2] Any non-superconducting material present, including contaminant dust, will heat up when alternating current is put through the superconductor. This heating will cause the resistance and impedance of the superconductor to rise, resulting in further heating. This effect can cascade rapidly,

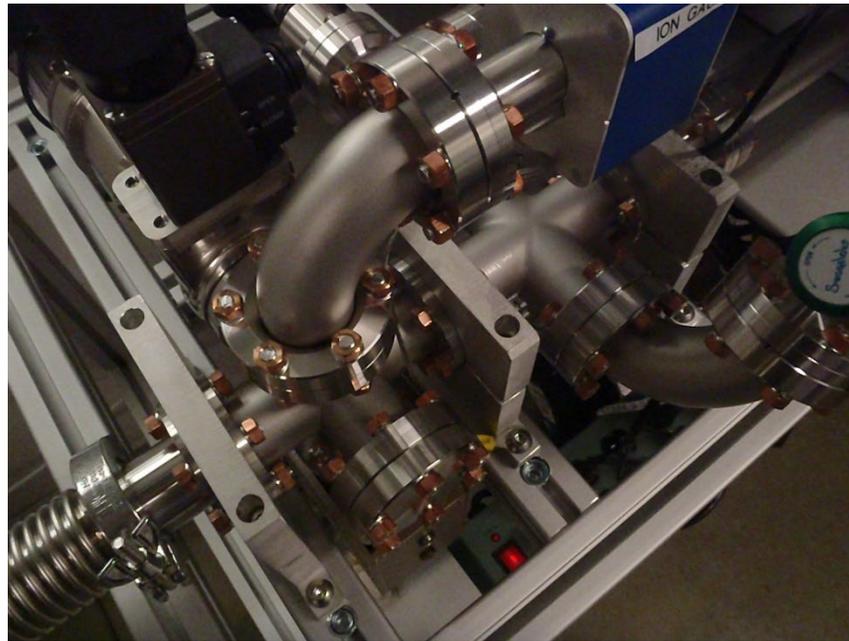
Figure 3. A vacuum assembly using stainless steel and silicon-bronze fasteners.

Several strategies for preventing galling and corrosion are already used in vacuum system fasteners. Stainless Steel/Silicon-Bronze interfaces, pictured in Figure 3, are often used for UHV/PF systems, and silver coatings are used in vacuum systems not sensitive to particle contamination. These methods do not provide significant protection from contact wear, however. Silicon-Bronze and silver are soft metals, and are particularly vulnerable to contact wear. Preventing contact wear requires hard, smooth, lubricious material, such as Titanium-Nitride (TiN) ceramic coating.

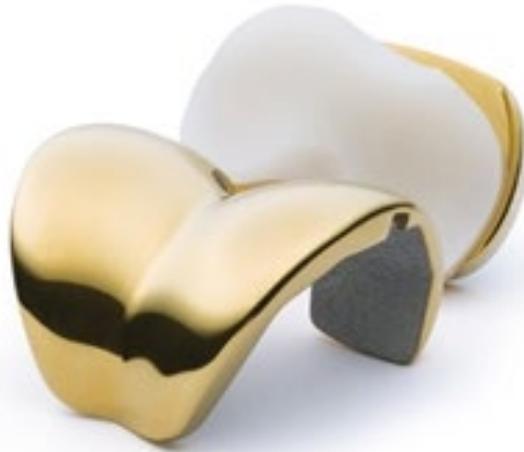
coated drill bits, and in applications where contact particle generation is a serious concern, such as orthopedic implants, like figure 4, where hard particles can cause swelling in adjacent tissue. [6]

Figure 4. A replacement knee with TiN coating.

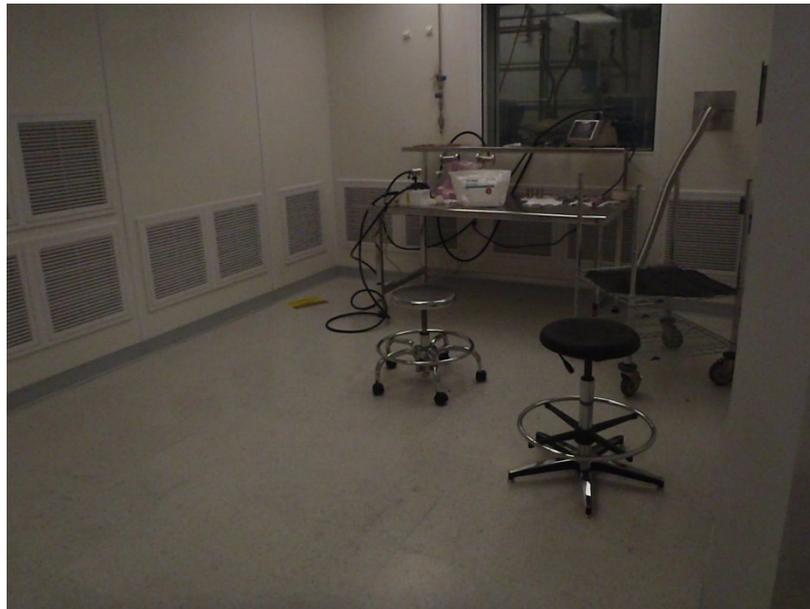
This room, shown in Figure 6, was nested within a Class 100 and a Class 10,000 clean room. To enter the area around the clean rooms required boot covers, and stepping over adhesive pads. To enter the Class 10,000 room required a lab coat, gloves, and

hair/beard nets. The class 100 and class 10 rooms required full-body cleanroom suits, as well as a second pair of boot covers and gloves covering the first pair, and a face mask and hood which covered the initial hair nets. All clean room entrances were immediately preceded and succeeded by adhesive floor pads, intended to remove dust from the bottoms of shoes or boot covers. The clean rooms were positively pressurized to prevent the entry of particles, and separated by doors or plastic curtains. All of the cleanrooms have constant downward airflow, to prevent the spread of airborne particles.

Figure 6. The class 10 cleanroom in the CMTF.

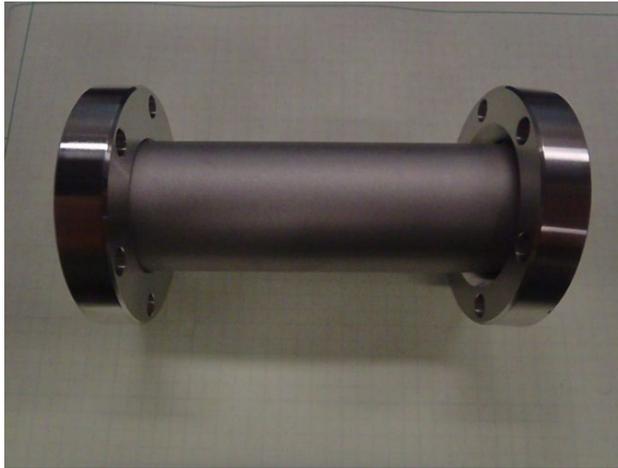
Figure 7. Vacuum spool with conflat flanges on both ends.

The spools and flanges (Figure 7) used in the experiment were purchased from MDC. They were cleaned to particle-free status in the CMTF cleanroom at Fermilab, and sealed in plastic clean room wrap until use. The testing stand was blown clean with nitrogen, wiped down with cleanroom wipes, sealed in cleanroom wrap, and kept within the wrap for the duration of the experiment, except for the pipe clamps (Figure 8).

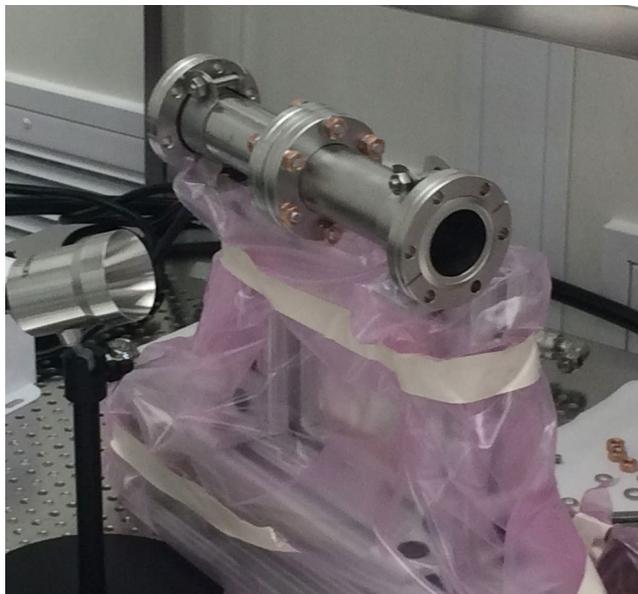
Figure 8. Testing fixture wrapped in clean room plastic.

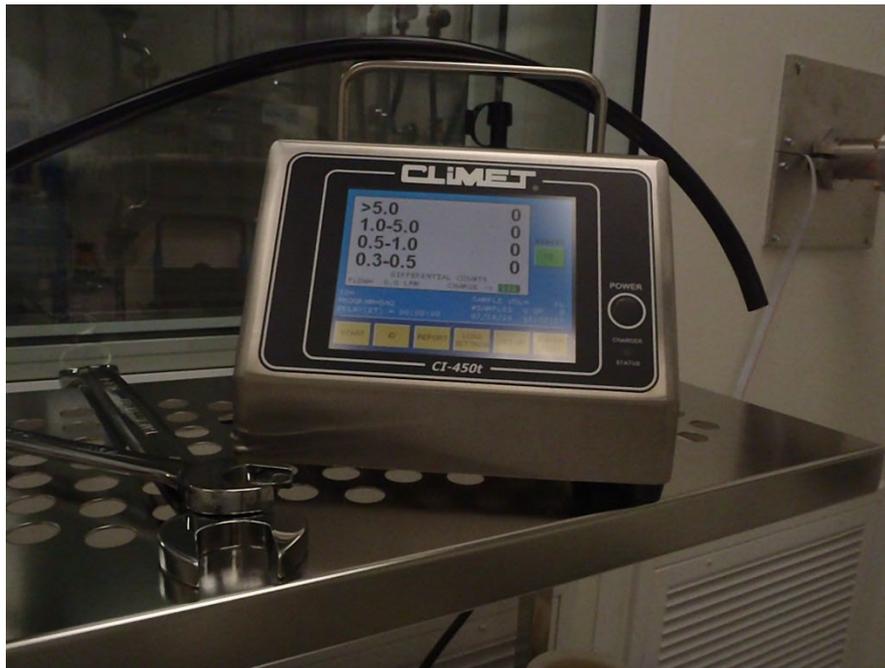
Figure 9. Climet particle counter.

The device used to collect particle count data was a Climet-750c particle counter, shown in Figure 9. It consists of a sampling horn, which intakes air, a body which detects particles, filters the exhaust, and provides a readout, and a hose to connect the two.

The counter is capable of detecting particles from .1 microns in diameter to 5 microns in diameter, and can detect and record the size of individual particles. It classes particles into size ranges, >5um, 1.0-5.0um, .5um-1um, and .3um-.5um. The intake rate of the counter is 75 liters per minute, and the maximum resolution available is one sample every 4 liters. In practice, this translates to 4-5 seconds per sample. The counter was connected to a laptop via a serial cable. The serial cable was passed from the body of

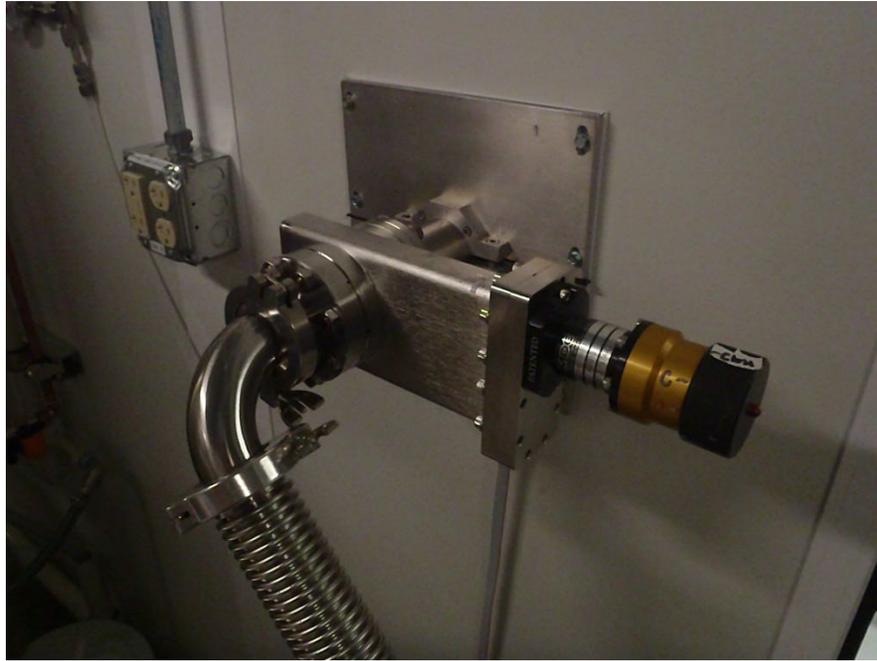
Figure 10. Wall port between cleanrooms

the counter in the Class 10 room, through two clean room wall ports (Figure 10), and into a laptop in the class 10,000 room.

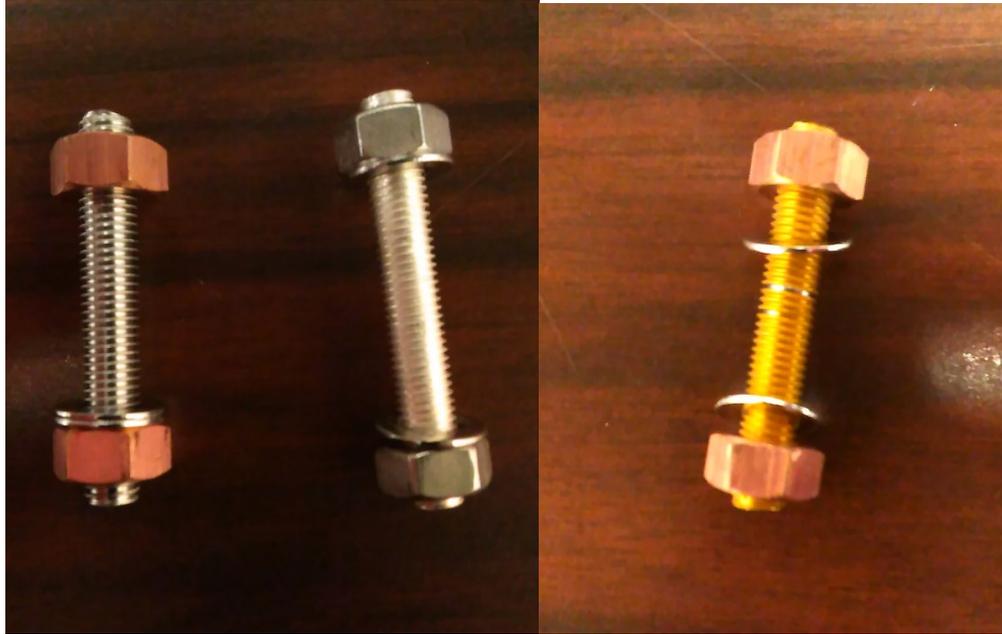
Figure 11. Steel, silver, and TiN studs.

The samples (Figure 11) were 1-7/8" long 1/4-28 threaded studs, coupled with two nuts and two washers each.

Stainless Steel, electro-polished studs were purchased from JT Industries, half of which were subsequently coated with TiN by Surface Solutions to a nominal thickness of 2um, according to AMS2444, Class 1 specification. The Silver studs were purchased uncoated from McMaster-Carr, and coated with silver by Krell Labs to AMS 2010 standard, with a max thickness of 5um.

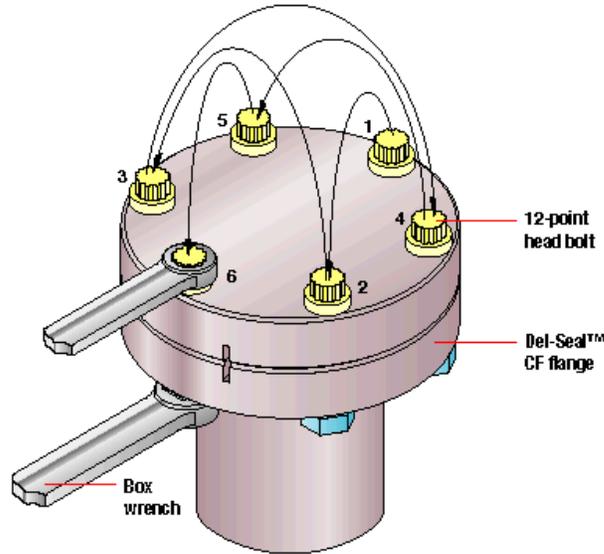
Figure 12. Bolt tightening pattern, from MDC.

7. The samples were tightened to 120in-lbs in a star pattern as per MDC spec and shown in Figure 12. However, each sample was tightened to full load in one wrench turn, as opposed to evenly and gradually, as specified by MDC. This was to prevent cross-contamination, and to perform the experiment within a reasonable timeframe.

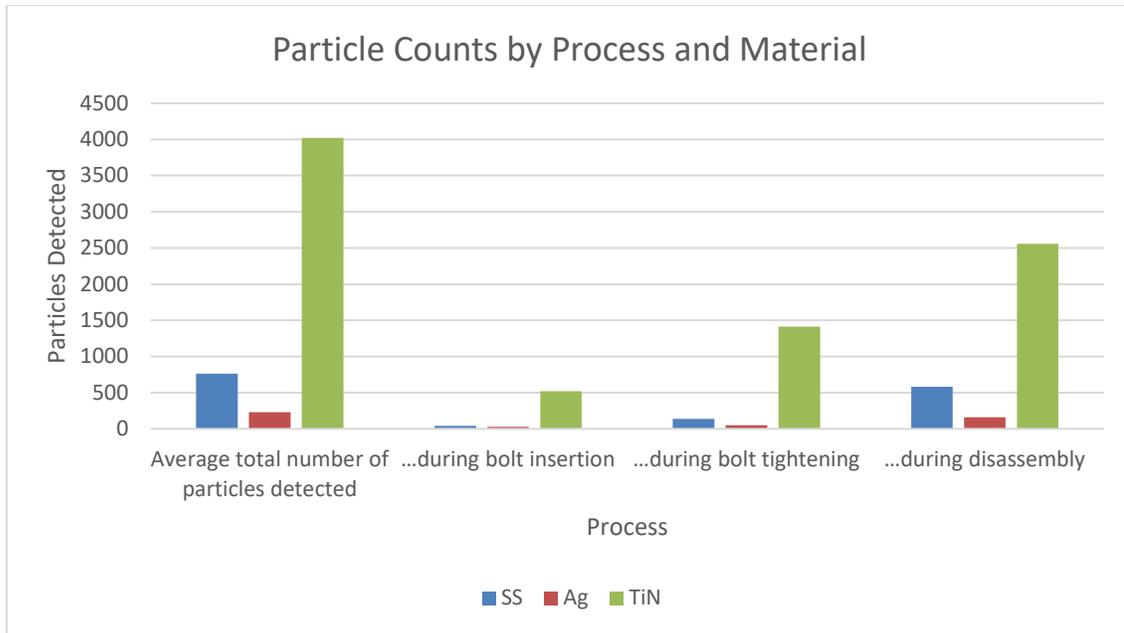
Figure 13. Particle count by process and material.

Sample Type	SS Particle Count	Ag Particle Count	TiN Particle Count
Average total number of particles detected	763	229	4021
...during bolt insertion	40	27	519
...during bolt tightening	140	51	1415
...during disassembly	583	160	2555

It can be seen that Ag bolts are the most cleanly, followed by SS, which are followed by TiN. The Test Statistics for the mean values are also found in Table 2. The test statistic is a measure used in a T-test in a manner similar to a standard deviation. To refute a null hypothesis; in this case, that Ag or TiN studs will generate the same amount of particles as SS studs, the means of the two samples must be a certain number of test statistics apart. The test statistic is determined by

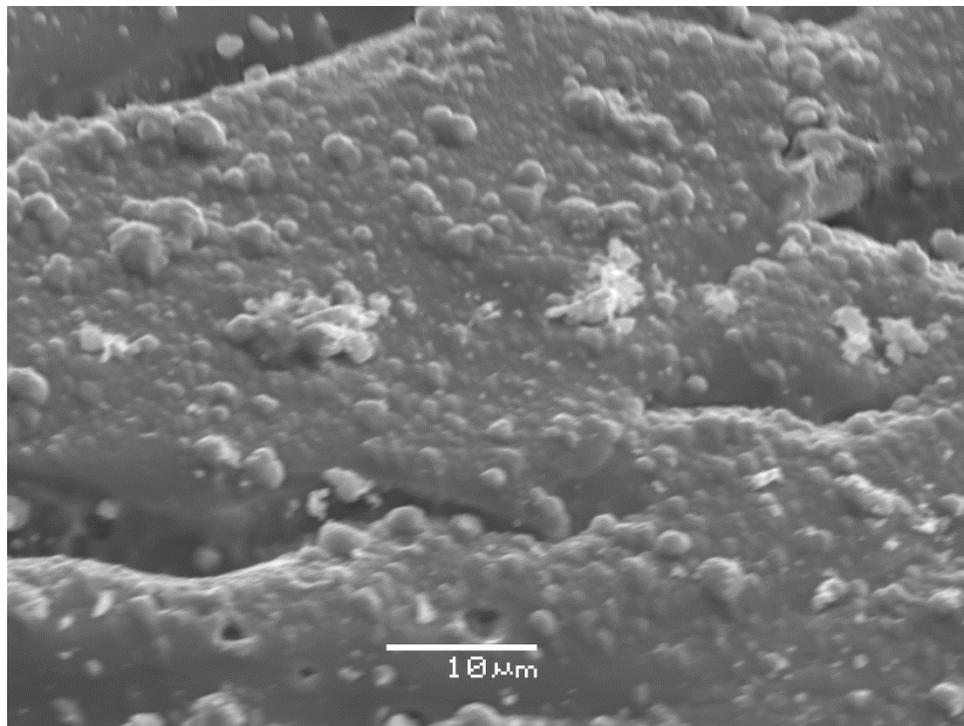
Figure 14. SEM image of a TiN surface with wear particles.

The samples were put under a SEM to determine the characteristics of their wear patterns, and to determine the reason for the high particle counts generated by the TiN studs, and the lower than expected Ag stud particle counts. The TiN studs were found to have a very rough, bumpy surface, which allowed the hard ceramic of the stud to wear away the relatively soft steel of the nut. Figure 16 shows the surface of a TiN stud.

The white flecks seen in Figure 16 were determined to be flakes of steel by X-ray spectroscopy performed in the SEM. In this case, we determine that the hardness of the ceramic did not mitigate particle generation as expected, but greatly increased it. It may be that the relative material hardness of the materials in contact is a more reliable

predictor of particle generation. These images show that the use of TiN studs does not result in TiN particles, but in Steel particles, eliminating the hope that using TiN would produce harmless superconducting contamination. Mubarak states that the TiN particles seen in Figure 16 are a common hazard during the sputtered Physical Vapor Deposition (PVD) processes that is used to apply the TiN coat.[10] However, there are many processes used to produce TiN coatings, many of which are optimized to reduce the macro-particles seen in Figure 16. Therefore, it is imaginable that a process could be selected that would result in fewer TiN macro particles, and less contamination generation.

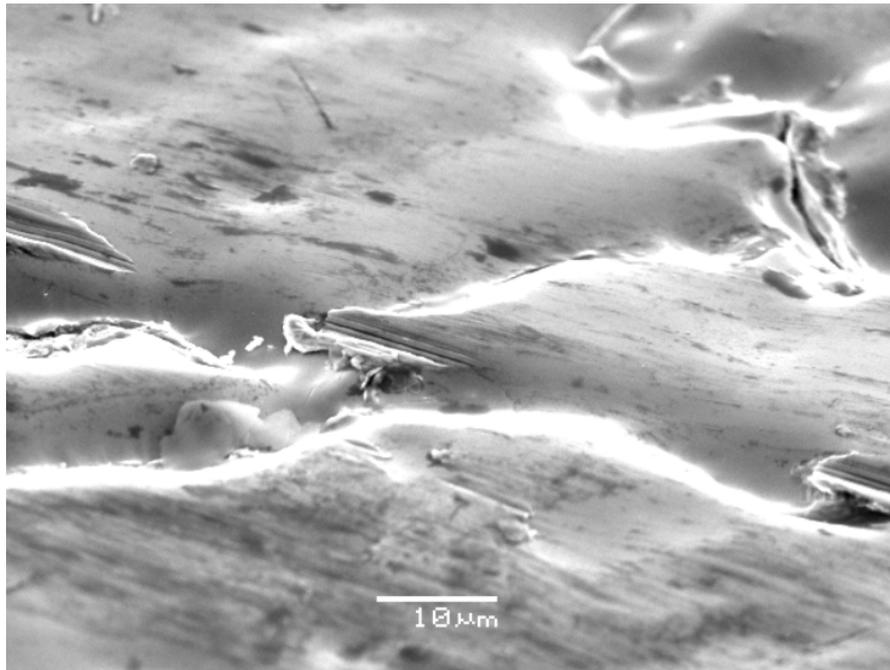
Figure 15. SEM image of stainless steel surface with wear marks.

The comparison of the SS and Ag coated studs gives insights as to why the Ag outperformed the SS. Gouge marks and clear signs of material removal on a SS stud can be seen in Figure 17.

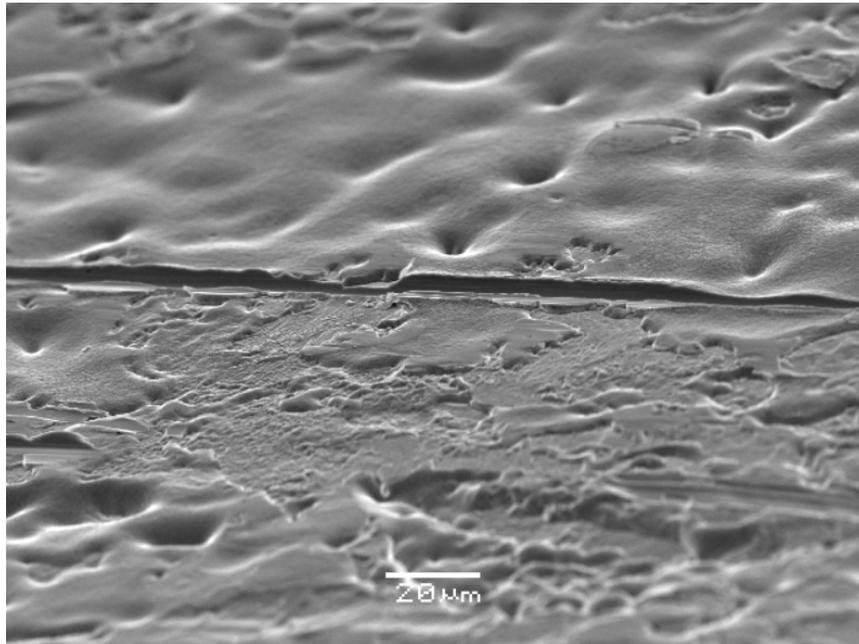
Figure 16. SEM image of silver coated surface with wear marks.

Wear marks can also be seen on an Ag coated stud in Figure 18, but the raised area and excess material around the wear marks indicates a ploughing wear mechanism , and that much of the material was retained. It may be that the softer and more ductile silver resulted in reduced material removal for the same type of abrasion.

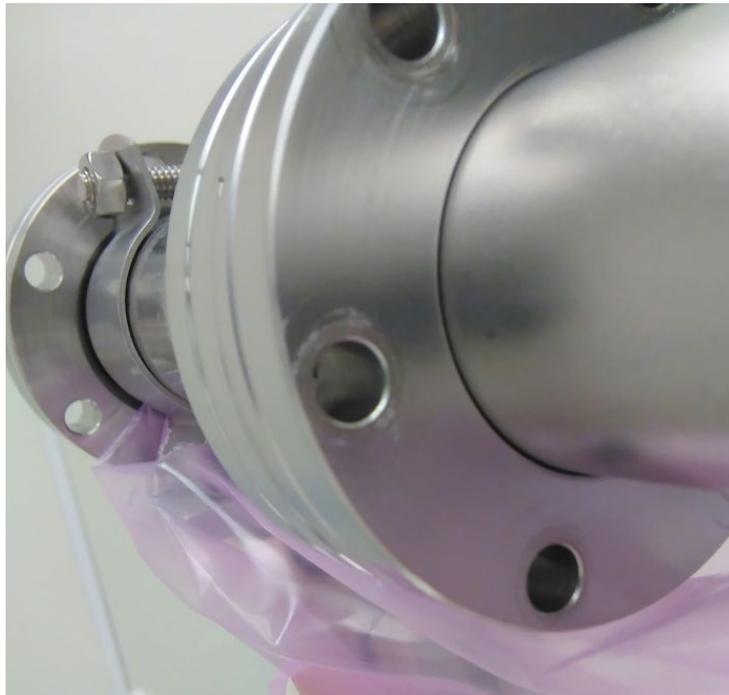
Figure 17. Galling damage on a conflat flange.

One of the purposes of protective coatings and of using dissimilar materials in UHV/PF assemblies is to prevent galling. If a stud and nut gall together, they can become impossible to remove by hand, making repairs to the system difficult or impossible. Galling can also make cleaned fasteners unreasonably hard to assemble. All the material combinations examined in this experiment completely eliminated galling between the stud and nut. However, galling did occur between the SS washers and the SS vacuum flange, the result of which is shown in Figure 19, as well as between nuts and washers.

Galling occurred both during and after tightening, which were detected by “pinging” sounds made when the washer broke free, and was accompanied by significant spikes in particle generation. This was one of the most significant and easily mitigated

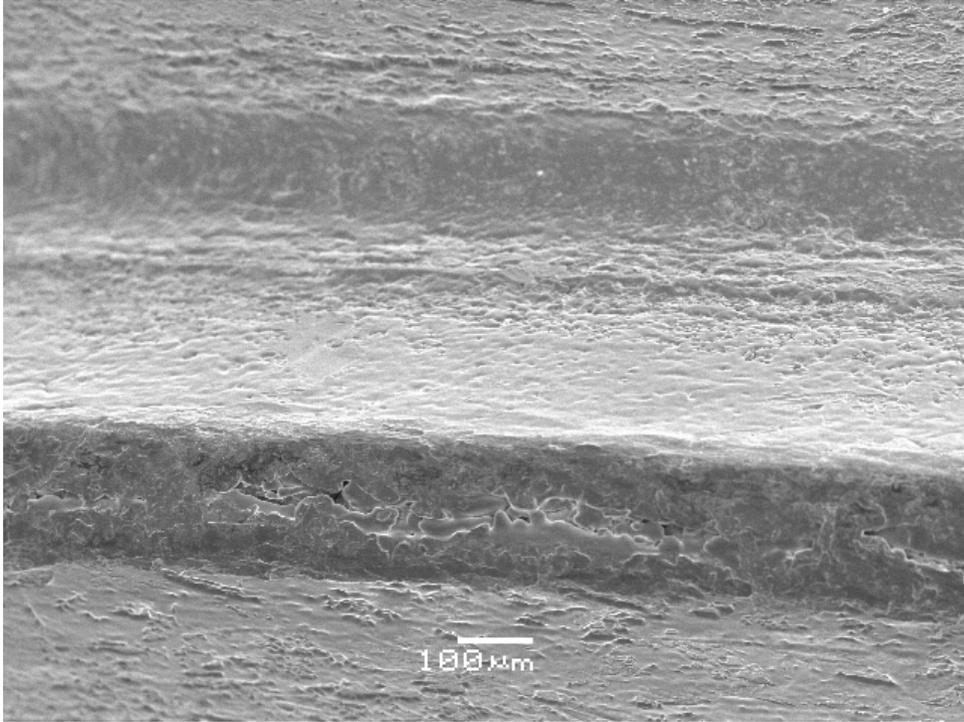
Figure B-11. Silver Thread

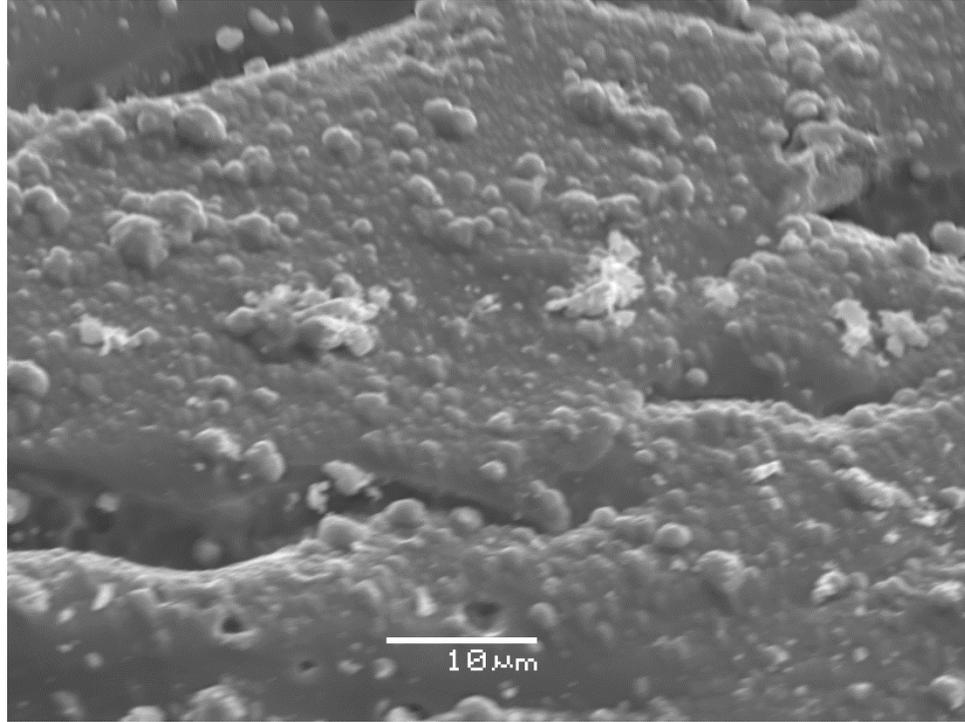
Figure B-21. TiN with Stainless Steel Wear Particles
