FERMILAB-TM-1718

Transrex 500 kW Power Supply Transducer Upgrades

TRANSREX 500 kW
POWER SUPPLY TRANSDUCTOR
UPGRADES

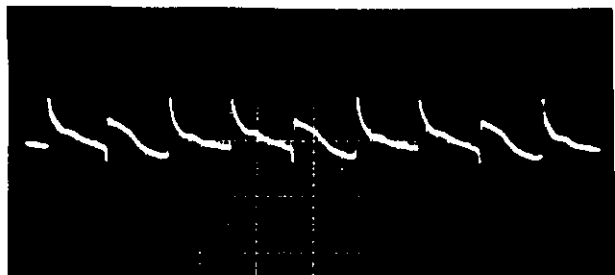
2A ORIGINAL AT 0 A

ALL FIG 5 mV/DIV
5 ms/DIV ?

The transducer head and chassis as built by Transrex was studied at 3 operating points which were: zero Amp, 500 Amp, and 2000 Amp dc current. The original Transrex schematic is shown in Fig. 3. The voltage ripple across the burden resistor at these 3 points is shown in Figs. 2A, 2B, and 2C. The spectrum analysis of this voltage at 2000 Amp, which results in 4 Vdc burden resistor voltage shows the burden voltage to contain the following components:

60.0 Hz	at	6370.0	μV_{rms}
15.0 Hz	at	22.4	μV_{rms}
9.2 Hz	at	8.2	μV_{rms}
4.6 Hz	at	5.0	μV_{rms}

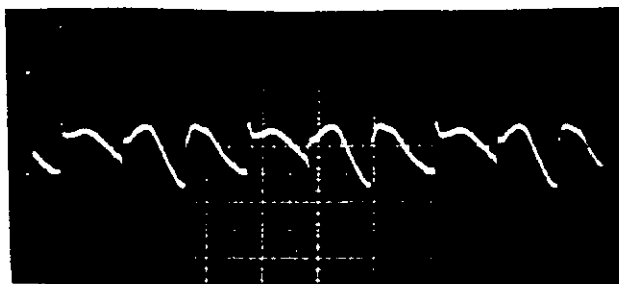
6A CHANGE 1,2 AT 0A

ALL FIG 5mV/DIV
5ms/DIV

The next upgrade was the replacement of the original amplifier board by a new amplifier board, shown in Fig. 5. The original boards were in poor electrical and mechanical condition due to corrosion and aging. The original board needed to be replaced. At this time it was noticed that there were also certain low frequency noise components in the burden resistor signal when the booster was running, in particular a 15 Hz component. These low frequency components were not present in the power supply current when the same power supply was run in a voltage regulated mode. These low frequency components resulted in a modulation of the power supply output current with 15 Hz, 9.2 Hz and 4.6 Hz in the current regulated mode. It was decided to sacrifice a percentage of the 60 Hz noise reduction gained in change #1 in order to reduce the low frequency noise of 15 Hz and lower by adjusting the break frequency of the A.C. feedback of the amplifier card. These low frequencies would be more evident in the magnetic field of beamline magnets driven by these power supplies. A gain of -10 to -12 dB was realized at 4.6 to 15 Hz. The 60 Hz component was still -3 dB less than it was in the original chassis. Figures 6A, 6B and 6C show the resulting ripple on the burden voltage. At 2000 Amp, and 4 Vdc burden voltage the ripple was:

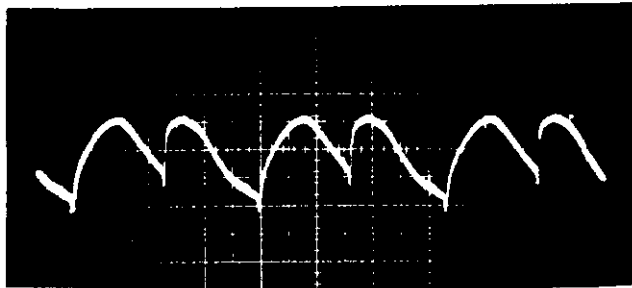
FIG 9A CHANGE 1,2,3,4,5 AT 0 A

ALL FIG 5 mV/DIV

5 ms/DIV

Another area of the transducer chassis that was investigated was the silicon diodes used in the sense winding bridge rectifier. It was thought that by using an active rectifier that the forward voltage drop variation of the diodes would be eliminated. The circuit used is shown in Fig. 8. Upon testing it was found that there was a 40% reduction in the peak to peak ripple on the burden resistor at 500 Amp and 2000 Amp as shown in Figs. 9A, 9B, and 9C. A spectrum analysis of the ripple showed a 12 dB reduction in the 60 Hz component at 2000 Amp and 4.0 Vdc burden voltage. The ripple at that point was:
