FERMILAB-CONF-09-219
Presented at the 2009 Particle Accelerator Conference
Vancouver, BC, Canada 4-8 May 2009

METHODS TO DETECT FAULTY SPLICES IN THE SUPERCONDUCTING MAGNET SYSTEM OF THE LHC

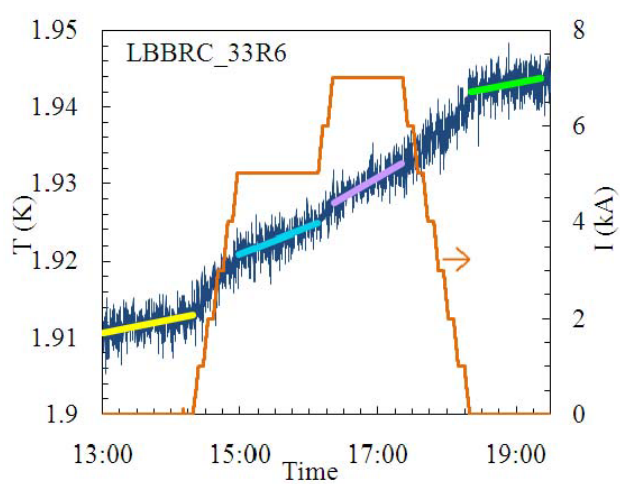
This technique is illustrated in Fig. 1, which shows the temperature in one dipole in sector 6-7 over a 4.5 hour period. The current was ramped to 5 kA and then 7 kA, and held at each current for 1 hour. A linear fit is made to T = f(t) during initial and final zero current periods, and during each of the high-current plateaus. Since superfluid helium effectively conducts heat throughout the common liquid volume, the measured dT/dt of all thermometers in a subsector are averaged, and the slope with zero current

Figure 1: Measured T = f(t) for one thermometer during a power run of the main dipole circuit. Linear fits during periods of constant magnet current are shown.

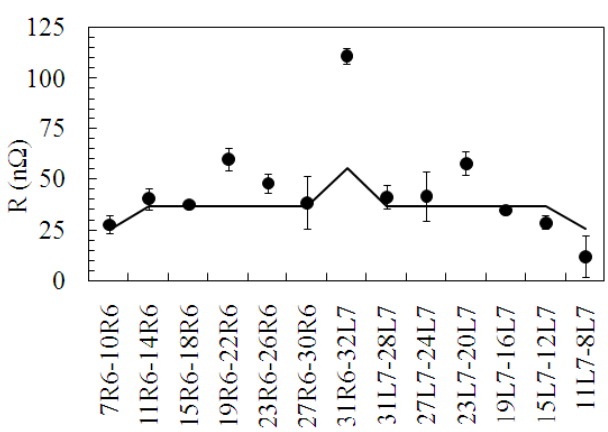
Fig. 2 shows the measured resistance per subsector for sector 6-7. The error bars returned by the least-squares fit are a measure of the scatter of individual measurements about the best fit for each subsector. The solid line represents the expected resistance per subsector. Ten of the 13 subsectors are of a standard length as described above. The central sub-sector is 1.5 times as long, and the end (dispersion suppressor) subsectors have 2/3 the number of dipoles.

The resistance in the central subsector (31R6-32L7) is 111±4 nΩ, compared with an expected 55 nΩ. The net excess resistance is 56±4 nΩ. Independent electrical measurements (see next section) found a resistance of 49 ± 3 nΩ in one of the dipoles in this subsector. This method also identified one subsector in sector 1-2 with an excess resistance of 108±5 nΩ, which was also confirmed electrically to be a high-resistance splice inside a dipole.

Figure 2: Total resistance in the dipole circuit in each sub-sector in sector 67, measured by the calorimetric method.

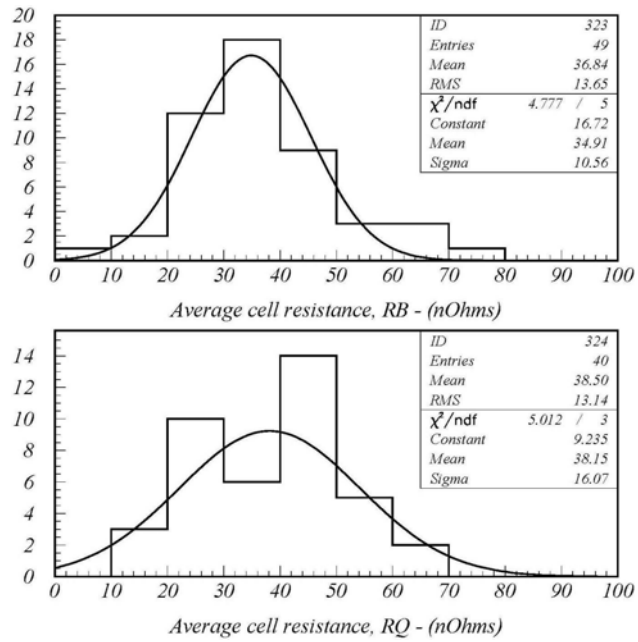
This method has been applied to the dipole (quadrupole) circuits in five (four) of the LHC sectors. Histograms of the calorimetrically measured total resistance per standard-length subsector are shown in Fig. 3. The two subsectors with confirmed resistive splices are not included in these plots, nor are the longer central and shorter end subsectors. The data are consistent with Gaussian distributions with means of ~35 nΩ and sigma of ~15 nΩ. This width is somewhat larger than the typical error bar from the individual fits to subsector data. This suggests additional systematic errors coming from small uncertainties in the cryogenic system settings. Since15 nΩ deposits only 0.7 W at 7 kA, detected in a helium bath>200 m long, this represents remarkable sensitivity.

Figure 3: Histograms of main dipole and quadrupole circuit resistances in standard-length sub-sectors, measured by the calorimetric method.

Not all splices covered by the calorimetric measurements were electrically measured to confirm or deny the presence of excess resistance. The dipole distribution shows a slightly asymmetric tail on the high side, which may indicate the presence of one or more faulty splices with resistances of a few 10's of nΩ. Table 1 shows, for each LHC sector, the 90% confidence upper bound on the maximum excess resistance, relative to the mean values shown in Fig. 3, that could exist in any subsector, based on calorimetry.

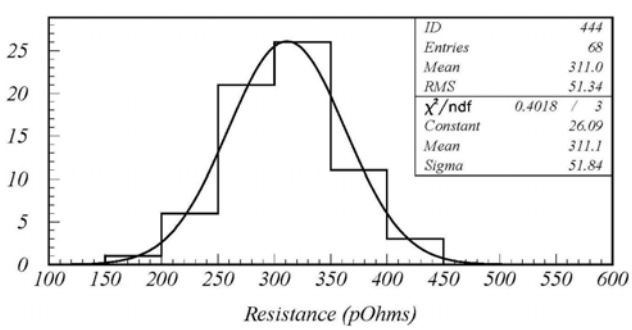
same pairs of voltage taps indicates an rms reproducibility error of 45 pΩ. The technique is labour and time intensive; therefore it was used only in subsectors deemed suspicious by the cryogenic analysis. In total 68 measurements were performed in five cryogenic subsectors, all on the dipole bus. No abnormal splice resistance was seen. The mean splice resistance is 311 pΩ, with an rms spread of 52 pΩ. (See Fig. 4.)

Figure 4: Histogram of electrical measurements of bus splice resistances.

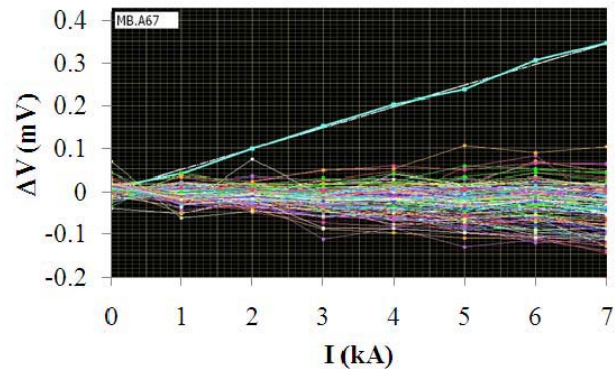
An electrical technique to identify faulty splices inside magnets was also developed. The "QPS snapshot" method uses the post-mortem system (2450 voltage measurements over 13 s with typical peak-to-peak noise of 4 mV), semi-automatically triggered at different current plateaus. The QPS measures voltage differences between two apertures of a dipole or two half-coils of a quadrupole, and therefore *differences* in splice resistances. QPS snapshot measurements were performed on five (four) sectors for the dipoles (quadrupoles). An example of the data for the 154 dipoles in sector 6-7 is shown in Fig. 5. A magnet (B32R6) with large resistance is clearly visible, which is in the cryogenic subsector identified as having excess resistance. Its resistance is measured to be 49±3 nΩ, consistent with the calorimetric measurements. Another magnet in sector 1-2 (B16R1) was identified by this technique with R = 100±3 nΩ, also consistent with the calorimetric measurements.

Figure 5: Voltage differences between two halves of all dipoles in sector 67.

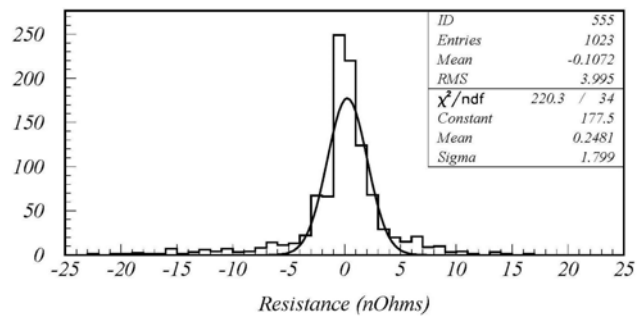
Fig.6 is a histogram of all of the snapshot measurements. The central peak has a width of about 2 nΩ. However there are long tails, which come from channels with extra electrical noise, and which may also include magnets with internal splices with R ~10 nΩ.

Figure 6: Histogram of electrical measurements of internal magnet splice resistance differences.
