Disassembly of DSA323 Collared Coil

TS-SSC 91-045
S. Delchamps
March 11, 1991

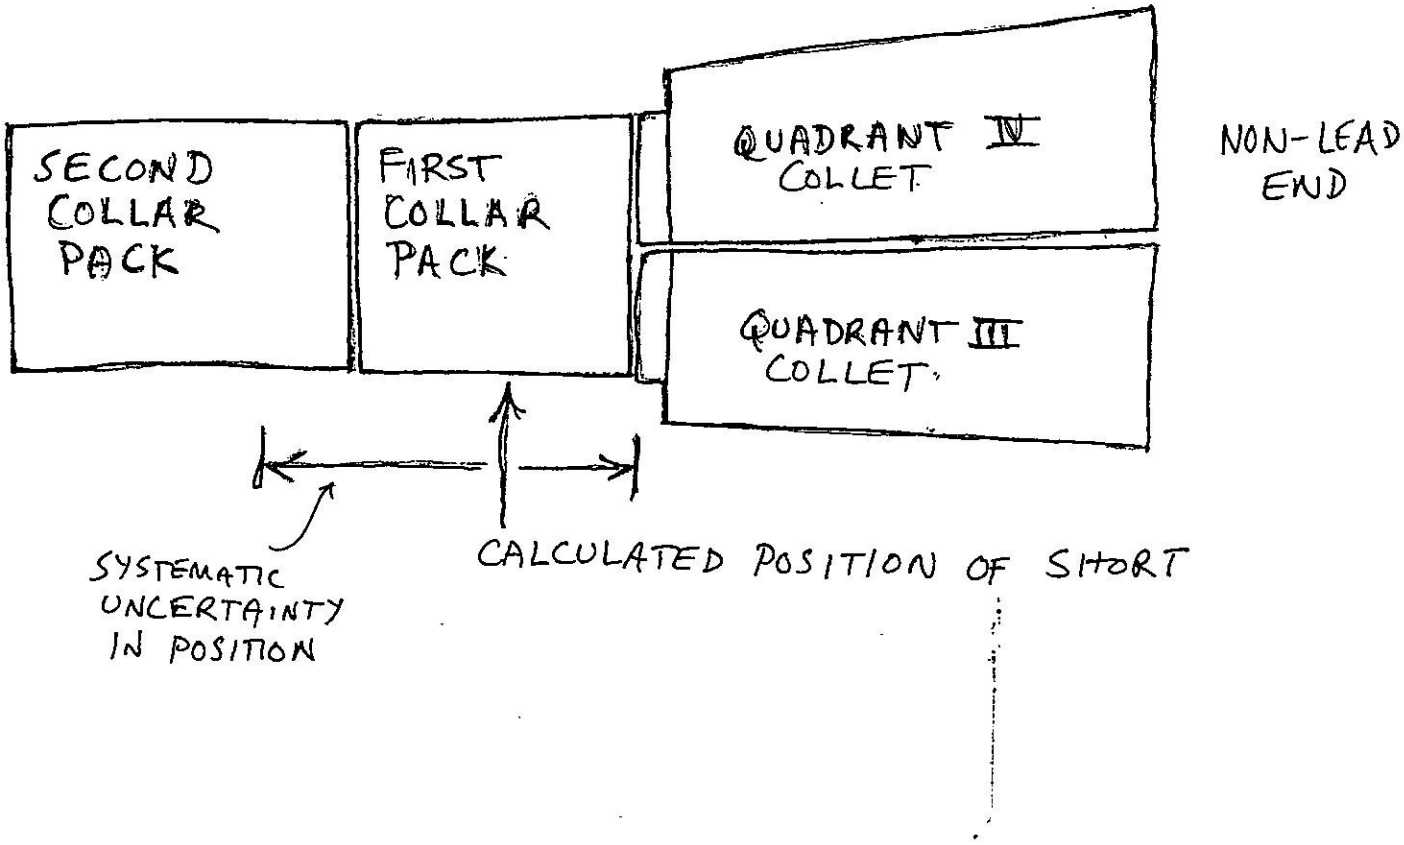
FIGURE 1

Measurements done with the collared coil assembly out of the yoking-skinning press [1] showed that the short (resistance ~25 kΩ) was between the coil and the collar packs (or collaring shoes), *not* the coil and either of the end clamps. (No coil to collar short had ever occurred previously in the Fermilab series of SSC model and 17 m dipole magnets.) It was determined that the short was in the second turn from the pole in the lower outer coil, within the first or second non-lead end collar pack in quadrant III. (See Figure 1.)

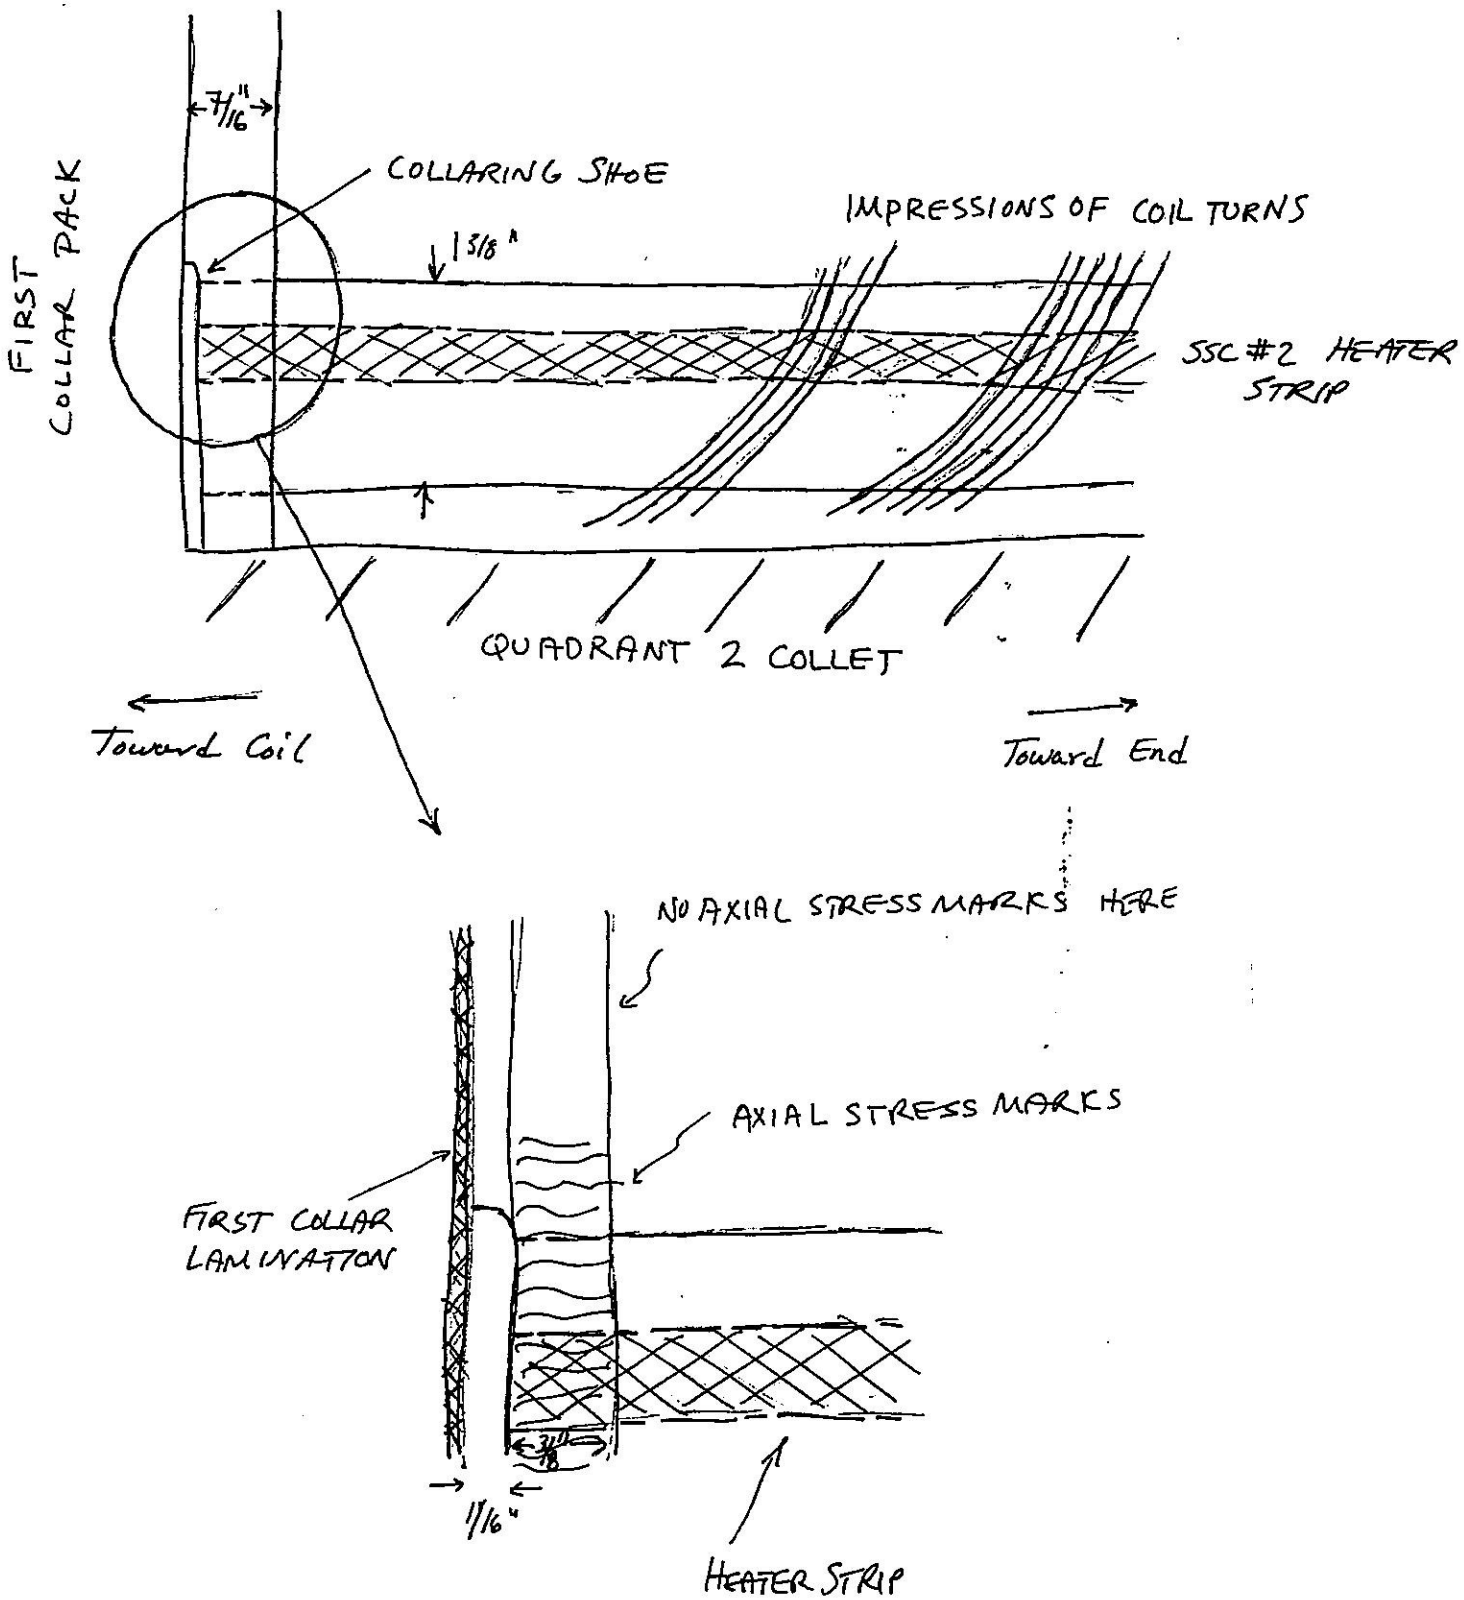
FIGURE 2

The non-lead end quadrant III collet insulator was removed, and a visual inspection of the region near the calculated short location was made. (See Figure 2.) We suspected that the problem might be caused by the corner of the brass collaring shoe, which projects about 1/16" beyond the end of the collars. However, there was no obvious damage to the kapton insulator near the corner of the collaring shoe.

Clear impressions of the coils were visible in the outer kapton insulator layers. Axial stress marks in the kapton near the collaring shoe indicated high stress near the end of the collar packs.

Sections of the brass collaring shoe and kapton insulating layers closest to the return end of the coil were cut off to allow closer examination. A small burr could be felt on the corner of the collaring shoe nearest the calculated position of the short. Some creasing of the kapton insulator layers near this burr could be seen. However, there were no obvious holes, cracks, or black marks.

Discussion: No obvious cause of the short was discovered, and no effects of arcing such as black deposits on the kapton insulating layers were seen. However, the burr on the collaring shoe is highly suspect, partly because of its close proximity to the calculated location of the short.

Disposition: Since no clear cause of the short was determined by these investigations, it was decided to take a conservative approach; DSA323 will be rebuilt from its component coils, with all new insulation and collaring shoes.

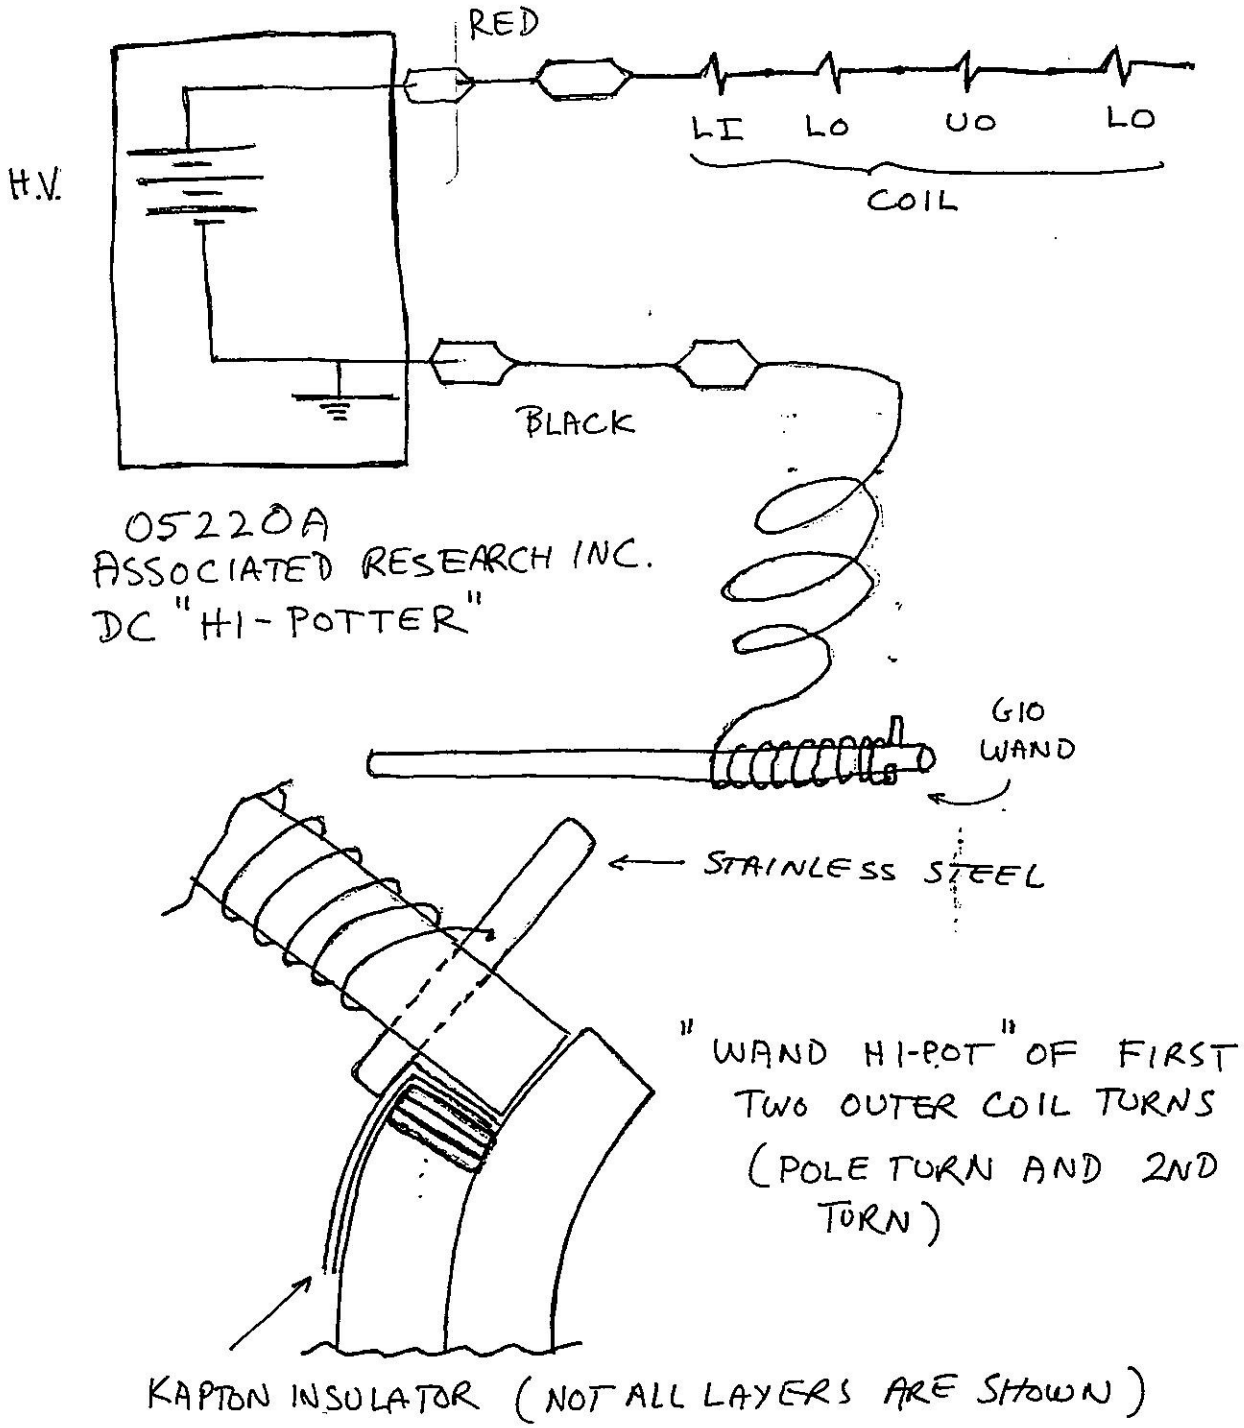
FIGURE 3

2. A wand hi-pot is done in the following manner. The high voltage lead of the hi-pot supply is connected to one of the coil leads. The low voltage lead is connected to a metal rod ~ 1" long and ~ 1/4" in diameter, which is attached to a G10 "wand." The rod may then be dragged up and down the surface to be hi-potted. (See Figure 3.) This technique has proved useful for finding areas in kapton insulator susceptible to breakdown.
