DSA324 Transfer Function
Spatial Distortion I

TS-SSC 91-173
S. Delchamps
September 5, 1991

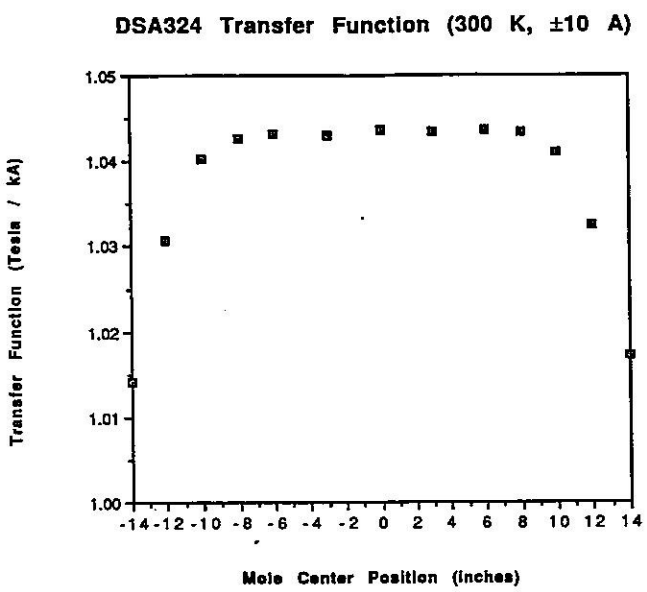
FIGURE 2a.

Figure 2a shows the DSA324 transfer function measured with the dipole bucking coils of BNL B2 mole, a tangential probe with nominal 24" active length. These data were taken at room temperature with 10 A transport current. (Because of the mole probe's length, only the points out to ±10 inches on each side have the entire active length of the probe in the yoked portion of the magnet. The horizontal axis is kept to the same scale as Figures 1a, 1b, and 2b to facilitate comparison.)

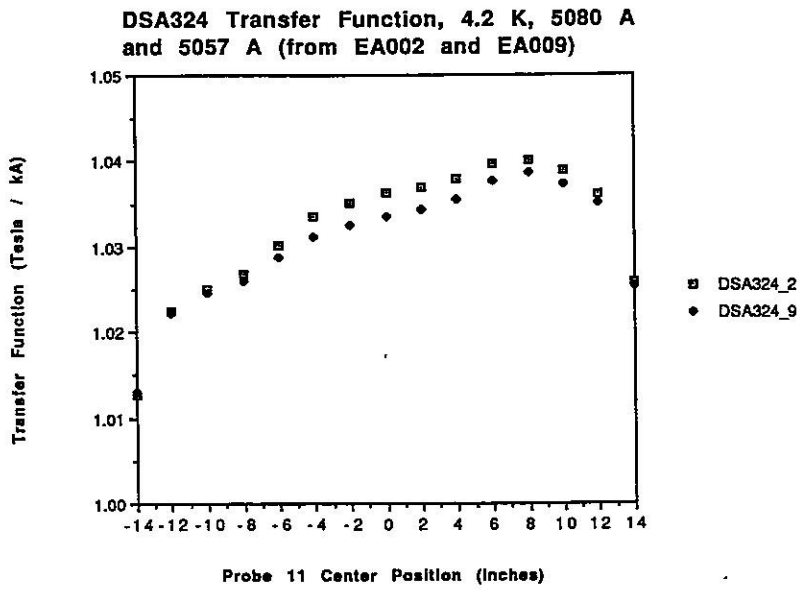
FIGURE 2b.

Figure 2b shows the transfer function for DSA324 measured with Probe 11 read out by the magnetometer. Figure 2c shows the result when the HAL2 system is used to read out Probe 11. Both tests are done at 4.2 K near 5 kA transport current. In both cases a clear distortion is visible relative to the pattern of DSA321 and DSA323.

The appearance of a distortion only in 4.2 K data suggests an effect of the iron yoke. Could the yoke pack near the return end be saturating at a lower field than the rest of the yoke? Since the iron contributes about 30% of the field at this current, the effect would be 1% / 30% ~ 3%. In other words, something has to be amiss with the yoke at the few percent level to account for the distortion. The change in transfer function across the return end monolithic pack indicates that the pack's properties change over its length.

Another possibility is the new 50 mm warm bore. Magnet DSA324 was the first magnet to be tested with this warm bore. If the bore tube were simply tilted relative to the magnet axis at an angle theta, the measured transfer function would be cos(theta) times its true value. To get 99% of the true value would require a tilt angle of 8 degrees, which would mean the bore tube was about 6 inches out of alignment from one end of the yoked portion to the other, which is much greater than the inaccuracy in the real bore tube. Besides, an overall tilt could not alone account for the distortion, since it would give a uniform decrease in transfer function. It may be that the bore tube contains some magnetic material, but it seems that this should lead to an increase in the transfer function.

1) Now that magnet DSA324 is warmed up, we will perform ESR measurments at 10 A current to determine whether the spatial distortion of the transfer function remains at room temperature.

2) DSA326 will be tested cold, and if the effect is still there, the new warm bore will be strongly suspect.

3) If the effect does not show up in DSA326 and is also not present in the low current data for DSA324, then something must be happening to DSA324 itself at low temperature.

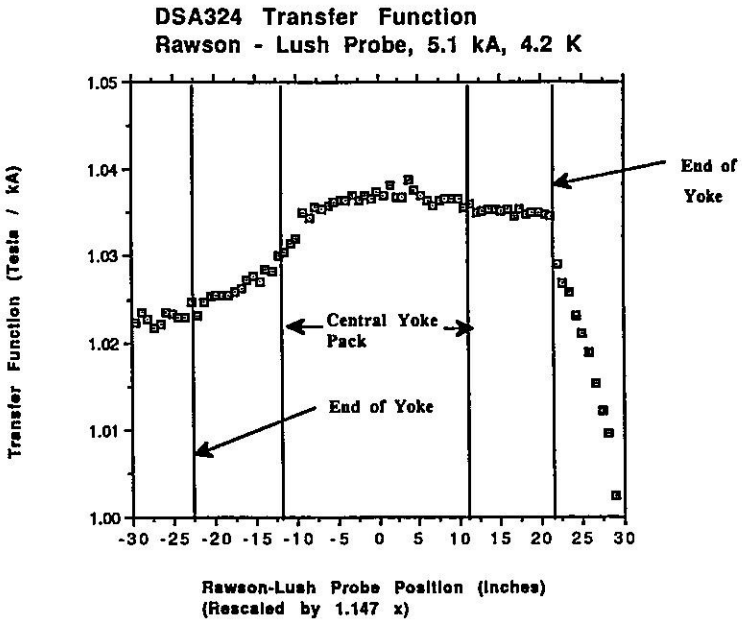
FIGURE 2d

Figure 2d shows the result for the Rawson-Lush probe, nominally 1/4" in length. These data were taken near 5 kA at 4.2 K[1]. A distortion of the transfer function is seen at the return end of the magnet. The distortion seems to be concentrated in the region of the return end monolithic yoke pack. The transfer function drops off rapidly outside the yoke at the lead end, but for some reason remains at a high value toward the return end.

[1]The horizontal axis values have been rescaled to make the rapid fall-off of transfer function at the lead end coincide with the nominal end of the yoke packs. A more accurate transformation of the LVDT data used must be made to be rigorous, and the absense of a rapid fall at the return end must be explained.

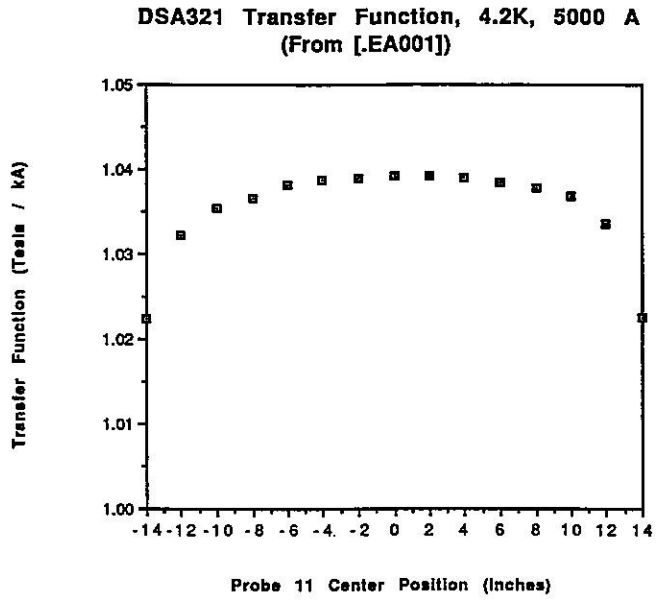
FIGURE 1a.

The Effect: The transfer functions for magnets DSA321 and DSA323, the first two model 50 mm aperture SSC dipole magnets tested at Fermilab, are shown in Figures 1a and 1b. The horizontal axis gives the position of the center of the "Morgan" coil Probe 11 in inches. This probe is nominally 18" long. The Lab 2 magnetometer was used to read out the probe in both cases. The outermost two points in each graph have part of the active area of Probe 11 out of the yoked portion of the magnet. Both transfer functions are measured near 5 kA transport current, at 4.2 K. A slight "bowing" downward toward the ends is apparent in both DSA321 and DSA323.
