SSC 40mm Magnet Collaring Problems

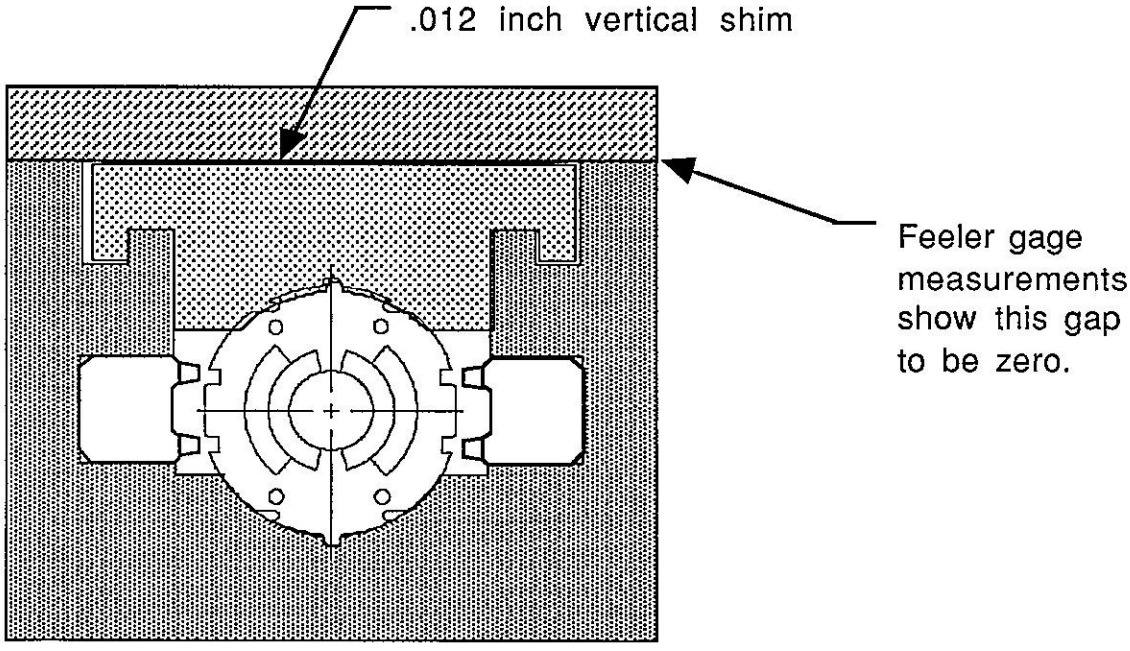
Figure 1.

Problems have been encountered in the collaring process. Specifically, when the mold is presumed closed as shown in Figure 1, the tapered keys still require substantial side force to insert. Even if the coil is, according to all dimensions on the drawings, overcompressed by as much as .012 inches by using a vertical shim as shown, the keys will not insert without force. It appears that significantly more overcompression is required than was anticipated.

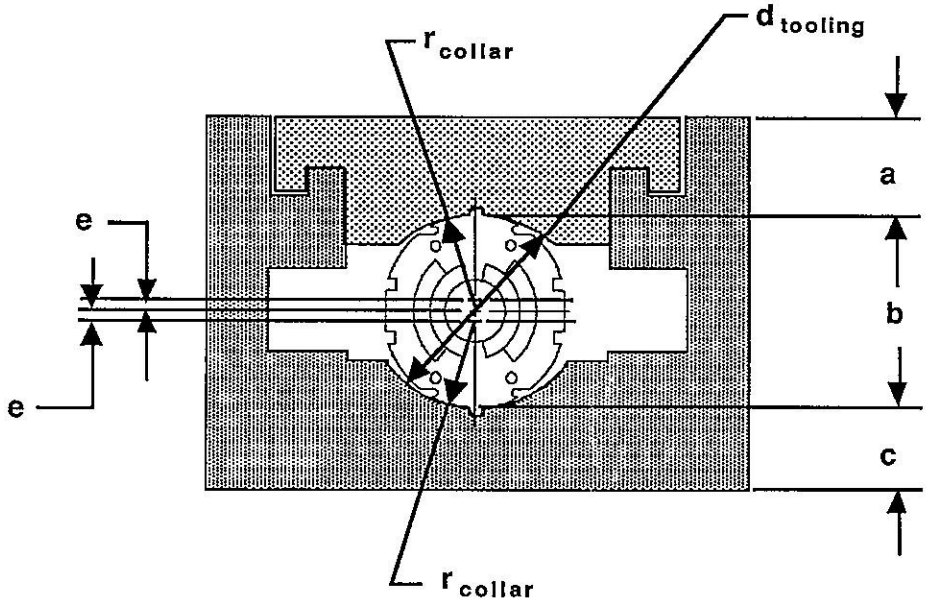
Figure 2.

a = 2.319
a + b on lower tooling = 6.683
$b_{tooling}$ = (a + b on lower tooling) - (a on upper tooling) = 6.683 - 2.319 = 4.364
r_{collar} = 2.180
e = .002
b_{collar} = 2.180 + 2.180 + .002 + .002 = 4.364
c = 3.070
$d_{tooling}$ = 4.3675 ($r_{tooling\ lower}$ = 2.1835 and $r_{tooling\ upper}$ = 2.184)

The important numbers to compare are the actual $b_{tooling}$ with the actual b_{collar}. They both are 4.364. So within our ability to measure, parts tolerances are not affecting the collaring problem.

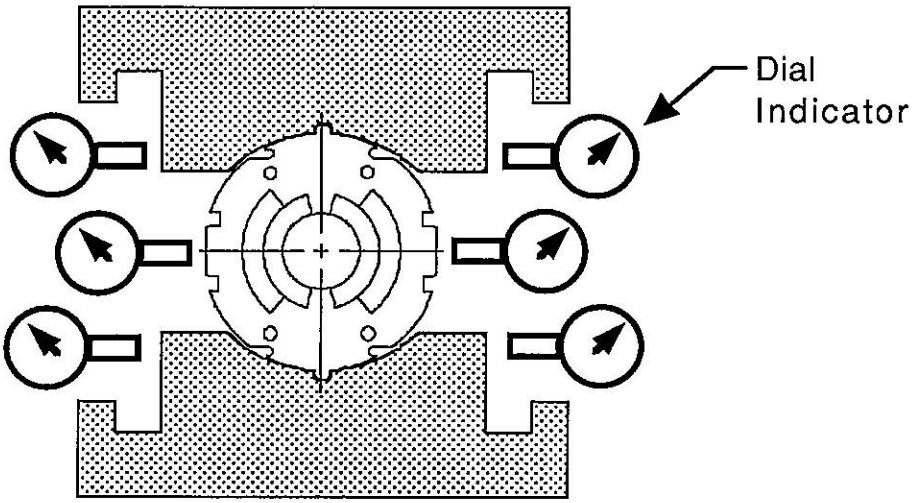
The collars, when the maximum vertical load is applied, deform by approximately 8 mils on the horizontal diameter. This is the result of measurements taken by Nick Hassan during collaring of DS0312 (see "Horizontal Deflection of Collar Laminations" TS-SSC 90-070). The horizontal tooling deflection totals approximately 5 mils (2.5 mils per side). Tooling "tops" were used on both the top and bottom to make measurements of the horizontal collar diameter possible. Measurements were taken of both the horizontal deflection of the collars and the tooling in the positions shown by dial indicators in Figure 3.

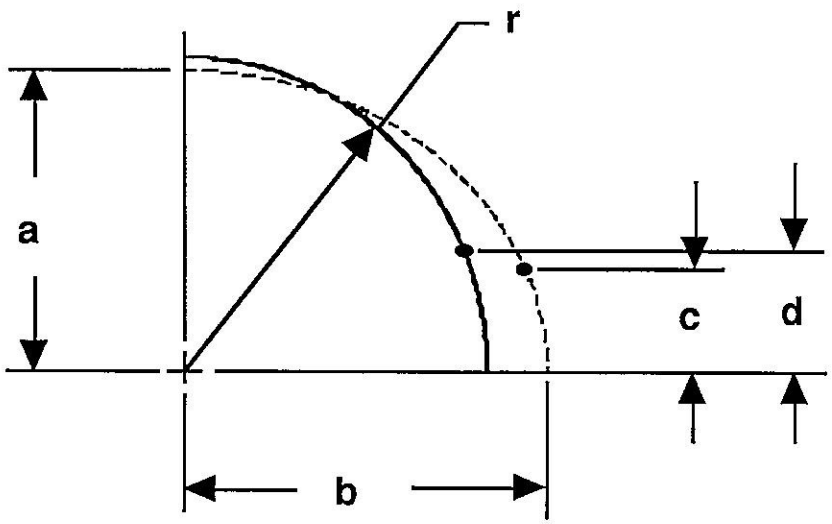
a.) The entire collar could be taking an oval shape, becoming 8 mils wider horizontally. The result of this type of deflection is shown in Figure 4.

horizontal radius is b = r + .004 = 2.185. The perimeter is still 13.704. The first order equation for the perimeter of an ellipse is $P = \pi[2(a^2+b^2)]^{1/2}$ The vertical radius (a) is therefore $a = \{[(p/\pi)^2/2] - b^2\}^{1/2} = [(4.362^2/2) - 2.185^2]^{1/2} = 2.177$. So, assuming the collar lamination takes an elliptical shape and the perimeter remains constant, the vertical radius has been decreased by 2.181-2.177 or 4 mils. Deflection of the outside radius of the collars would therefore cause the collared coils to require 8 extra mils of overcompression.

This type of deflection would also cause a change in the height of the key slot. In Figure 4, the vertical distance to the bearing surface of the key slot of the undeflected collar is d, while the same distance on the deflected collar is c. d = .181 on the undeflected collar. As derived from a CAD layout, The difference between d and c is smaller than .0001. This means that the upper key slot has effectively closed by .0001 due to the collar deflections. This is small enough to be disregarded. It is unclear how the lower key slot deflects.

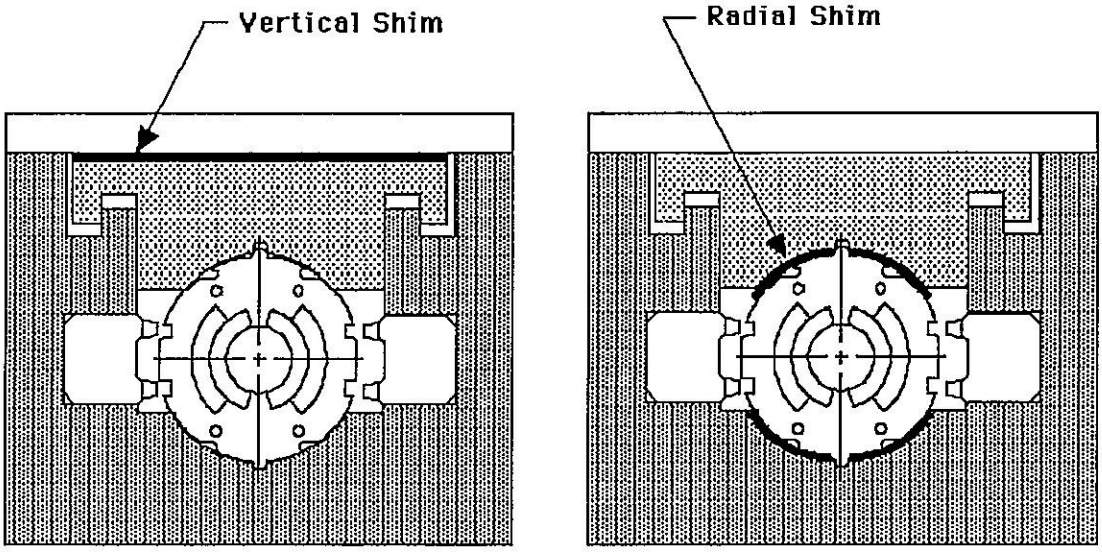
Figure 5.

Attempts have been made to eliminate the collar's ability to ovalize to conform to the tooling diameter by using radial shims when collaring. These shims are placed directly around the collars to take up the difference in radius between the collars and tooling. (This difference can be seen by comparing r_{collar} with $r_{tooling}$ in Section 1). Use of a radial shim should in theory eliminate any ovalizing of the collar lamination that does not include a corresponding tooling deflection of the same magnitude. In theory, if the collar is ovalizing, a 3 mil radial shim placed as shown in Figure 5 (for example) should provide more compression than a 6 mil vertical shim, because the 3 mil radial shim would provide 6 mils of vertical shim plus prevent the collars from ovalizing.

If the collars were not ovalizing when no radial shim is used (or if the tooling were deflecting with the collars when the radial shim is used), the 3 mil radial shim and the 6 mil vertical shim should be equivalent. The two situations were compared in collaring experiments by Nick Hassan on magnet DS0312. There appeared to be no significant difference, indicating that either the collars are not ovalizing or the tooling is deflecting with the collars.

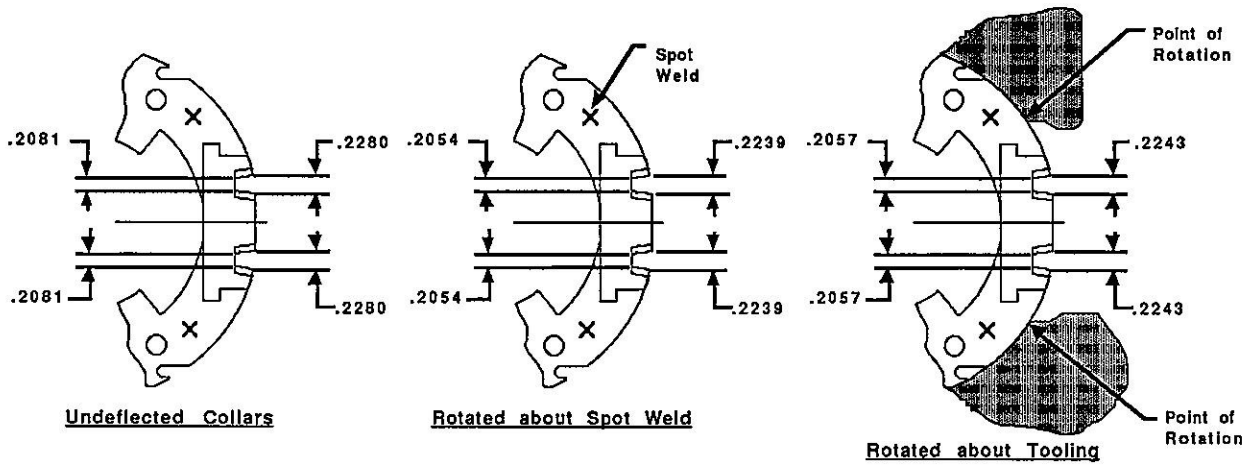
b.) The sides of the collar lamination could be rotating outward while the height of the lamination remains the same. The effects of this on the key slot are shown in Figure 6. They are drawn from a CAD layout by Nancy Bartlett.

Three different situations are shown. The undeflected collars show the key slot size if no rotation were taking place. Two types of rotation are shown. If the collar sides are rotated about the spot weld, the key slot is effectively made smaller by .0041 on the outside surface and .0027 at the bottom. If the collar sides are rotated about the corner where the tooling contacts the collar, the key slot is made smaller by .0037 at the surface and .0024 at the bottom. In either case this effect would cause approximately 4 mils of additional overcompression to be required. The key slot configuration changes do not seem to be very sensitive to the point of rotation.

The measured tooling lamination deflections seem to be inconsistent with the idea of the collars rotating significantly about the tooling as in the third part of Figure 6. The collars would have to be ovalized before they contact the tooling by an amount that would already account for almost the entire .008 horizontal deflection. Rotating about the spot weld, however, is not precluded by the tooling deflections.

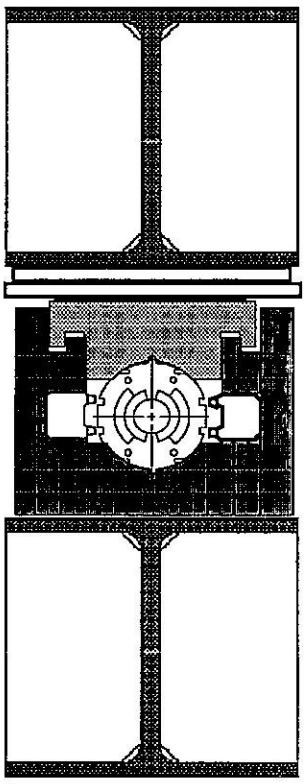
The collaring tooling is compressed by two plattens. The plattens consist of boxed I beams as shown in Figure 7.

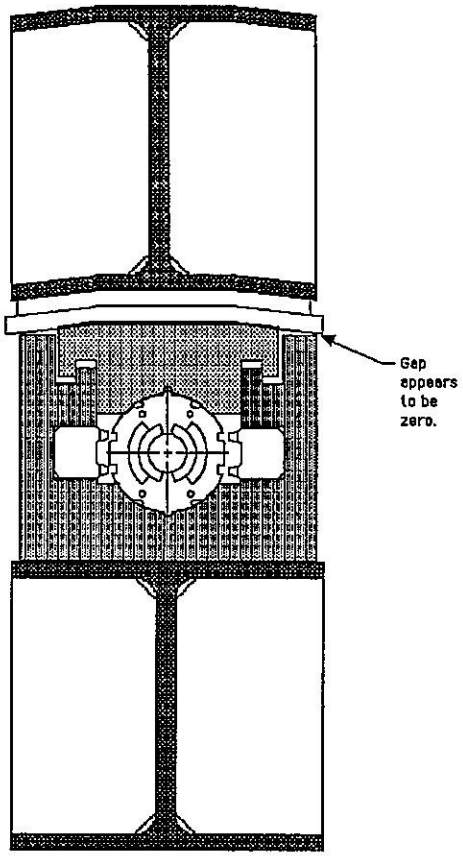
When the vertical cylinders are powered, the upper platten is acted upon by three forces. Two rods pull down on it from positions 28 inches apart. These forces are reacted by the coil pushing up on the platten in the center. The upper platten can deform into the shape shown in Figure 8. If this situation exists, the gap can appear to be zero as shown while the collared coil is not completely closed. Preliminary finite element analysis by Eric Haggard has indicated that the deflections may be significant. To determine the magnitude of this effect, a solid steel rod of the same outside diameter as the inside diameter of the tooling will be placed into the collaring tooling in the long press. Gaps will be measured at the full range of press pressure. The change in gap (subtracted from the expected compression of the steel rod) will determine how much the platten is deflecting. The steel rod is expected to be available by Nov. 14.

The direction of the deflections in the upper tooling described in this section, if the tooling follows the platten deflections, are in the opposite direction as the ones discussed in Sections 2 and 3. Here the surface of the tooling is convex, while previously it was concave. The sections appear to be contradictory.

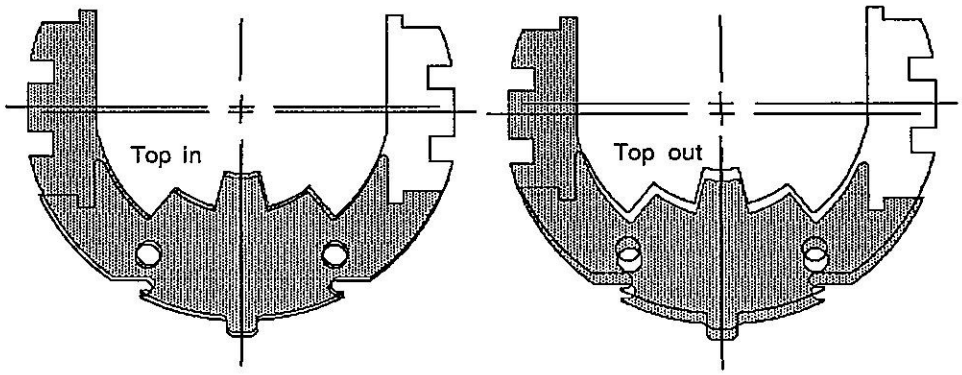
Misregistered pairs come in two types with respect to the vertical misregistration. They are shown in Figure 9. The shaded laminations are assumed to be on top of the line-only laminations (in other words, closer to the reader). "Top in" means the top lamination is closest to the center of the bore of the magnet. "Top out" means the top lamination is farthest from the bore of the magnet.

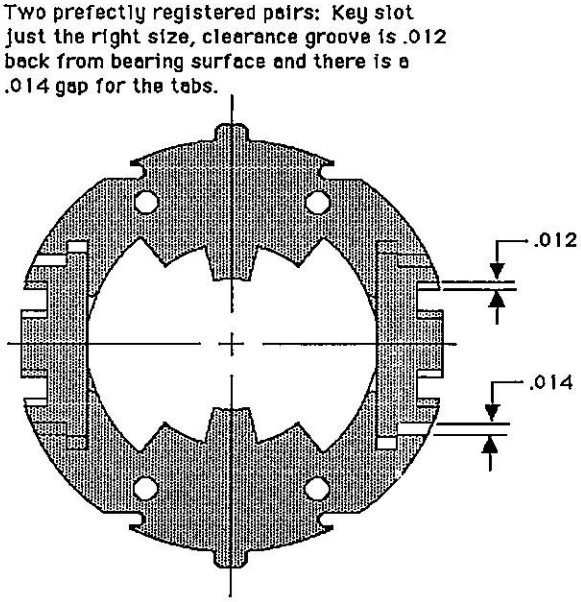
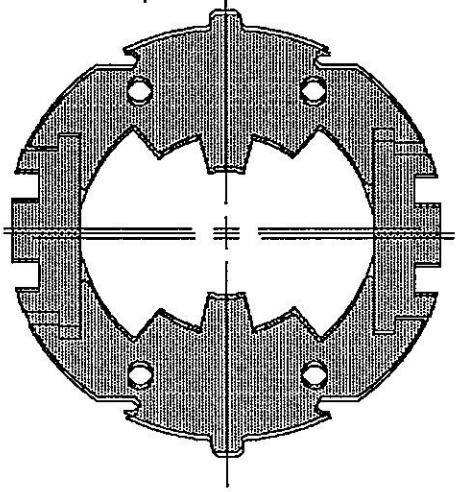
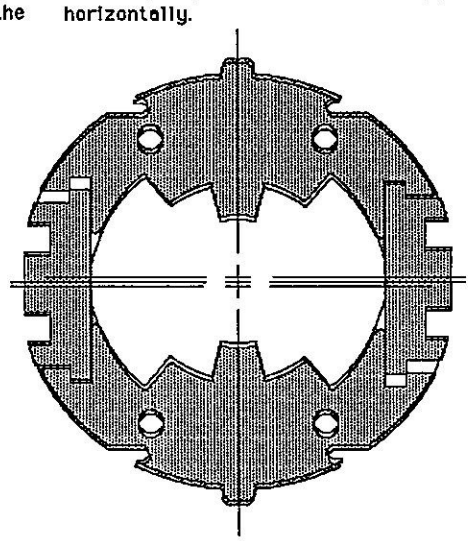
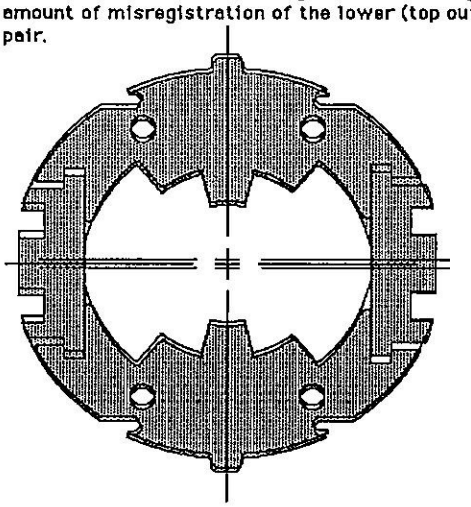
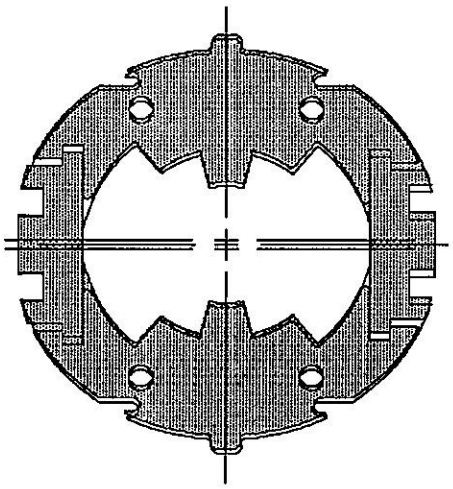
Figure 10.

Top in -to-top in: Right side key slot is larger by the amount of misregistration of the upper pair. Left side key slot is larger by the amount of misregistration of the lower pair. Clearance surface is closer to the bearing surface in both cases by the same amount as the misregistration. Tab gaps are unchanged in two quadrants and reduced by the sum of the misregistrations in the other two quadrants.

Top out-to-top out. All effects are exactly the same as a top in-to-top in but reversed about the vertical axis. A top out-to-top out pair is in fact identical to a top in-to-top in pair which has been flipped horizontally.

Top in -to-top out. Key slot is exactly the correct size on the left side and increased in size by the sum of the two misregistrations on the right side. Clearance surface is closer to the bearing surface on the right side by the sum of the misregistrations. Tab gaps on the upper left and lower right are smaller by the amount of misregistraion of the upper (top in) pair. Tab gaps on the lower left and upper right are smaller by the amount of misregistration of the lower (top out) pair.

Top out-to-top in. A top out-to-top in pair is identical to a top in-to-top out pair which has been flipped horizontally. All effects are identical but reversed about the vertical axis.

In all cases, the misregistration causes the key slot to grow larger while the clearance for the back surface of the tapered key gets smaller. This indicates that misregistration of lamination pairs does not contribute to the collaring problem. It probably does not make the key slot appear significantly larger, though (a reverse effect), because there are still a large number of well registered pairs intermixed with the poorly registered ones.

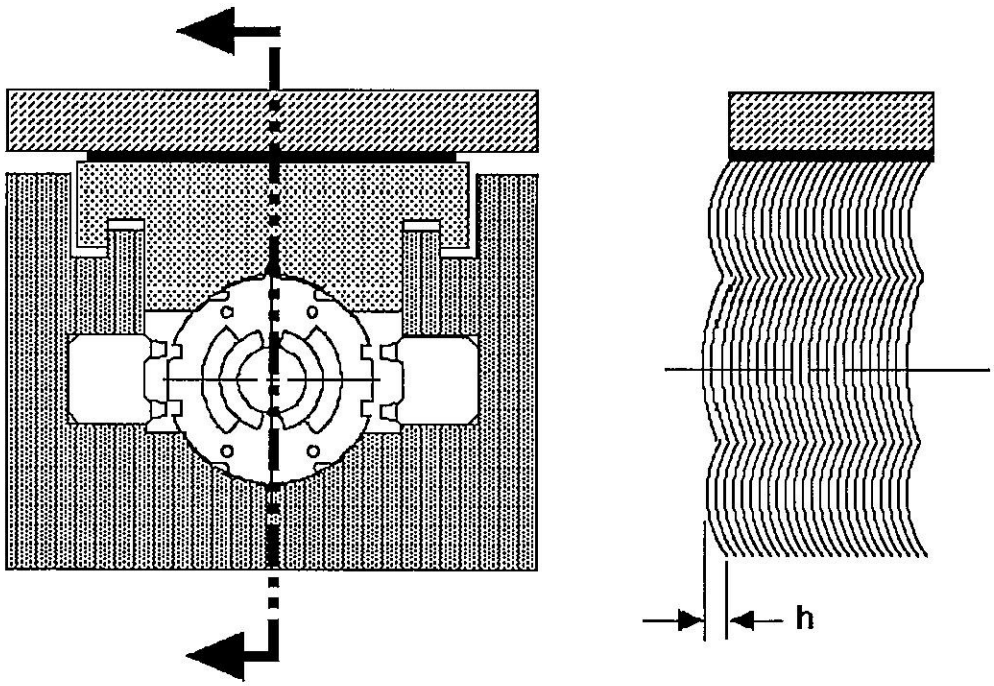
Figure 11.

Both the collaring tooling and the collared coil assembly, being laminated structures, have very little resistance to shear. As a result they can curve as shown in Figure 11 under the loads applied by the platten.

Lower tooling compressions would not contribute to the collaring problem. This means that the whole assembly (collared coil in tooling) would compress due to the lamination curving by .0014 + .0007 = .0021 inches. We do not know, of course, if the .030 figure for h is realistic or if the curvature is circular, but the figures show that this effect is at most a small contributor to the problem. If the curvature were some shape other than circular, the vertical deflection would be more severe for the same h value.

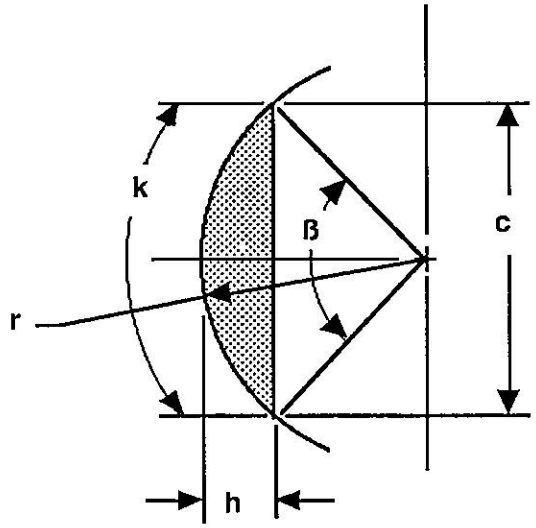
Figure 12.

If we assume the maximum longitudinal deflection (h in Figures 11 and 12) is .030 and the shape of curvature is circular, we can calculate the vertical deflection.

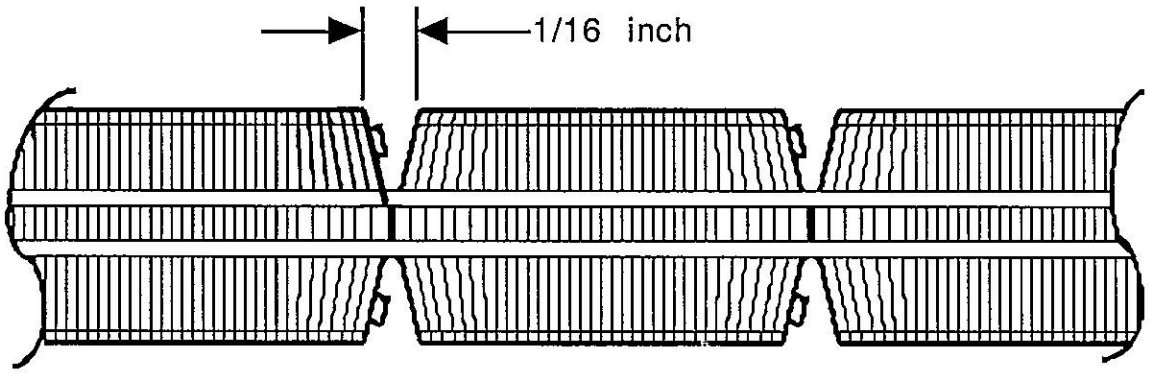
Collar packs are stacked very loosely. As a result the collar laminations tend to slant when the pressure is applied in the collaring press. The design gap between collar packs of 1/32 inch is frequently in excess of 1/16 inch at the poles while closing to zero at the parting plane as shown in Figure 13. This causes the height of the collar laminations to be locally smaller.

$r_{collar} = 2.181$. Half the gap between laminations at the top = .03. $x^2 + .03^2 = 2.181^2$ $x = 2.1808$ $2.181 - x = .0002$. The total collared coil height is therefore smaller locally by .0004 due to this effect. This is not a significant contributor to the problem unless the laminations are taking a curved shape and bending much more near the top. This does not appear to be the case from observation. In any case it would probably occur only locally near the ends of the packs.
