DCA312 Yoke Chevroning

TS-SSC 91-177
S. Delchamps
October 8, 1991

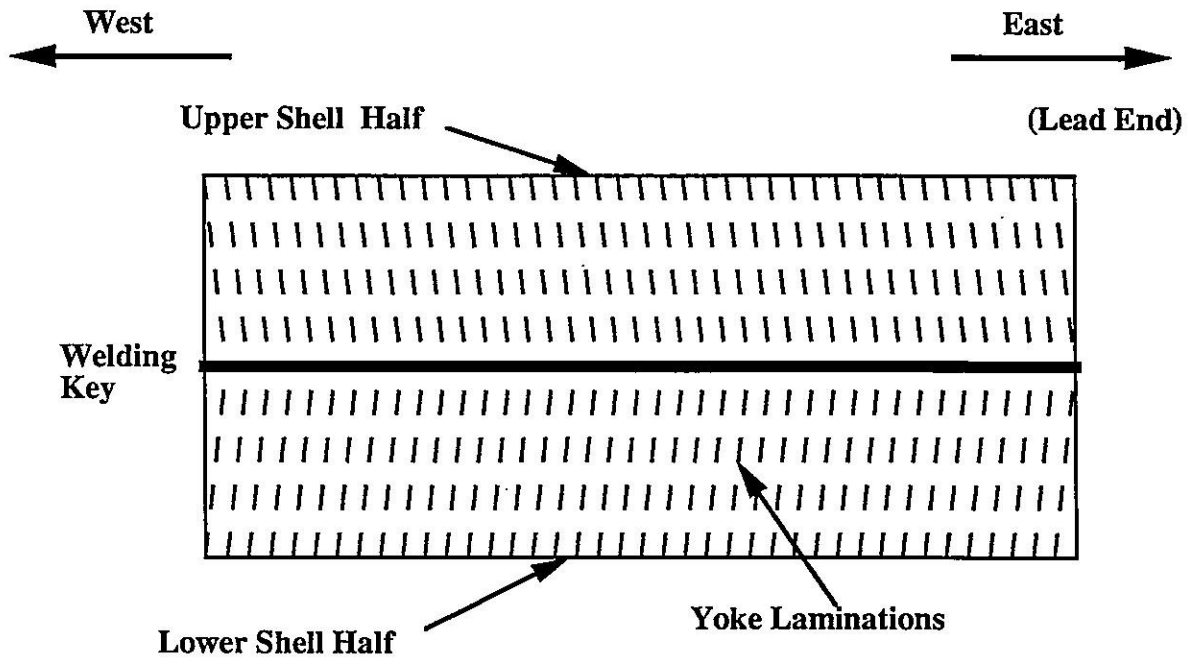
Description of the Incident: "At full pressure [7000 psi] before welding of the cold mass all of the 12 foot yoke packs shifted causing the press pressure to drop from 7000 psi to 6000 psi."[1]. (This occurred on August 26, 1991.)

After this incident, the press pressure was dumped and the cold mass was rolled out of the press. When the upper shell half[3] was removed, it was found that the upper and lower yoke laminations had "chevroned" as shown in Figure 1. The degree of the chevroning was not recorded quantitatively, but those present recall it as 5 to 7 laminations[4] as measured from the parting plane to the outer surface of the yoke laminations. The laminations tilted toward the west as shown in the figure.

Figure 1. Chevroning of Yoke Laminations in DCA312

Proposed Solution to the Chevroning Problem: The proposed solution[7] to the chevroning problem, which is evidently caused by a lack of stability of the yoke assembly under pressure, is shown in Figure 5. First, a higher packing fraction (99%; the original value was 98%[8]) will be used in the standard packs. Second, epoxy reinforced "monolithic" packs will be placed not only at the ends of the yoke assembly but at three positions along the magnet to give better support.

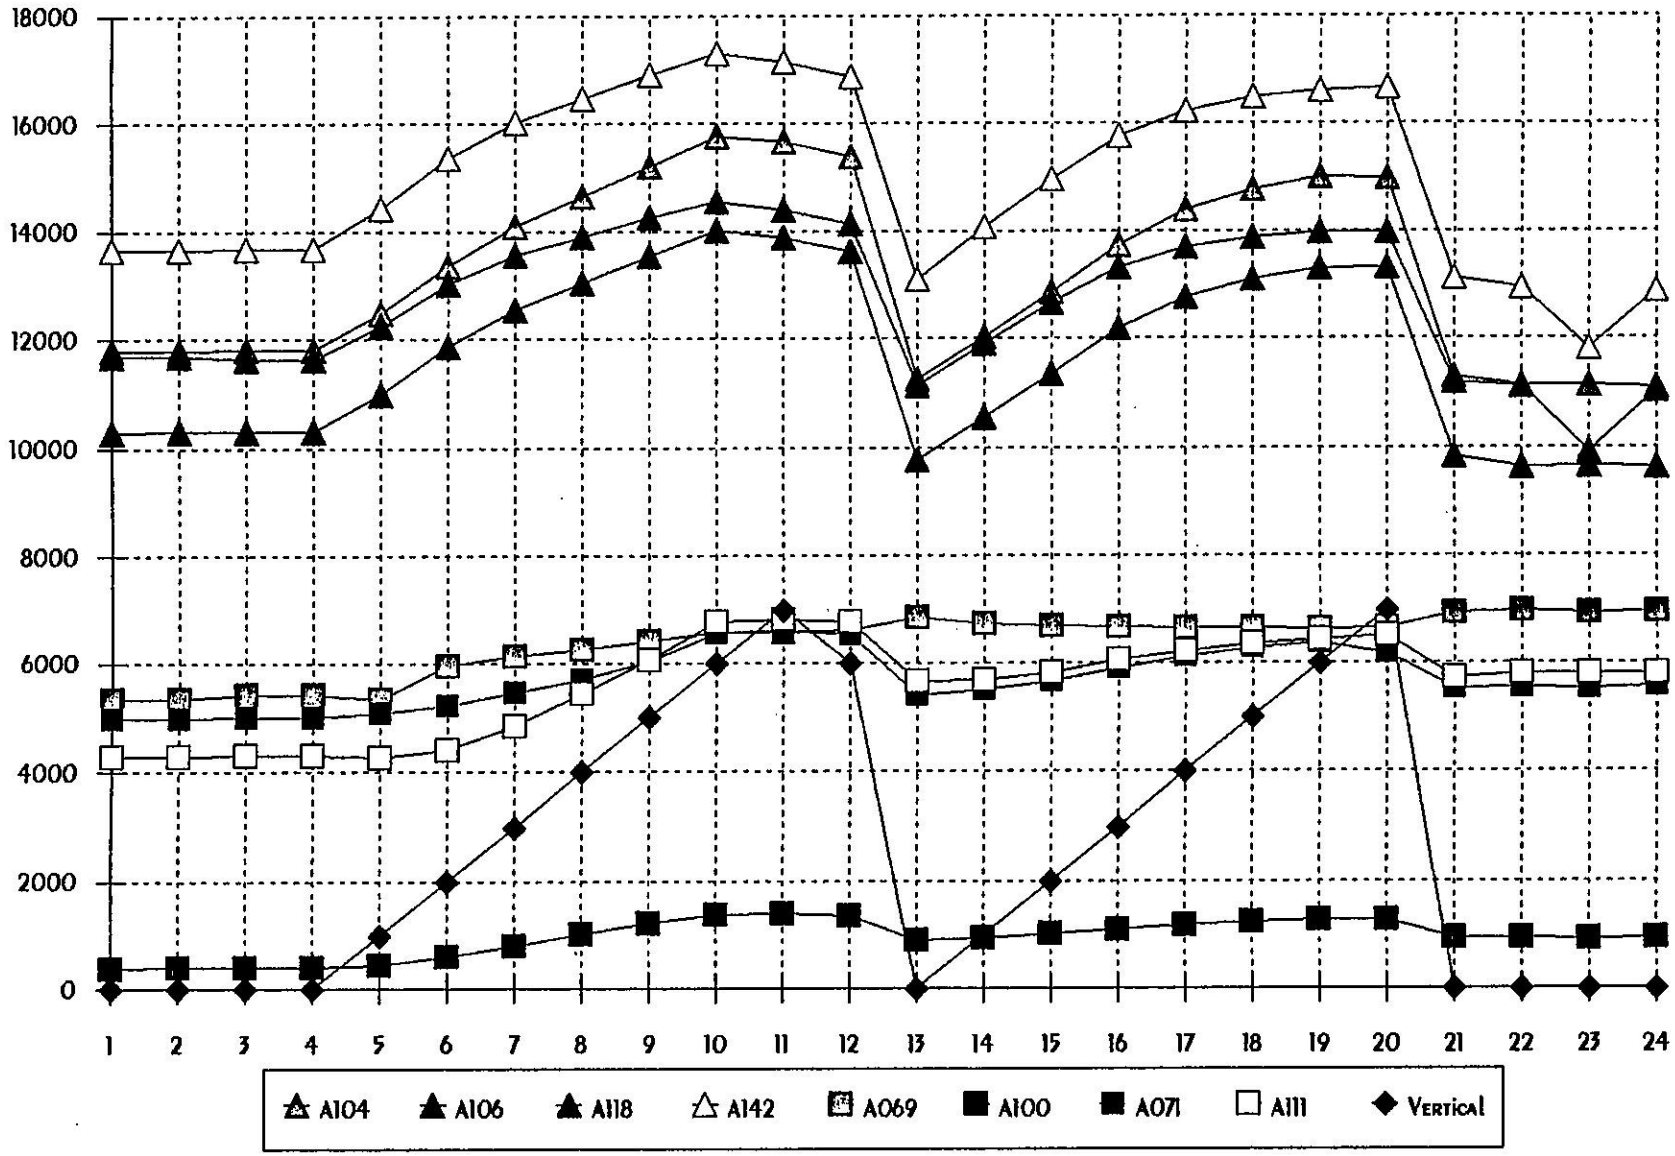
FIGURE 2a

Measurements Taken During the Incident: Both collar strain gauge and shell strain gauge measurements were taken as the yoking press pressure was raised. The first pressing values for the shell gauges were discarded, so that for these gauges we cannot compare the first and second pressing cycles. However, collar strain gauge data exist for both pressure cycles, and are shown in Figures 2a and 2b.

The triangles in the Figures 2a and 2b denote inner coil gages. It is seen that on the second pressing, where the chevroning took place, the inner coil stresses increase at the same rate as on the first pressing. However, they start and end at a lower pressure on the second pressing.

The outer coil gauges show little change in stress on either the first or the second pressing; one of them (A115 in the lead end pack) shows an odd double-valued behavior.

DCA 312 LEAD END YOKE READINGS

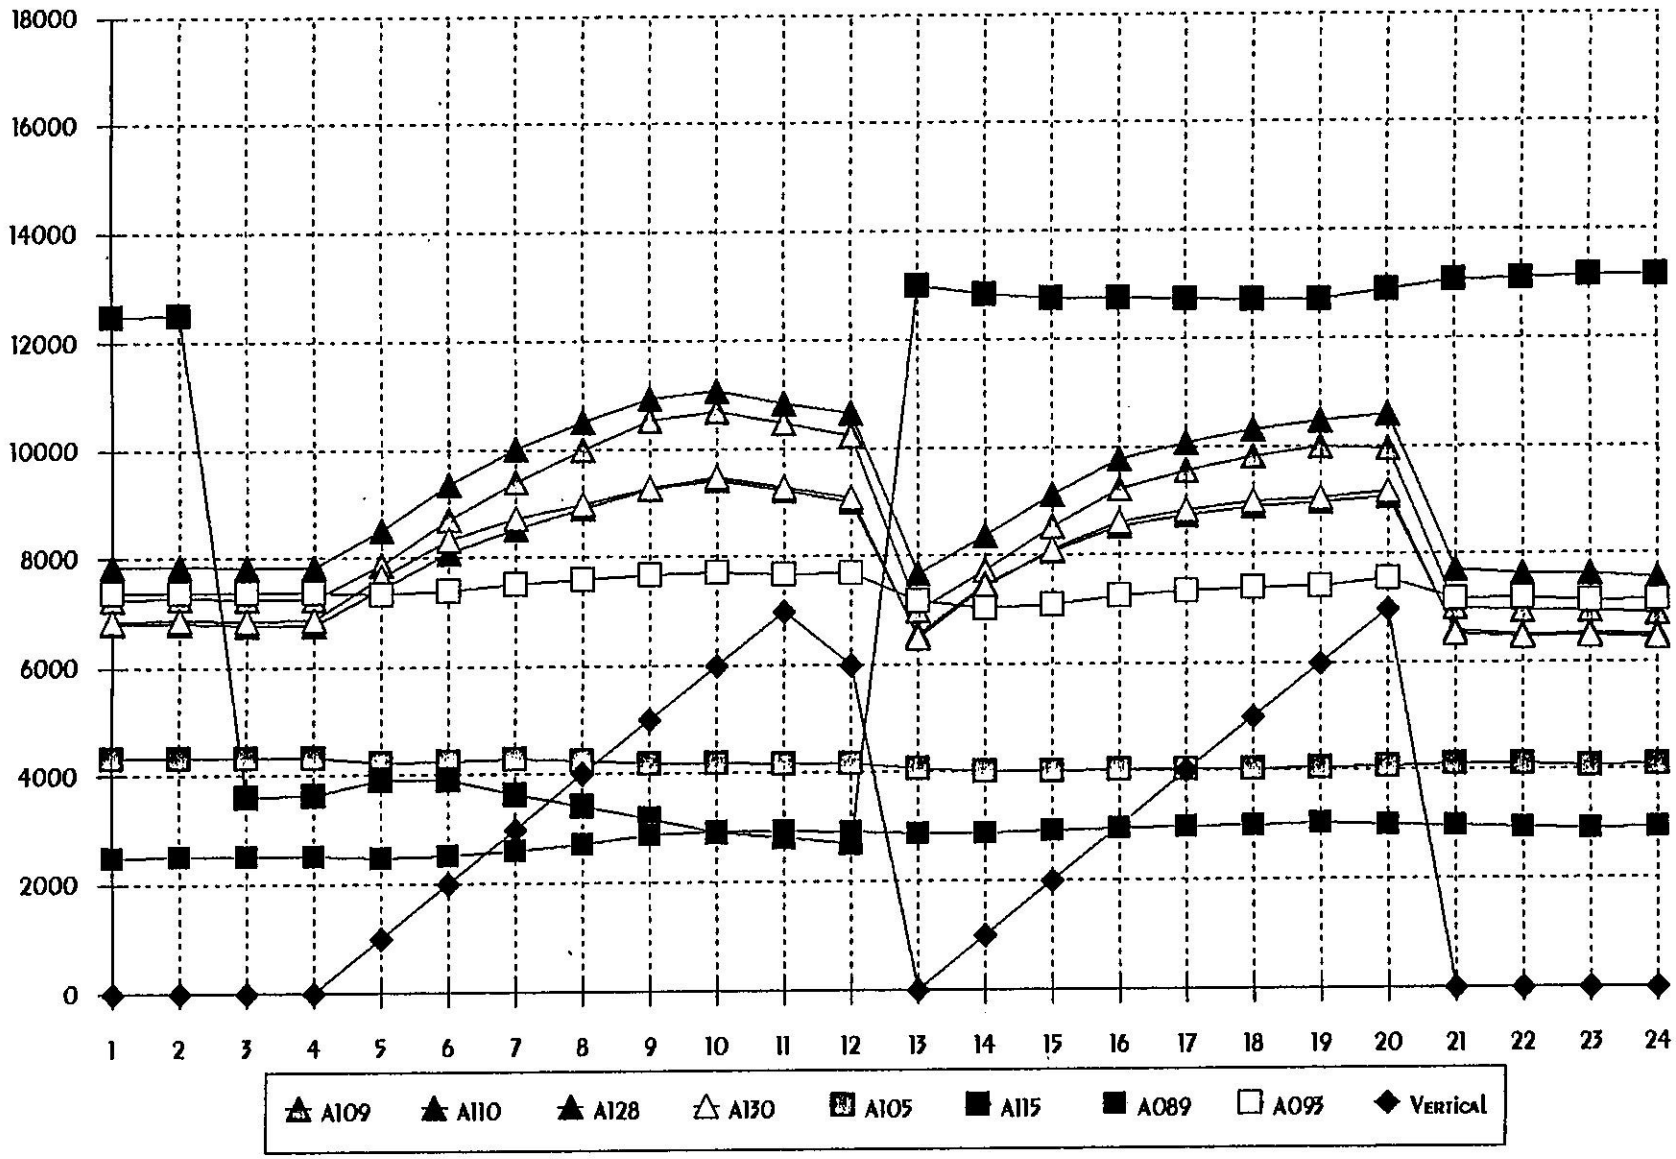
FIGURE 26

DCA 312 RETURN END YOKE READINGS

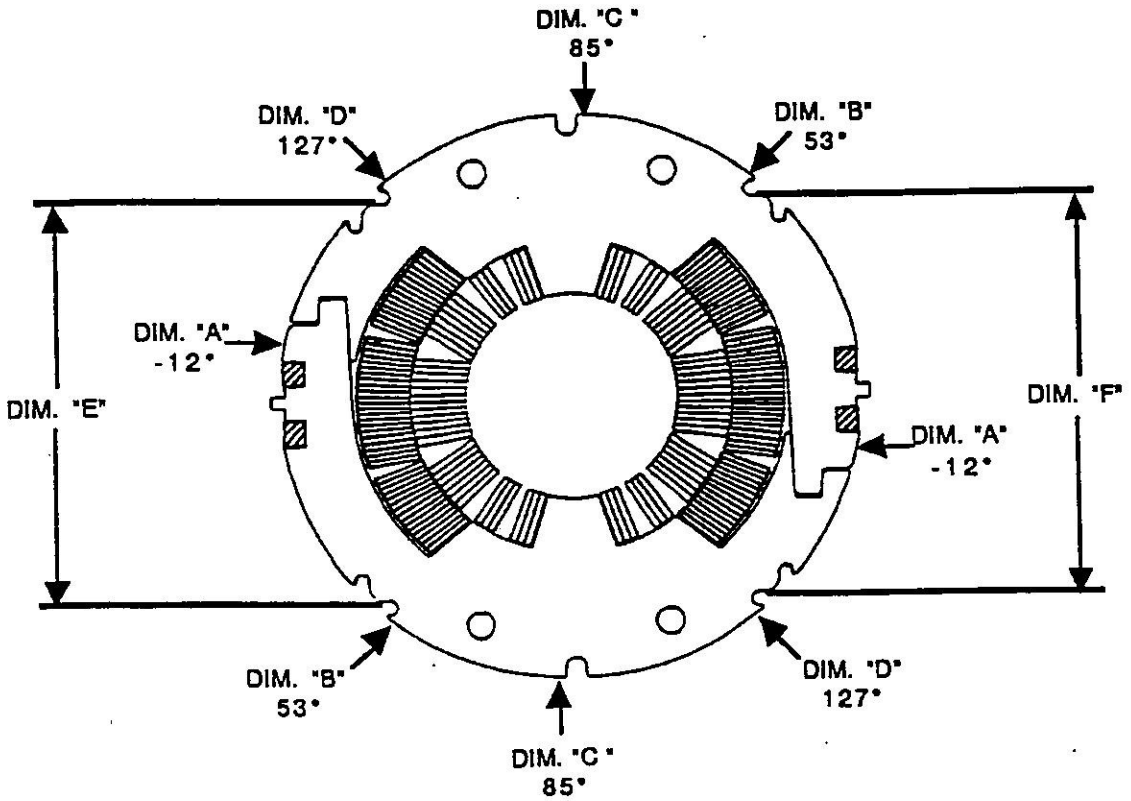
Coil Diameter and Size: Some superficial scratching and bending of the collar laminations was observed near the return end of the coil. Table 5 shows collar size measurements before and after the incident averaged over the entire length of the coil. The collar diameter is measured at four azimuthal positions, labeled A - D, and and shown in Figure 3. Two other size measurements, labeled as E and F, are also shown in the figure and given in Table 5. (The full set of measurements are included as an appendix to this report.)

Measurements E and F may have changed significantly in some parts of the collared coil assembly. This change could in principle be due to the chevroning incident. The post-incident r.m.s. values are larger in some cases than the pre-incident values. This may be due to the "rushed" nature of the post-incident measurements.

Figure 3. Collar Diameter and Height at Alignment Feature Measurements

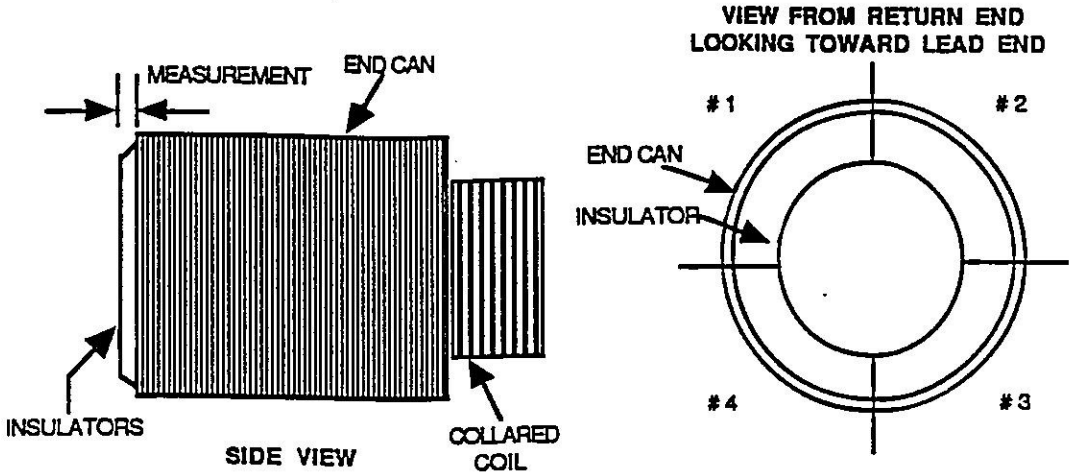
End Clamp Position, Diameter, "Closure": The return end clamp was found to have slid ~.1" toward the return end of the collared coil assembly. Both the lead and return end caps were removed, and the relative positions of the G10 CR insulator surfaces and the ends of the aluminum end clamp cylinders were measured ("closure" measurement, see Figure 4). The diameters of the end clamp cylinders were measured as well. None of these dimensions was found to have changed by more than 2 mils from the pre-incident values. (Unfortunately, the raw post-incident data have been lost.)

Quadrant #1 .038 Quadrant #2 .043

Quadrant #3 .045 Quadrant #4 .039

Figure 4. End Clamp "Closure" Measurement

The lead end clamp assembly was apparently not damaged. At the return end, the green putty used to make the saddle surfaces flush with the collet insulator surface cracked when the return end clamp slid. This green putty was repaired. Both end caps were re-
welded. No attempt was made to move the return end clamp back to its original clamped position.

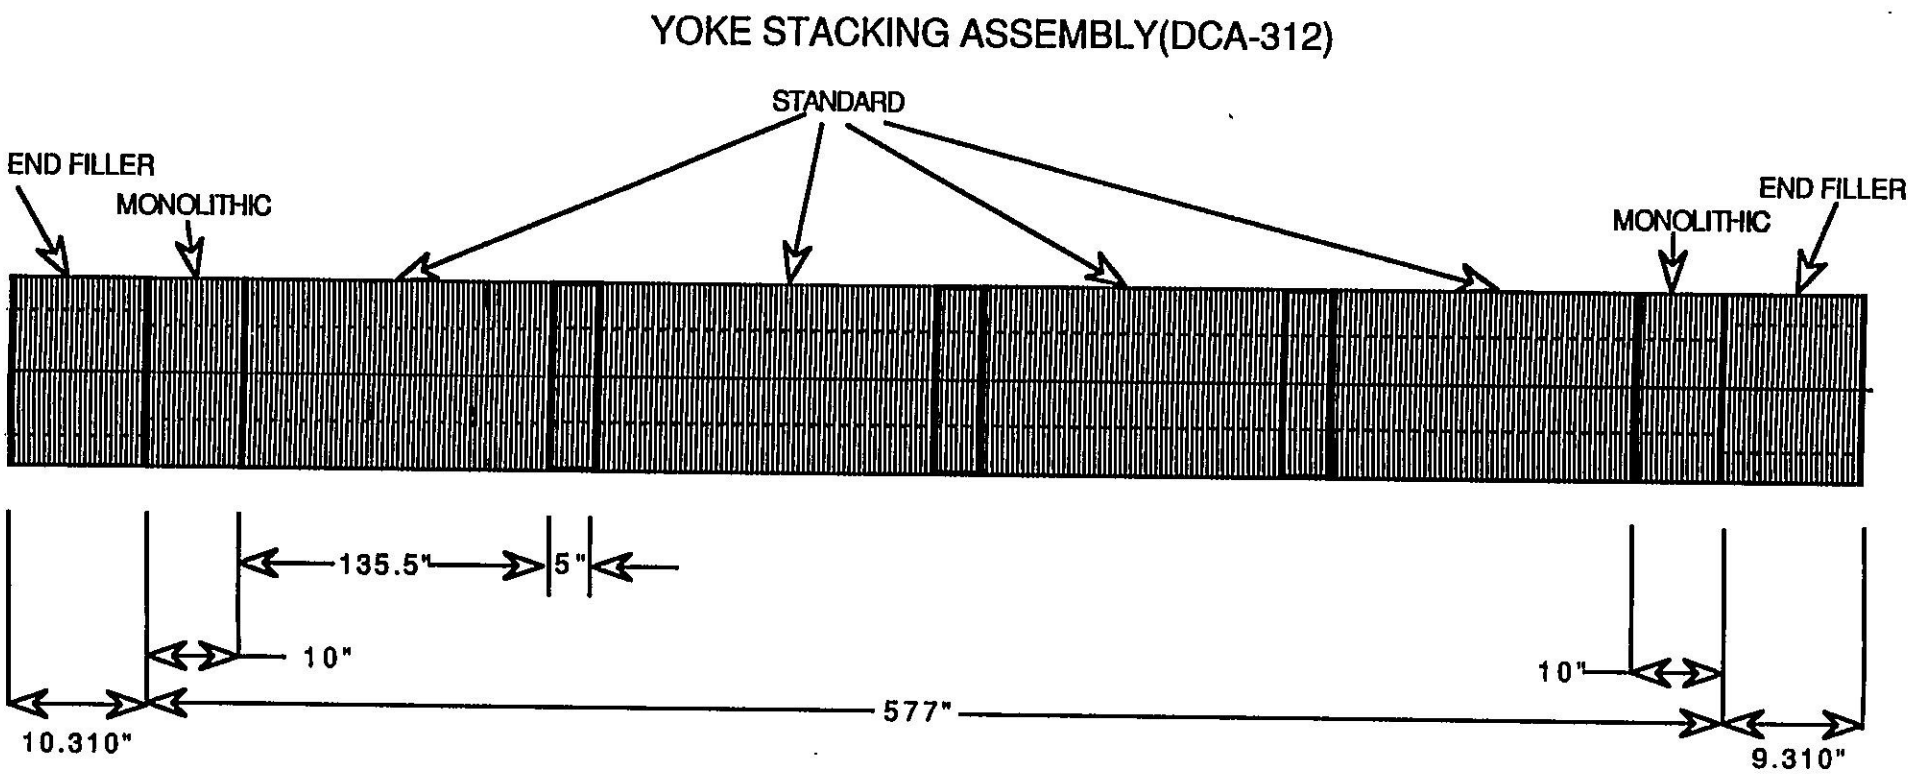
Figure 5. Proposed Solution to Yoke Lamination Chevroning Problem (M. Gordon)

This approach has already been used in the assembly of the DCA312 and DCA313 cold masses.
