# HB650 CRYOMODULE DESIGN: FROM PROTOTYPE TO PRODUCTION*

*Abstract*

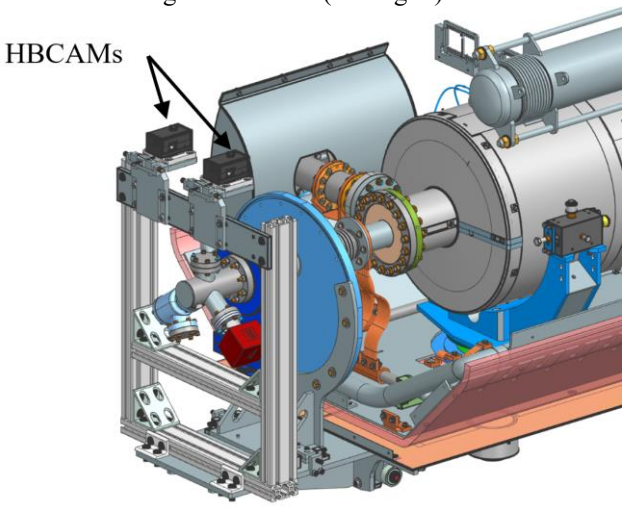
- One of the goals of the monitoring cameras (HBCAMs) were to check the alignment of the cavities after the coldmass insertion [5]. To do this, the HBCAMs locations with regards to the coldmass need to be fixed. During the assembly process a support on wheels was used, which didn't provide enough precision. For next cryomodules, the HBCAM support will be part of the beam pipe end assembly tooling. Thus, the HBCAM support will remain attached to the coldmass during the insertion (see Fig. 1).

Figure 1: HBCAMs on the beam pipe end assembly tooling.

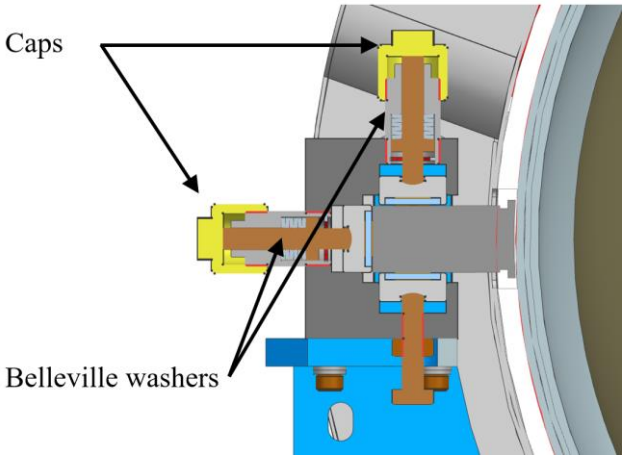
- The C-shape elements on each cavity lugs are used to keep the cavity aligned after cool-down [1] but also to constraint the cavity during transportation by using a cap. The plan was to use these caps only for transportation, but the latest calculations have shown that these caps can remain in place during the cold tests which will ease the assembly process. The Fig. 2 shows the design and location of these caps. Also, for production cryomodule the stiffness of the Belleville washers will be higher to make sure that the bearings are always in contact to the cavity.

Figure 2: C-shape elements with caps.

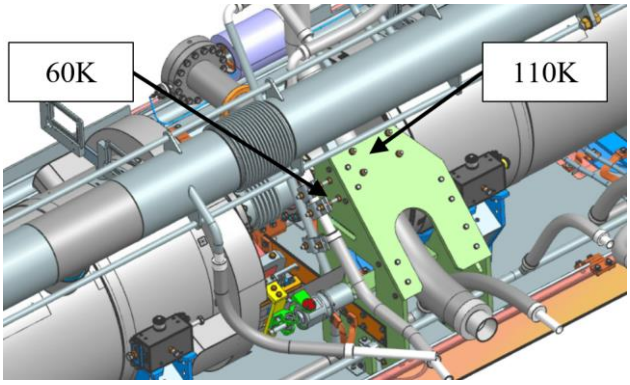
From all the temperature sensors inside the coldmass, only two sensors on the middle G10 support read unexpected values (See Fig. 3), with values even higher than the temperature of the thermal shield. However, these high temperatures were not enough to explain high heat loads at 2K.

Figure 3: High temperature measured on the middle G10 support.

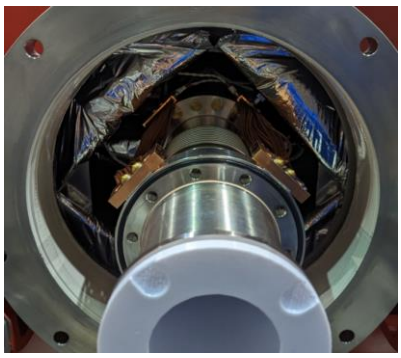
2K heat loads measurements have been done by running the HTTS temperature at 110K instead of 50K and also by removing the helium flow in the LTTS. For both cases the heat loads increased as expected. Thus, the radiation from room temperature to 2K became the main point of interest. Investigations have shown that the heat loads by radiation from the room temperature coupler parts which are inside the coldmass were not accounted for and MLI on the thermal shield was not close enough to the coupler.

Figure 5: Warm part of the coupler going through the thermal shield.

Calculations showed that it was contributing to around 15 W to the 2K heat loads. The G10 emissivity being close to 1 and located right in front of one coupler, this radiation seems to be also responsible of the high temperatures measured on the middle G10 support. In addition, it was estimated that microphonics in the cool-down valve were contributing to around 5 W to the 2K heat loads. Therefore,

To reduce the heat loads a plan has been set up to make design improvements after the 1st warm-up of the cryomodule. Each coupler port will be open, and the warm parts of the coupler will be removed. Then an aluminum plate will be connected to thermal shield (See Fig. 11 and Fig. 12) and MLI and tape will be set up to shield the radiation. Temperature sensor on the G10 support will be checked and MLI will be put on the G10 middle support. These improvements won't be good enough to fix completely the heat loads issue, but we expect to reduce them by 5 to 10 W. In addition, the temperature of the G10 middle support should drop significantly.

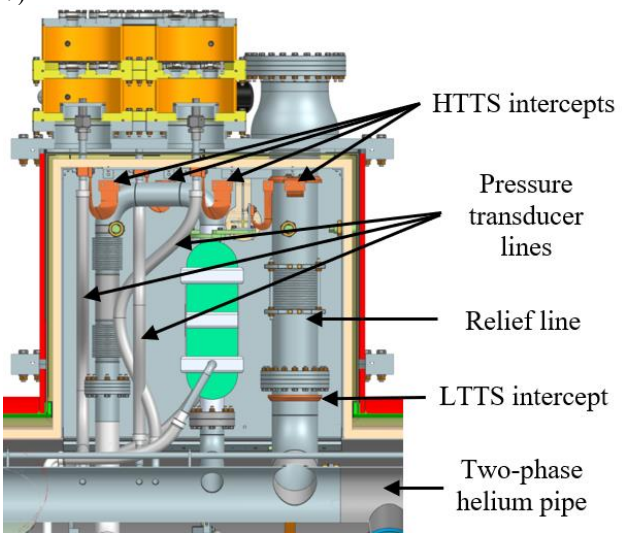
Concerning the heat loads difference with cavities at 2K and 4K, it is likely due to the "Rollin films" going up against the walls of the three flexible tubes inside the pressure transducer lines and making shorts with the thermal shield (See Fig. 6). 20 W due to "Rollin film" seems important but this phenomenon could be facilitated by more than 50 wires present inside each of these tubes. (See Fig. 7).

Figure 6: Pressure transducer lines and relief line interfaces.

To validate that heat loads difference with cavities at 2K and 4K is due to the "Rollin films", heaters will be installed at the bottom of each pressure transducer lines. If that is the case the heat loads should drop when the heaters are on. To save time during the warm-up, the top part of the cryomodule won't be removed, all the work will be done through an access port [1]. Thus, it won't be possible to add temperature sensors on the pressure transducer lines.

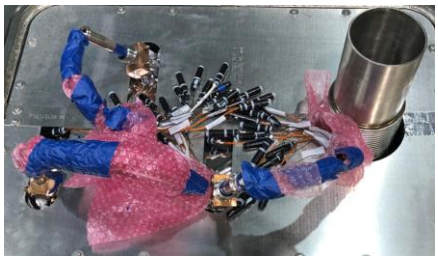
Figure 7: Wires through the pressure transducer lines.

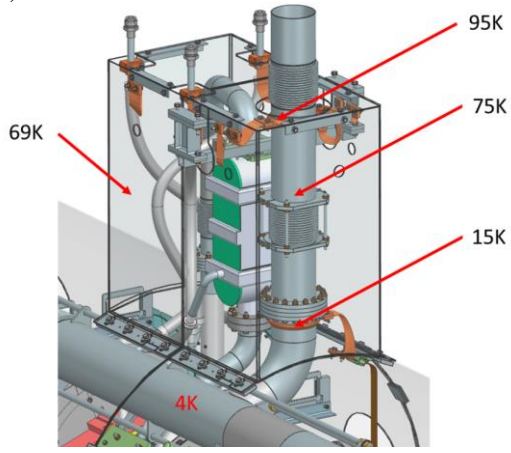
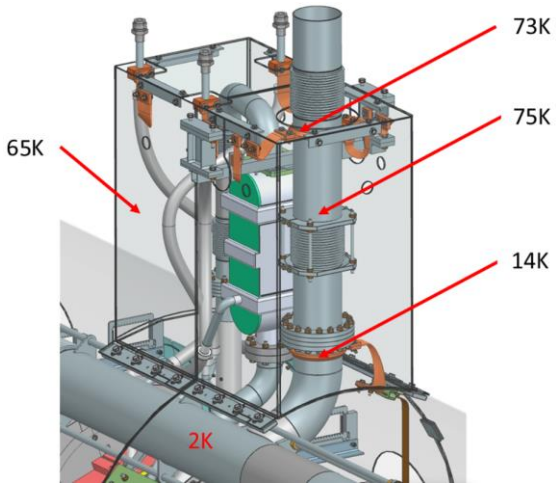
Temperature sensors located on the top part of the HTTS shows a temperature drop switching cavities from 4K to 2K which tends to validate this analysis (See Fig. 8 and Fig. 9)

Figure 8: Temperature values with cavities at 4K.

Figure 9: Temperature values with cavities at 2K.

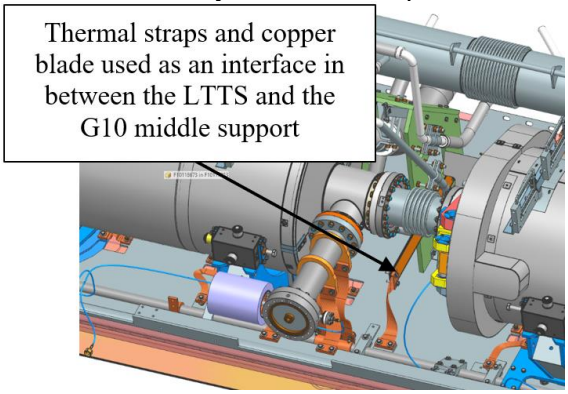
Six temperature sensors are located along this line that shows a temperature increase of 2K in between couplers 4 and 3. This is likely due to the fact that the LTTS line is connected to the G10 middle support (See Fig. 10). Thus, part of the heat loads by radiation ends up on the LTTS.

Figure 10: LTTS / G10 middle support interface.
