FERMILAB-TM-1931

Screw Compressor Bearing Failure at C0#4

Carl Pallaver and Terry Cross

April 1995

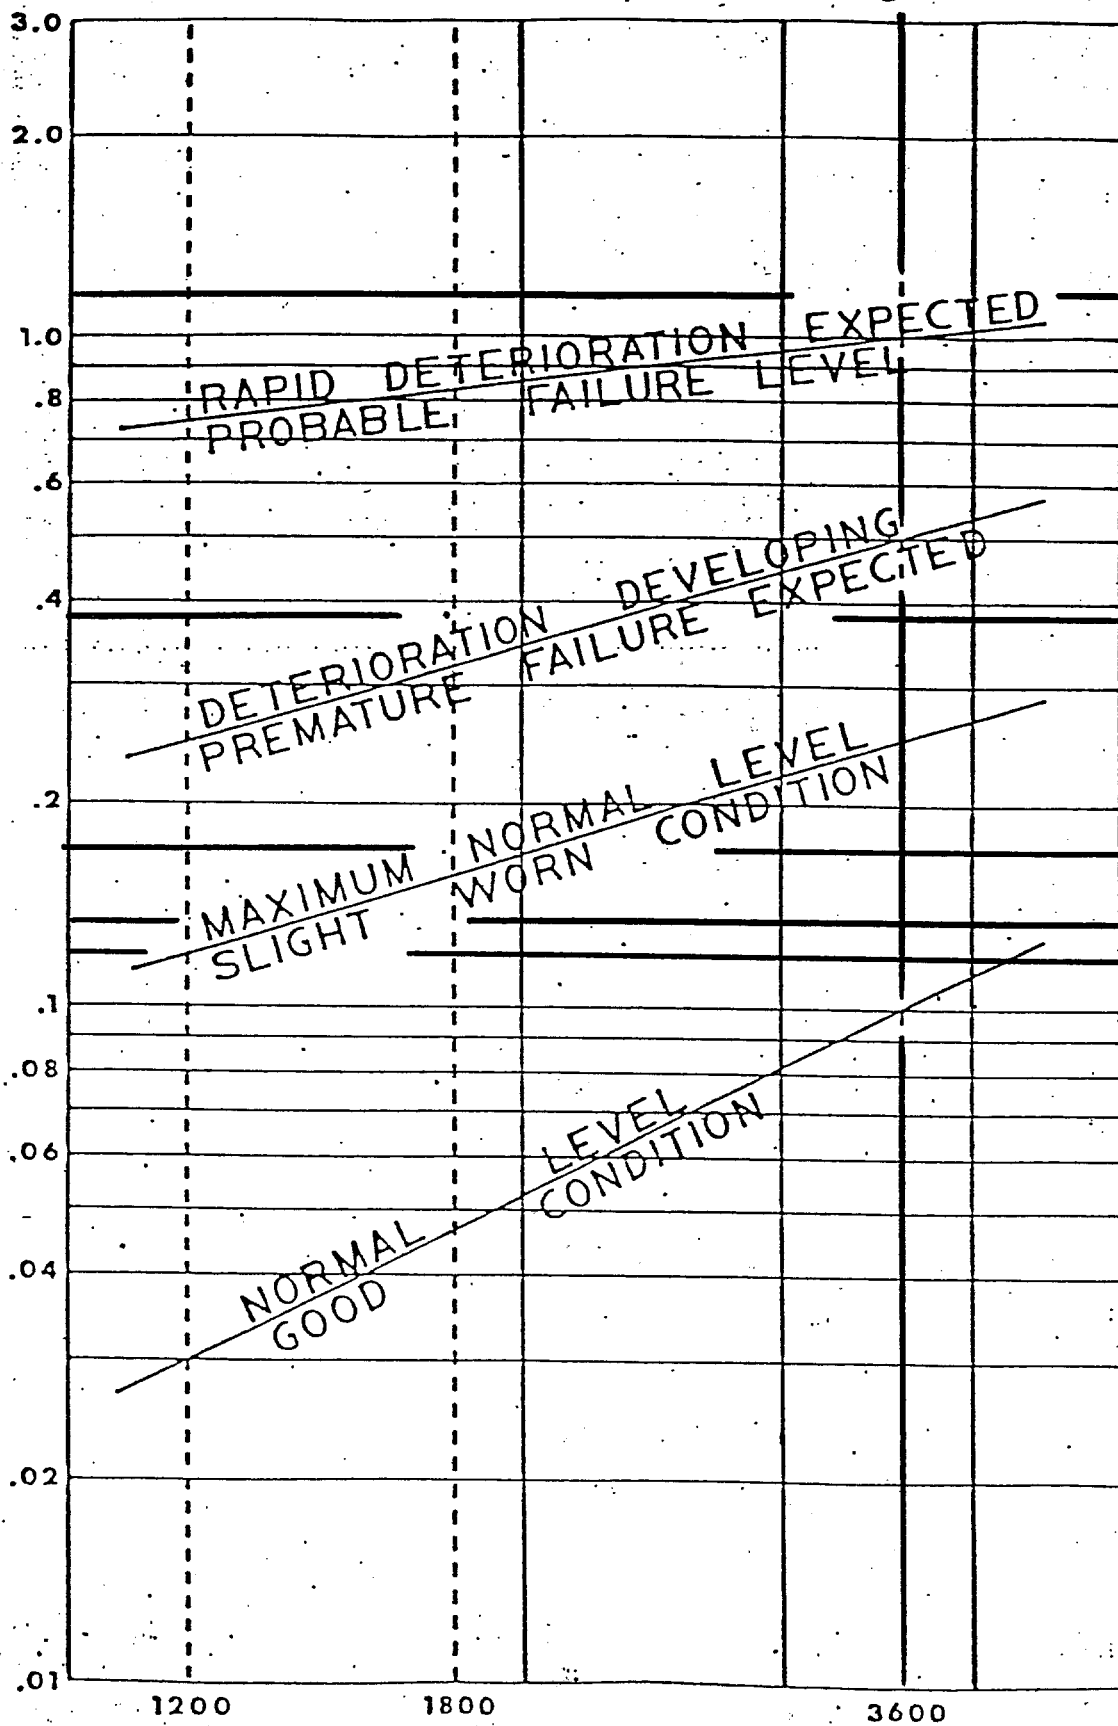
SPIKE ENERGY ACCELERATION (g-SE)

Spike energy readings have the sensitivity required for early detection of bearing failure and ultrasonic measuring of bearings may be a better method for our monthly readings.
