MQXFA11 shipping incident report

US-HiLumi-doc-4341

Date: 08-08-2022

US HL-LHC Accelerator Upgrade Project MQXFA11 shipping incident report

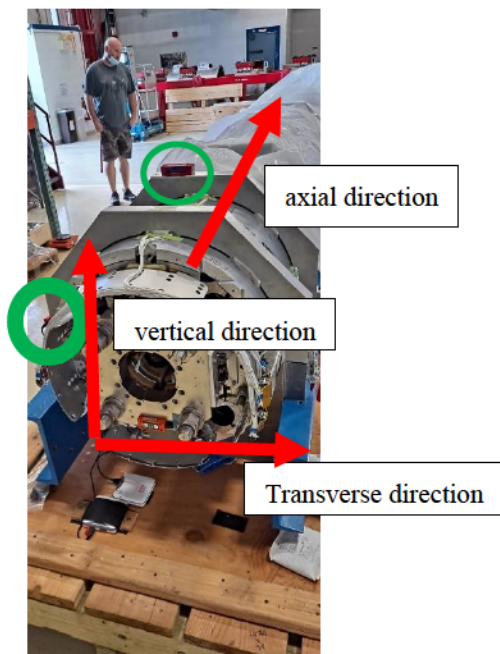
The memory of the devices on the end plate and on lead end fixture clamp was full the day before the accident, therefore only three devices were collecting data during the accident: the two GP1L devices and the slamstick on the non-lead end clamp.

The axes of the accelerometers are oriented in a different way depending on the device position. To avoid any confusion, the reader should refer to the directions defined in Fig.4. Those directions are defined for both for the GP1L and the slamstick devices.

Figure 4: Picture of the MQXFA11 magnet. The green circles identify the accelerometer positions. The red arrows indicate the shock directions used in accelerometer data analysis
