**D-Zero Solenoid Quench Investigation:**  
**Observations, tests, and commentary**  
**Fall 2004 - Spring 2005**

D-ZERO ENGINEERING NOTE # 3823.111-EN-576

March 24, 2005

Russell A. Rucinski, Richard P. Smith

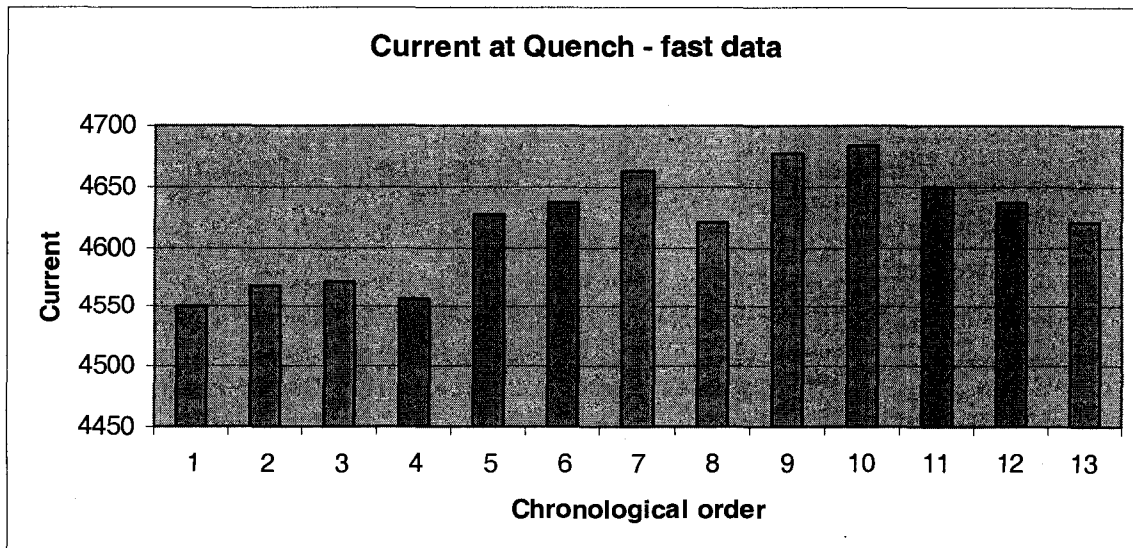
2. The magnet will quench at a steady current (non-changing magnetic field) of 4620 Amperes by raising the liquid helium coolant temperature. This implies that mechanical motion of the superconductor is not to blame for initiating the quench since a temperature increase alone initiates the quench.

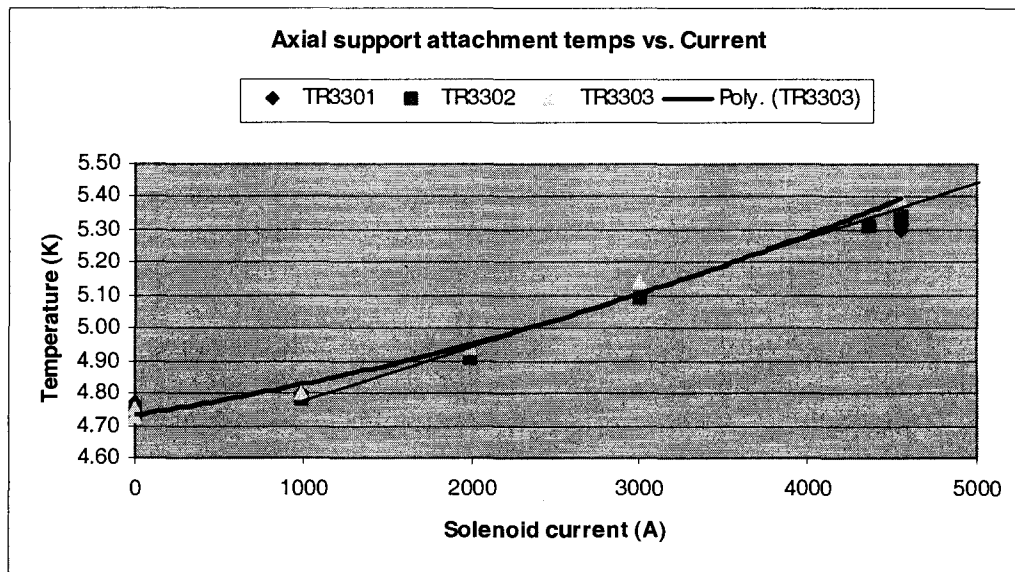
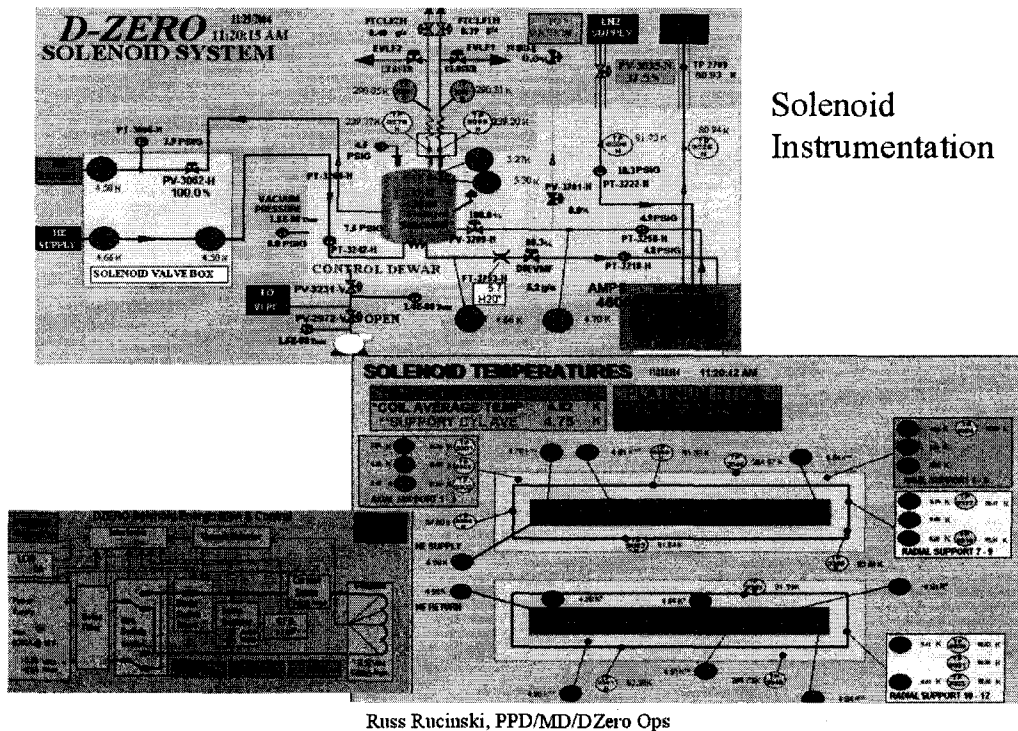
7. The temperature rise of the axial support links is directly related to solenoid current. The graph below demonstrates the rise in temperature with step changes being made to magnet current (red line with rectangular markers). The vertical scale is temperature in degrees Kelvin except for magnet current, which is 0-5000 Amperes. Axial temperature sensors TR3301, TR3302, and TR3303 increase during charging and remain elevated. It is inconclusive if the rise is linear or quadratic.
