REPAIR OF ZGS RING MAGNET COIL DAMAGED CONDUCTOR SECTIONS*

J. A. Bywater, R. C. Niemann,** V. J. Sevcik, R. B. Wehrle
Argonne National Laboratory
Argonne, Illinois 60439

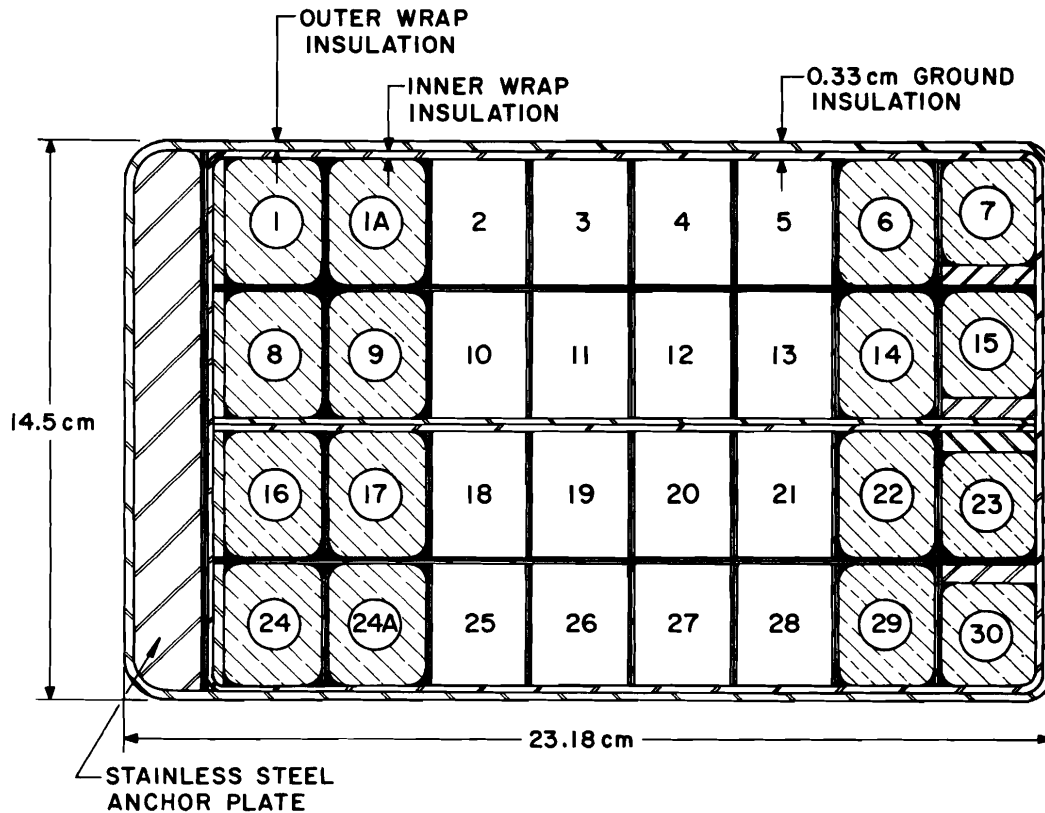
FIG. 2. OUTER SIDE COIL

Figure 1 shows the octant coil and Figure 2 shows the cross section of the outer side coil. The conductor in the inner and outer side coil are continuous bars of copper with a central water cooling hole. At the coil ends half of the conductors are bent vertically upward and the other half are bent vertically downward. Brazed to these vertical conductors are horizontal conductors which complete the electrical circuit
